**ASBESTOS CONTAINING MATERIALS  
SURVEY REPORT**

**103 Retro Street, Emerald QLD 4720**

Report Number 622.10968.00000-0050-R01-ASR-103 Retro St

01 November 2017

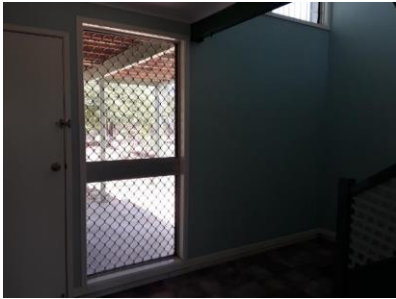
Ground Floor Entrance foyer	Wall throughout , Fibrous Cement	18m <sup>2</sup>	NAD
5-1001

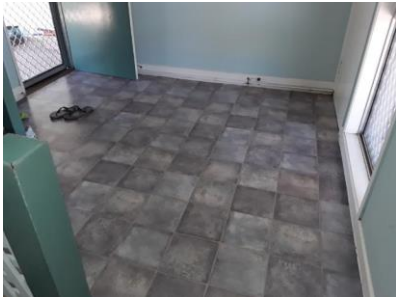
Ground Floor Entrance foyer	Floor vinyl sheet, Vinyl Products	8m <sup>2</sup>	NAD

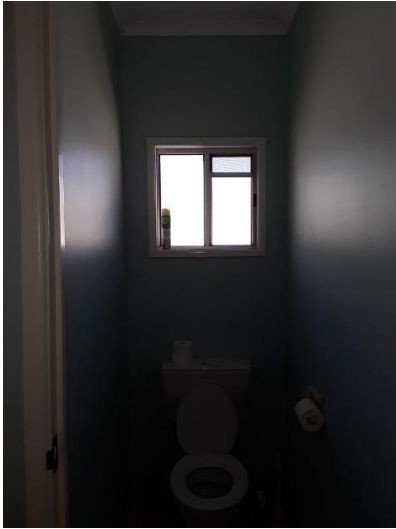
1st Floor Toilet	Wall throughout , Fibrous Cement	10m <sup>2</sup>	NAD
Similar to 5-1002

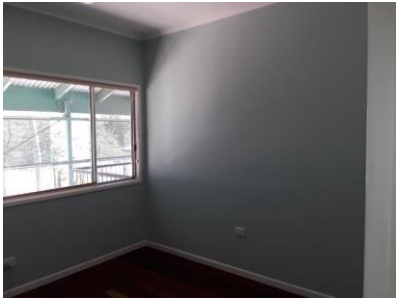
1st Floor Bedroom centre of house	Wall throughout , Fibrous Cement	24m <sup>2</sup>	NAD

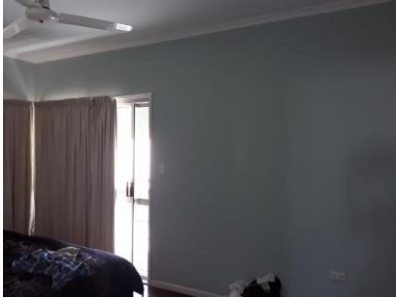
1st Floor Bedroom NW cnr	Wall throughout , Fibrous Cement	30m <sup>2</sup>	NAD
Similar to 5-1002

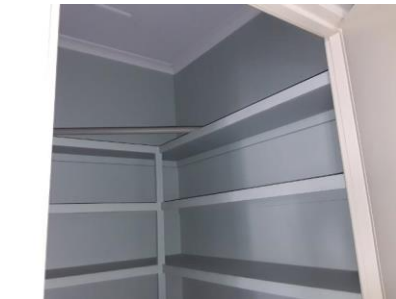
1st Floor Store room in hallway where man hole is located	Wall throughout , Fibrous Cement	15m <sup>2</sup>	NAD
Similar to 5-1002

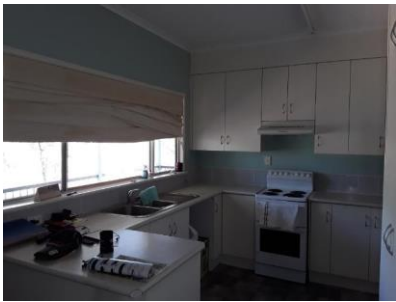
1st Floor Kitchen	Wall throughout , Fibrous Cement	15m <sup>2</sup>	NAD

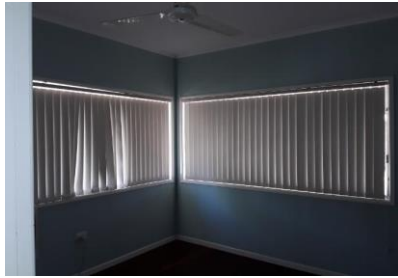
1st Floor Bedroom NW cnr	Wall throughout , Fibrous Cement	18m <sup>2</sup>	NAD
5-995

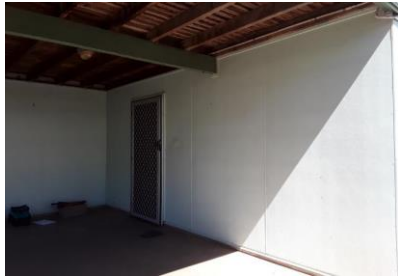
External lower level	Walls sheeting north, south, west, and east sides, Fibrous Cement	80m <sup>2</sup>	NAD
5-1000

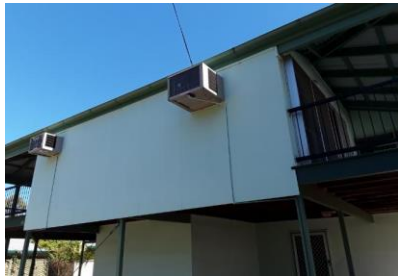
External upper level	Walls sheeting north, south, west, and east sides, Fibrous Cement	90m <sup>2</sup>	NAD
