**ASBESTOS CONTAINING MATERIALS
SURVEY REPORT**

115 Retro Street, Emerald QLD 4720

Report Number 622.10968.00000-0050-R01-ASR-115 Retro St

01 November 2017

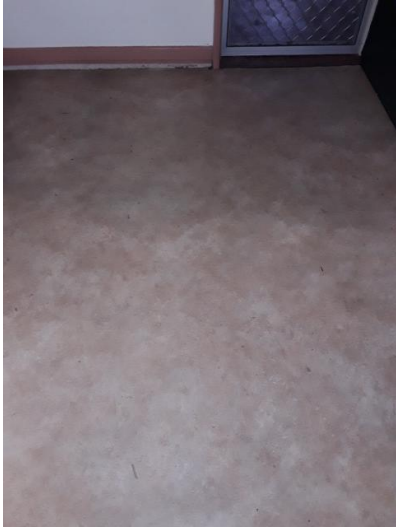
Ground Floor Entrance foyer	Vinyl sheet floor , Vinyl Products	12m ²	NAD

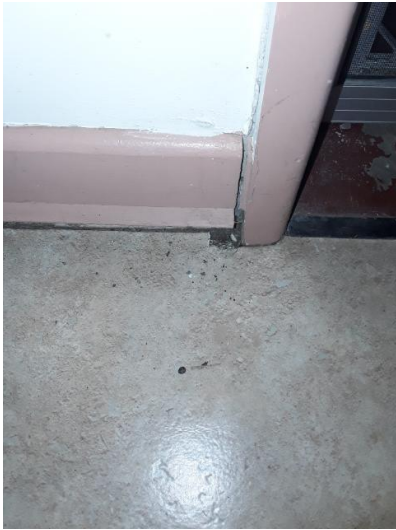
Ground Floor Entrance foyer	Vinyl sheet floor under top layer, Vinyl Products	12m ²	NAD
5-965

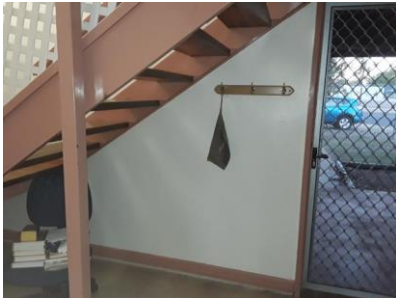
Ground Floor Entrance foyer	Wall, Fibrous Cement	32m ²	NAD

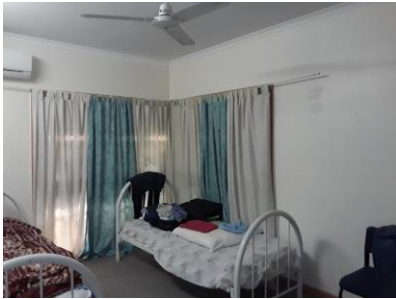
1st Floor Bedroom SW cnr	walls throughout , Fibrous Cement	38m ²	NAD
Similar to 5-962

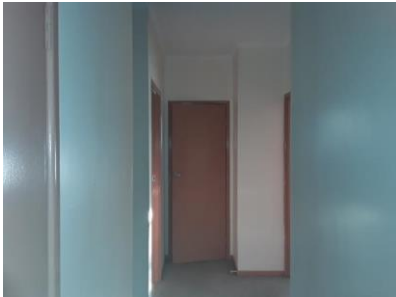
1st Floor Hallway	walls throughout , Fibrous Cement	20m ²	NAD

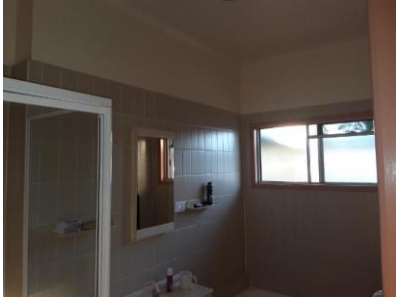
1st Floor Bathroom	Wall, Fibrous Cement	15m ²	NAD
5-953

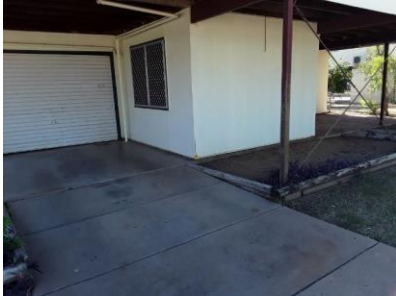
External wall sheeting lower walls - N,S,E, & W Sides	Wall, Fibrous Cement	100m ²	NAD
5-954

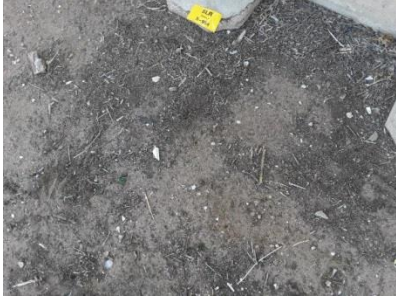
External garden bed on South side of house	Debris on ground, Fibrous Cement	<1m ²	NAD

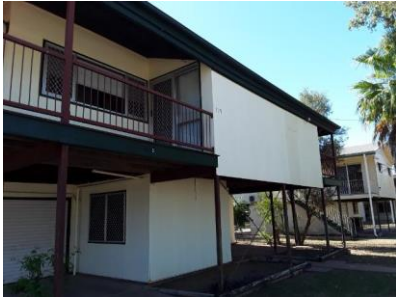
External upper wall sheeting on all sides	Wall, Fibrous Cement	100m ²	NAD
5-964

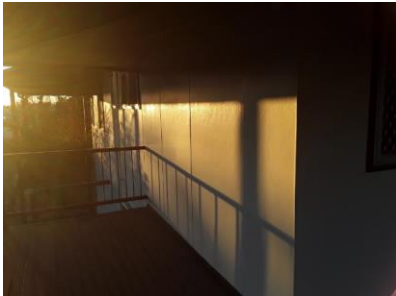
External upper wall sheeting	External Walls - North, south, East, and west, Fibrous Cement	68m ²	NAD
