Division 5 Hazardous Materials Assessment

120 Spencer Street
Melbourne, Victoria

CBRE Asset Services

August 2018

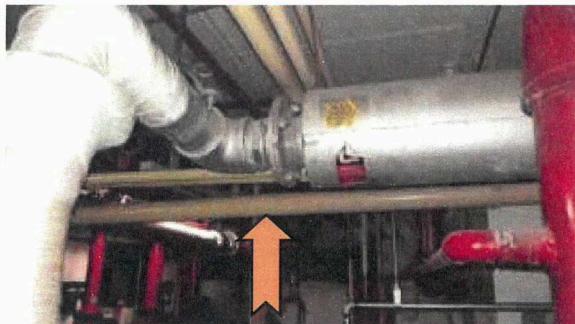
Photo 1. Basement 3 – Hydrant Pump room – Flange – Asbestos-containing gasket material – Noel Arnolds sample J114032-02

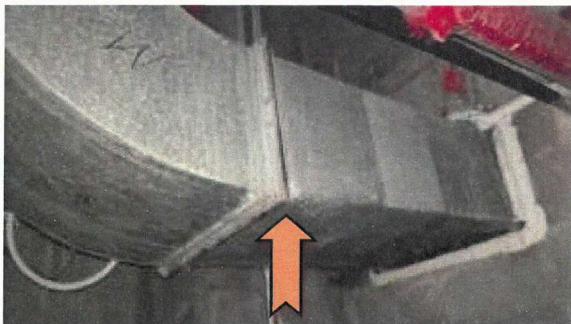
Photo 2. Basement 2 – Car park – Air conditioning riser adjacent diesel storage tank – Asbestos-containing mastic on flanges. Sample 22505-001-003

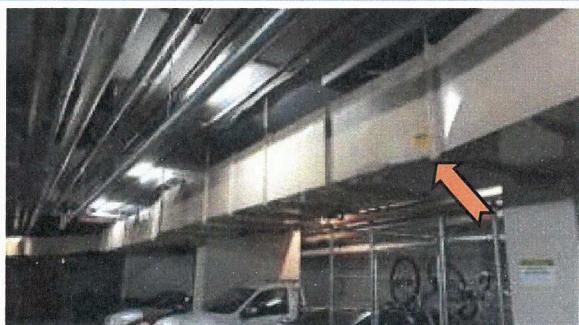
Photo 3. Basement 1- Car park – Square duct work – Flanges – Asbestos-containing mastic. Sample 22505-001-005

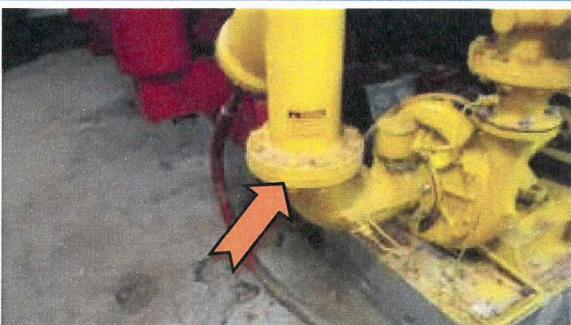
Photo 4. Basement 1 – Plantroom – Pipe work – Flanges – Asbestos-containing gasket material. Sample 22505-001-010A

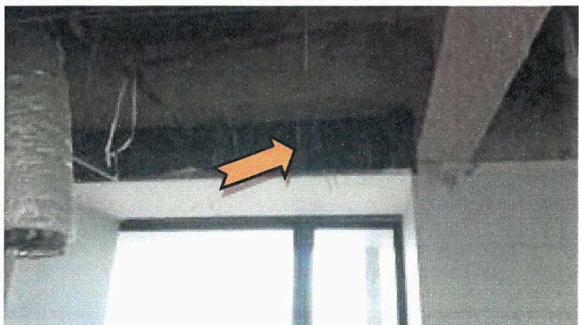
- Friable asbestos was identified in the form of slag on the walls of the Level 23 - Tank storage room and Plant room;
- Friable asbestos was identified in the form of sprayed insulation on columns and brackets within the extended eave cavities located around the perimeter of Level 21 and Level 22. It should be noted that extended eave cavities were not observed on other Levels of the Site;

Photo 5. Level 22 – Extended eave cavity – Perimeter columns – Asbestos-containing sprayed insulation. Sample 22505-001-017

- Access should be restricted to the friable asbestos-containing insulation identified within the extended eave cavities on Levels 21 and 22. The installation of a physical barrier would suitably enclose the gap above the perimeter windows and prevent access to the asbestos insulation. As the installation of the barrier may inadvertently disturb the asbestos, the barrier should be installed by a ‘Class A’ asbestos removal contractor under controlled conditions. Accessible vermiculite dust and debris suspected to contain asbestos should also be removed in conjunction with the barrier installation. Alternatively, the asbestos insulation can be removed by a ‘Class A’ licenced asbestos removal contractor;

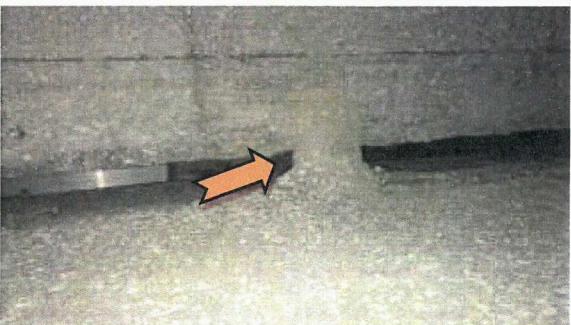
Photo 6. Level 22 – Extended eave cavity – Bracket - Asbestos-containing sprayed insulation. Sample 22505-001-017

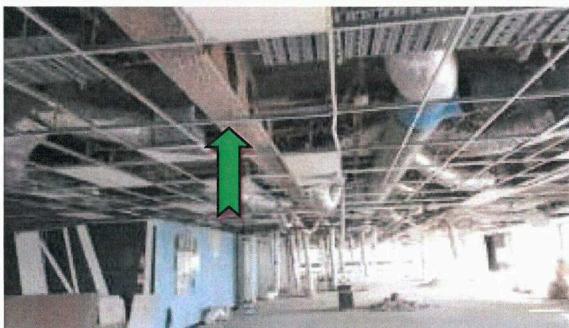
Photo 7. Level 22 – Ceiling space – Structural beams – Non asbestos-containing sprayed vermiculite. Sample 22505-001-015

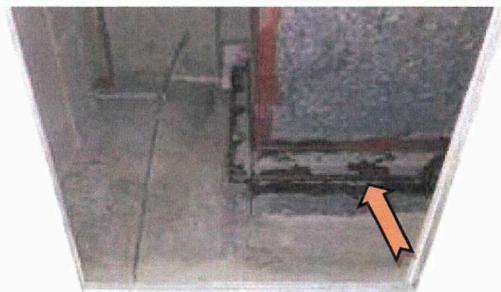
Photo 8. Level 10 – Service Riser– North end – Open heater bank and ductwork – Asbestos-containing red mastic. Sample 22505-001-027

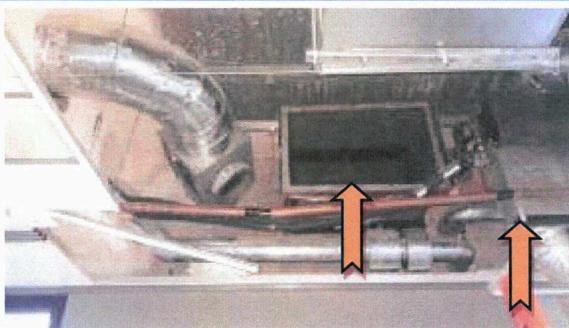
Photo 9. Level 19 – General tenancy – North end – Open heater bank and ductwork – Asbestos-containing grey mastic. Sample 22505-001-027

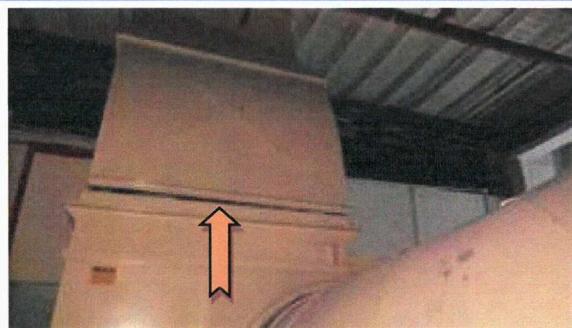
Photo 10. Level 23 – Plantroom – Square ductwork – Asbestos-containing mastic on flanges. Sample 22505-001-035.

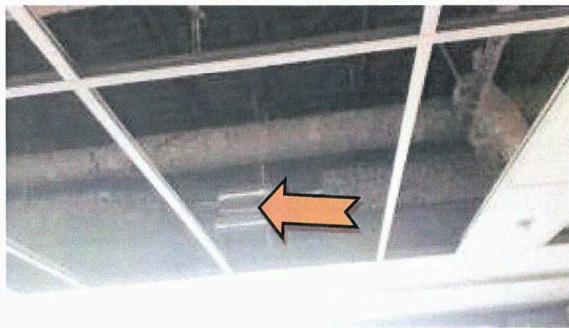
Photo 11. Level 20 - Ceiling space – Pipe work to heaters around perimeter – Foam insulation with non-asbestos-containing bitumen layer. Sample 22505-001-025.

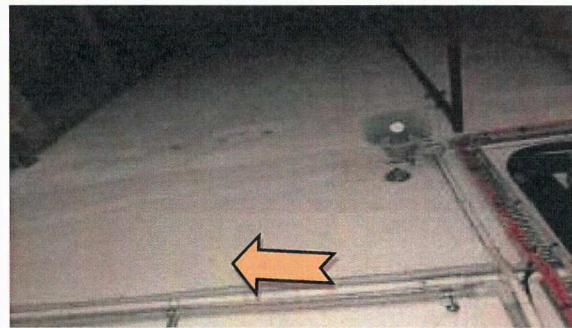
Photo 12. Level 23 – Plantroom – West wall adjacent tank storage room – Asbestos-containing slag. Sample 22505-001-(036-037)

- Friable asbestos-containing insulation debris in poor condition was identified beneath beams on top of the brick wall within the Level 23 – Tank storage room. In addition to the aforementioned debris, asbestos-containing insulation slag bound within the paintwork was identified on to be present on the walls of the tank storage room. As such, Prensa recommends that the area be isolated until such time the asbestos-containing materials be removed by a ‘Class A’ licenced asbestos removal contractor. The removal works should be undertaken under friable asbestos conditions;

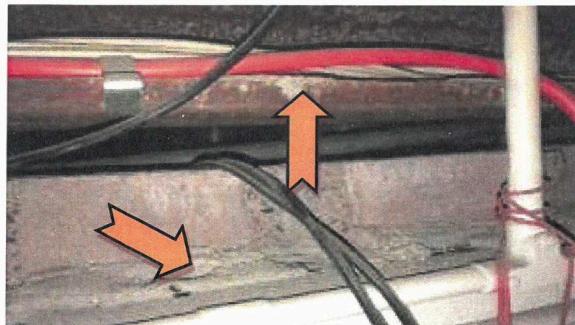
- Friable asbestos in poor condition was identified in the form of loose insulation beneath metal beams on top of brick walls of Level 23 – Tank storage room;

Photo 13. Level 23 – Plantroom – West wall of tank storage room. Loose asbestos debris on top of brick walls, below metal beams. Sample 22505-001-039

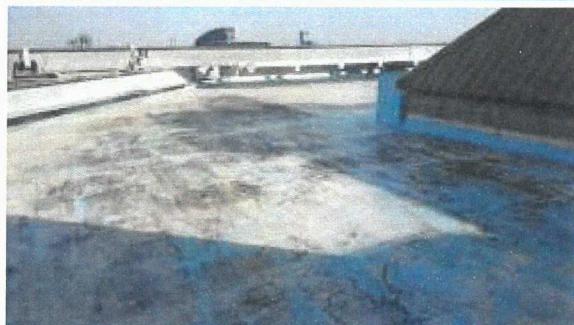
Photo 14. Roof – Floor – Water proofing – non asbestos-containing Malthoid. Sample 22505-001-046.
