**ASBESTOS CONTAINING MATERIALS  
SURVEY REPORT**

**15 Willans Street, Emerald QLD 4720**

Report Number 622.10968.00000-0050-R01-ASR-15 Willans St

01 November 2017

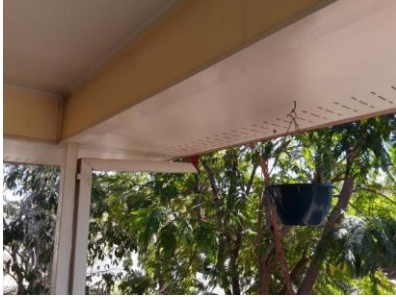
External Soffits all sides	Soffit, Fibrous Cement	48m <sup>2</sup>	NAD
2-002

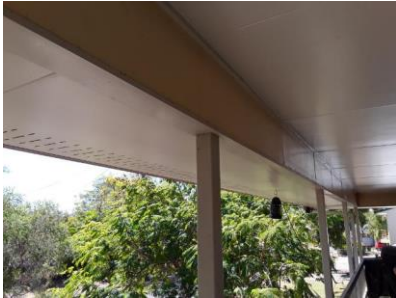
External Front porch fascia	Fascia , Fibrous Cement	28m <sup>2</sup>	NAD
