ASBESTOS CONTAINING MATERIALS SURVEY REPORT

185 Borilla Street, Emerald QLD 4720

Report Number 622.10968.00000-0050-R01-ASR-185 Borilla St

01 November 2017

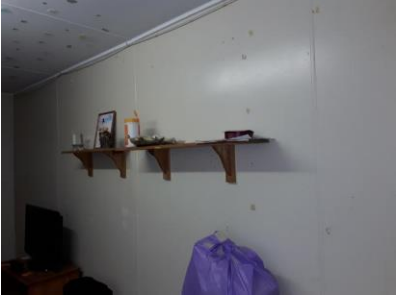
Ground Floor Storeroom in garage area	Walls throughout, Fibrous Cement	28m ²	NAD
Similar to 3-004

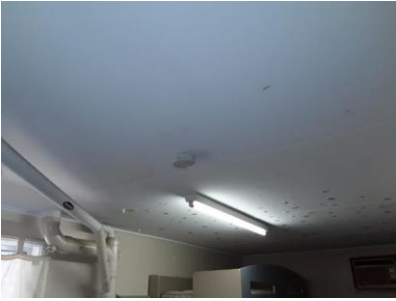
Ground Floor Storeroom in garage area	Ceiling, Fibrous Cement	10m ²	NAD

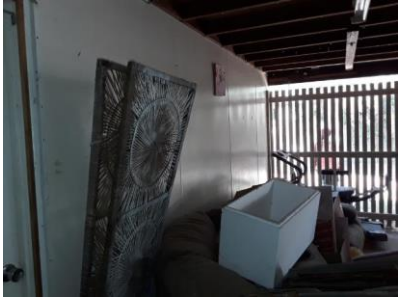
Ground Floor Storeroom in garage area	External walls, Fibrous Cement	24m ²	NAD
Similar to 3-004

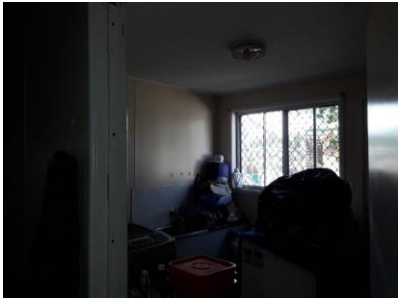
Ground Floor laundry	Walls throughout internally and externally, Fibrous Cement	32m ²	NAD
Similar to 3-004

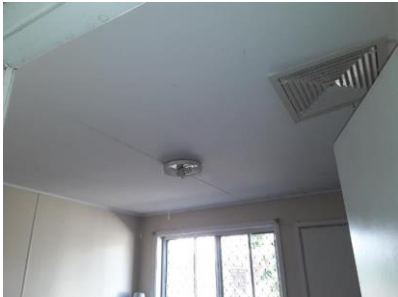
Ground Floor Storeroom in garage area	Ceiling, Fibrous Cement	4m ²	NAD

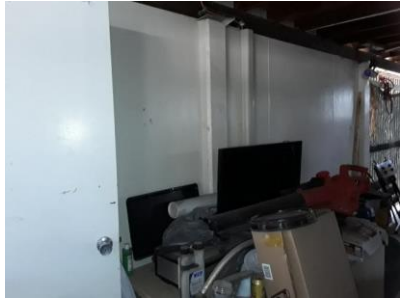
Ground Floor garage internal	Northern wall, Fibrous Cement	6m ²	NAD
Similar to 3-004

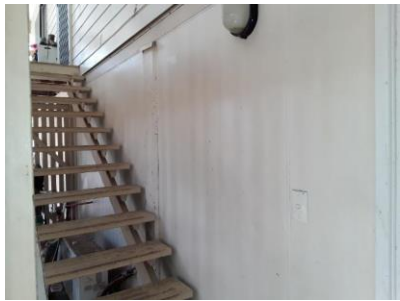
Ground Floor Stairway to level 1	Wall sheeting, Fibrous Cement	10m ²	NAD
3-001

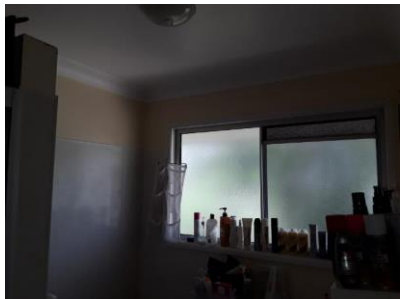
1st Floor Bathroom	Walls throughout , Fibrous Cement	10m ²	NAD

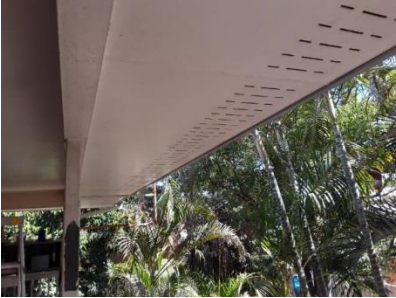
External External - soffits north,south,east,and west	Soffit fluted, Fibrous Cement	45m ²	NAD
3-003

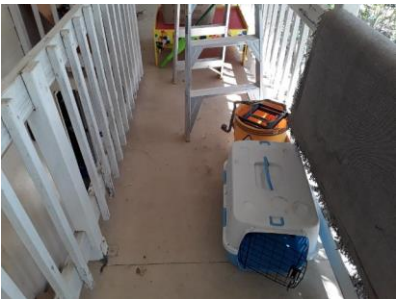
External Front porch	Floor , Fibrous Cement	20m ²	NAD
3-005

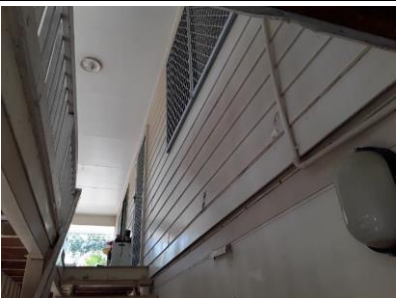
External External cladding	Cladding , Fibrous Cement	100m ²	NAD

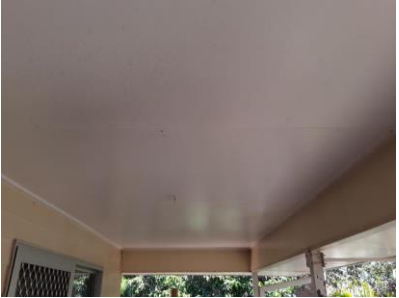
External Front porch	Ceiling and surrounding fascias, Fibrous Cement	30m ²	NAD
