# 400 Kent Street Asbestos Assessment

400 Kent Street Street, Sydney, NSW 2000

Prepared for: CBRE

EP0777.001 | 16 March 2018

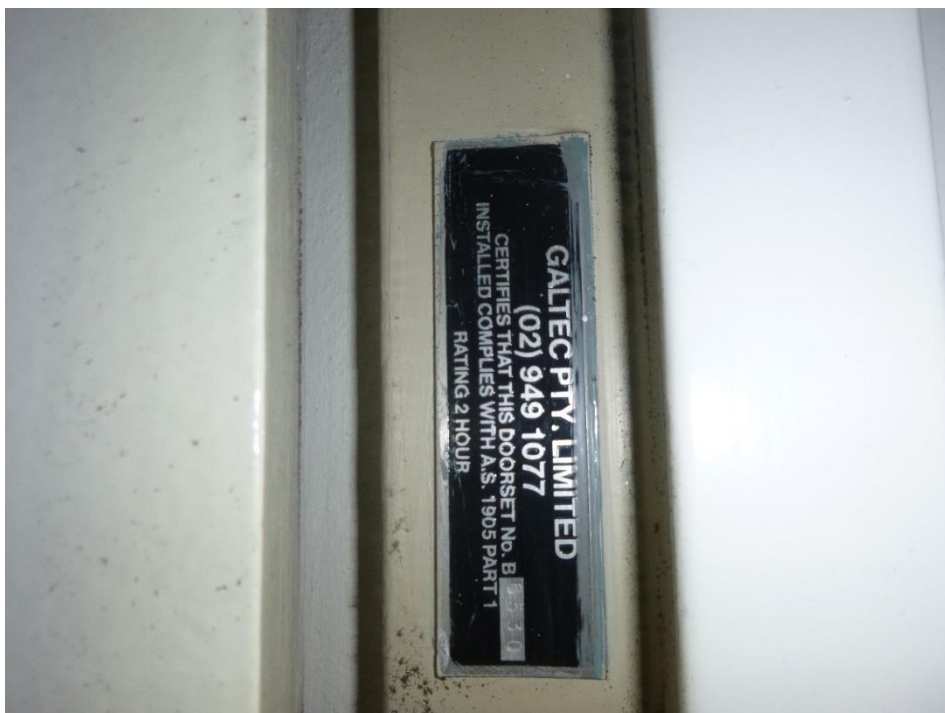
| Location<br>(Sample Identification) | Sample Position<br>/ Type | Hazard Group | Photo<br>ref: | Approx.<br>Extent | Friability | Sealed | Condition | Potential for<br>Disturbance | Risk of<br>exposure |
|---|---|---|---|---|---|---|---|---|---|
| Levels 1 – 11<br>Northern and southern fire stair<br>wells<br>Fire doors<br>(Not sampled – sealed items) | Fire door core <sup>3</sup> | <b>Asbestos<br/>(Suspected<br/>Positive)<sup>4</sup></b> | Plate<br>2 | 22 units | Non-<br>friable | Not<br>sealed | Good | Low | Low |

<sup>3</sup> Evidence would suggest that an extensive study was done involving the fire doors of both fire escape stairwells. Most of the doors inspected within these two (2) areas had a hole drilled into the top which was plugged with a heavy-duty filler. No supporting documentation has been made available to EP Risk prior to this report being written.

<sup>4</sup> Due to the age and appearance of the tags associated with these doors, EP Risk considers it likely that these doors contain asbestos. The tags also do not specify a year of manufacture or installation.

**Plate 2** – Levels 1 – 11, fire escape stairwells, fire doors – suspected asbestos-containing fire door core. No definitive markings present such as manufacturing or installation data found on newer fire doors.  
**Date:** 09/03/2018

- EP Risk recommends further investigation into the possible existence of asbestos within the fire door cores of both the northern and southern fire stairwell doors. At present these sets of doors are suspected to contain friable asbestos due to the age and appearance of the doors and the information tags on the door spines, which have a lack of manufacturing and installation data that is typically found on newer, non-asbestos doors.
- During demolition/refurbishment works, if any suspected ACM are encountered that are not referenced in this Assessment, then works must cease and an asbestos hygienist should be notified to determine whether the material contains asbestos
- The ACM identified in **Table 2** should be removed from Site and disposed of as **Special Waste (Asbestos)** at a suitably licensed waste facility lawfully able to accept the waste.

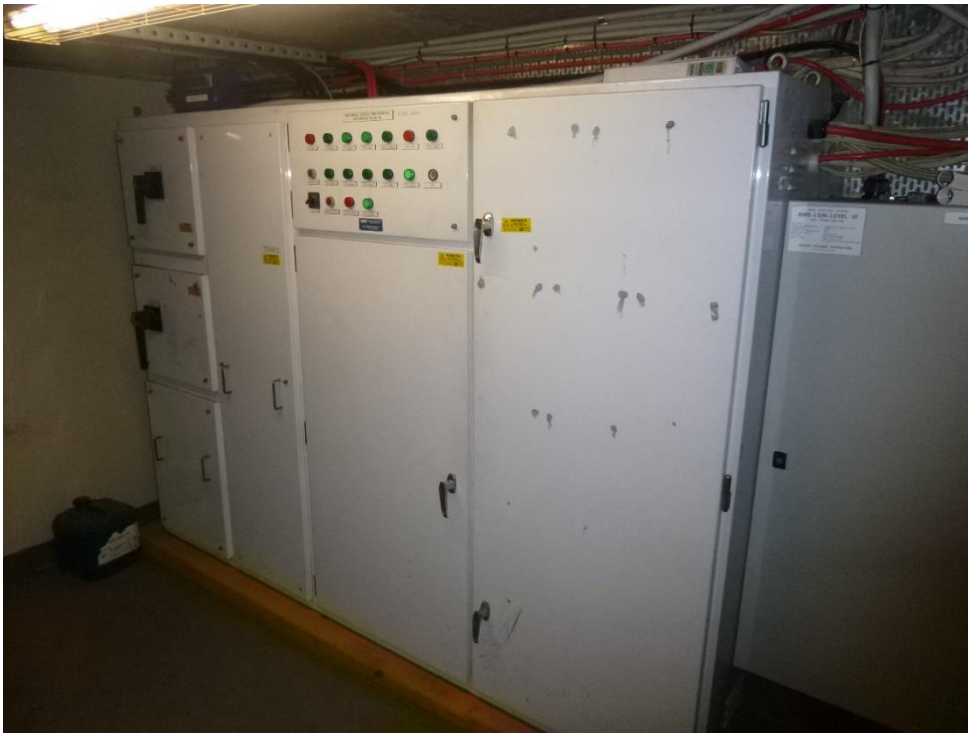
| Location<br>(Sample Identification) | Sample Position<br>/ Type | Hazard Group | Photo<br>ref: | Approx.<br>Extent | Friability | Sealed | Condition | Potential for<br>Disturbance | Risk of<br>exposure |
|---|---|---|---|---|---|---|---|---|---|
| Level 12<br>Plant room – central<br>“Mechanical Services Non-Essential<br>Switchboard No. SB-12A”<br>(Not sampled – Electrical Hazard) | Switch board<br>- bituminous<br>backing board | <b>Asbestos<br/>(GreenCap:<br/>Presumed<br/>Positive)<sup>5</sup></b> | Plate<br>3 & 4 | 2 m <sup>2</sup> | Non-<br>friable /<br>bonded | No | Good | Low | Low |

<sup>5</sup> Item suspected to contain asbestos by GreenCap 2017. During EP Risk's 2018 inspection all panels of unit were opened, and no suspected asbestos-containing backing boards were noted. There is potential for several asbestos-containing fuses to be present, further investigation may be required whilst unit is de-energised.

**Plate 3** – Level 12, plant room, central area, electrical board “Mechanical Services Non-Essential Switchboard No. SB-12A” wide angle view of the whole panel enclosure.

- EP Risk deems the likelihood for asbestos to be present within the two (2) electrical boards of the level 12 Plant Room to be very low and as such does not recommend removing these electrical backing boards.

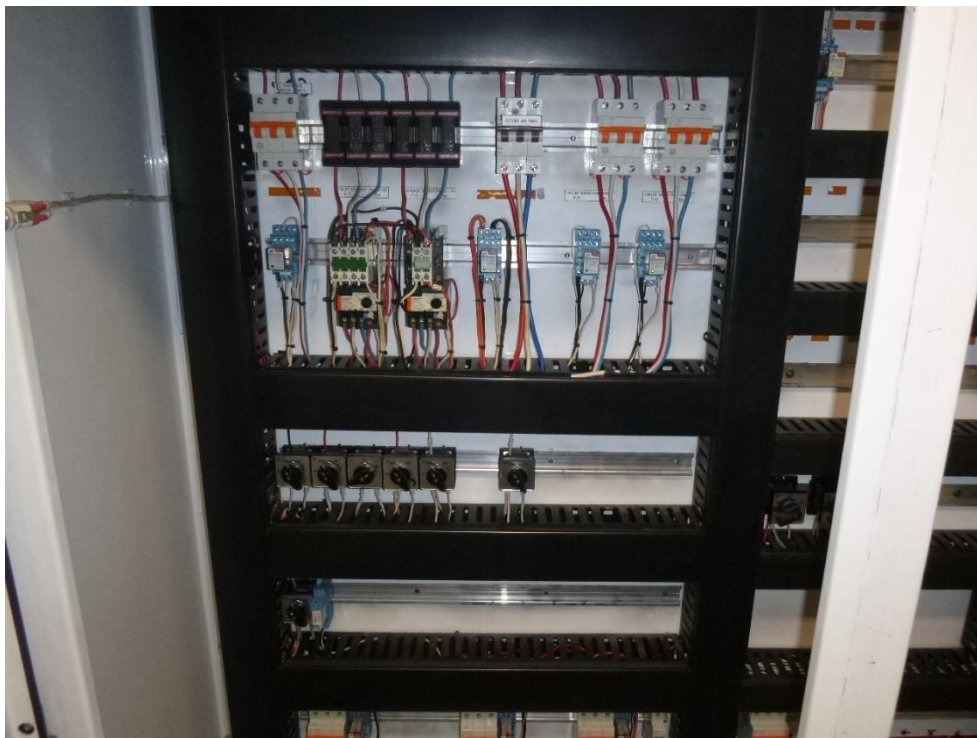
**Plate 4** – View of the internal components within the electrical board: “Mechanical Services Non-Essential Switchboard No. SB-12A”. No asbestos visually detected. Panel was live therefore no sampling undertaken.

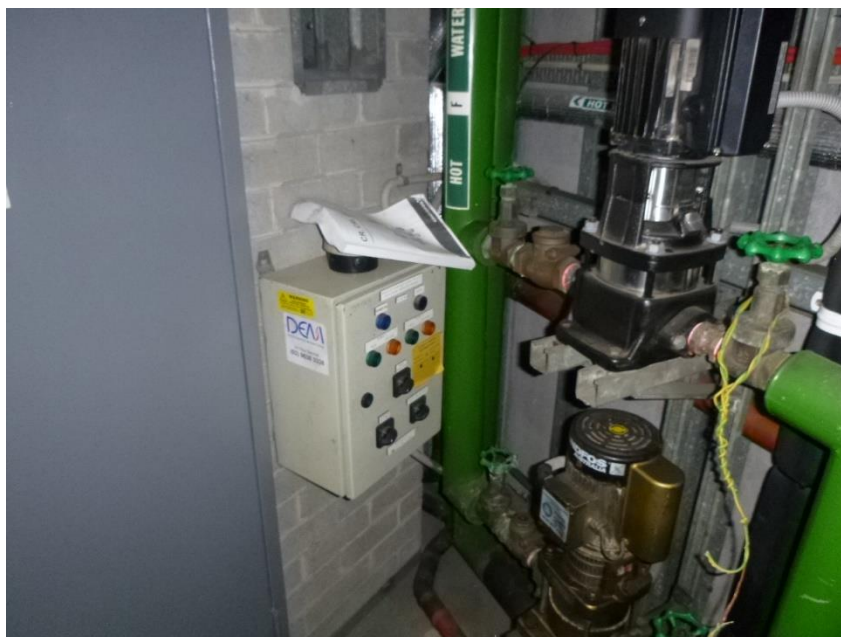
| Location<br>(Sample Identification) | Sample Position<br>/ Type | Hazard Group | Photo<br>ref: | Approx.<br>Extent | Friability | Sealed | Condition | Potential for<br>Disturbance | Risk of<br>exposure |
|---|---|---|---|---|---|---|---|---|---|
| Level 12<br>Plant room – north western area<br>Adjacent double doors to Hydrant<br>Diesel Pump<br>(Not sampled due to Live Electrical<br>Hazard) | Switch board<br><br>- bituminous<br>backing board | <b>Asbestos<br/>(GreenCap:<br/>Presumed<br/>Positive) <sup>6</sup></b> | Plate<br>5 & 6 | 1 m <sup>2</sup> | Non-<br>friable /<br>bonded | No | Good | Low | Low |

<sup>6</sup> Item suspected to contain asbestos by GreenCap 2017. During EP Risk's 2018 inspection internal components were inspected, no suspected asbestos-containing backing boards were noted. There may be potential for several asbestos-containing insulation products to be present. Further investigation may be required whilst unit is de-energised.

**Plate 5** – Level 12, Plant room – north western area, adjacent double doors to Hydrant Diesel Pump  
Not sampled due to Live Electrical Hazard.

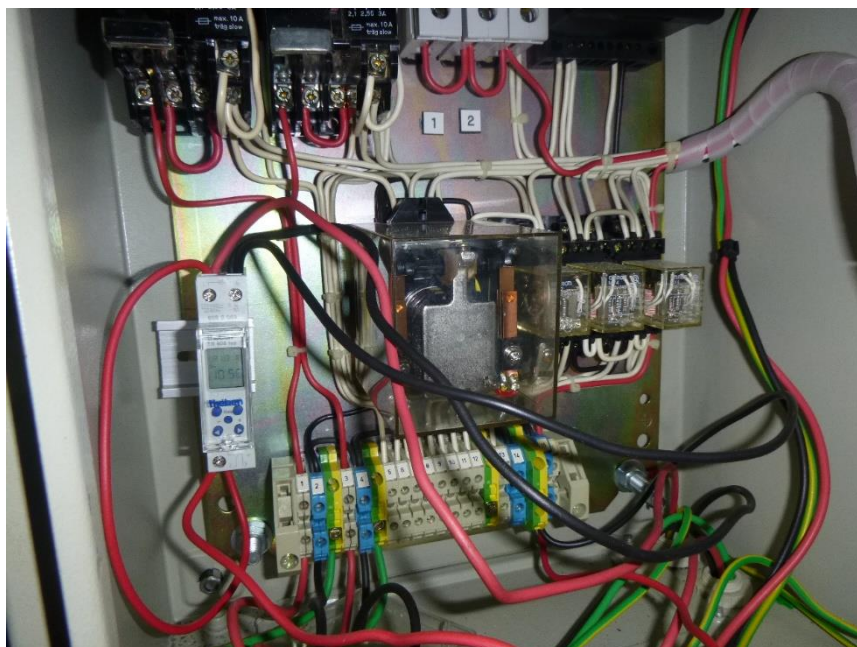
**Plate 6** – Level 12, Plant room – north western area, adjacent double doors to Hydrant Diesel Pump. A view of the internal components within the electrical board. No asbestos was visually detected.

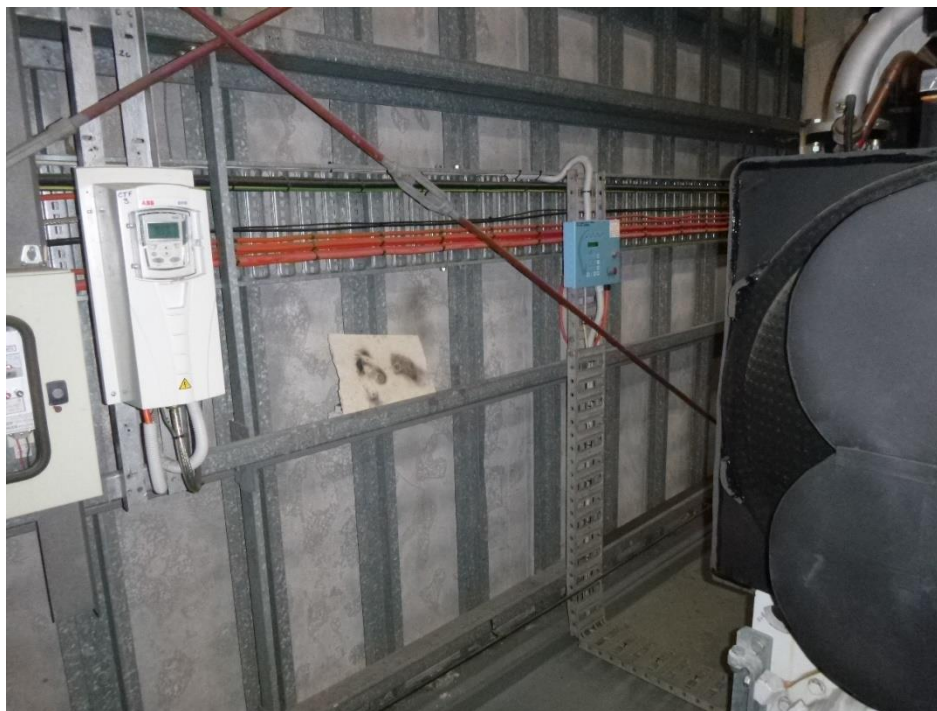
| Location<br>(Sample Identification) | Sample Position<br>/ Type | Hazard Group | Photo<br>ref: | Approx.<br>Extent | Friability | Sealed | Condition | Potential for<br>Disturbance | Risk of<br>exposure |
|---|---|---|---|---|---|---|---|---|---|
| Level 12<br>Plant room<br>Southern wall ledge<br>Adjacent Chiller No.1<br>(EP0777_ACM_001) | Stored fibre<br>cement sheet<br><br>- Fibre cement<br>sheeting debris | Asbestos<br><br>(No Asbestos<br>Detected) | Plate<br>7 | - | - | - | - | - | - |

**Plate 7** – Level 12, Plant Room, southern wall ledge adjacent to Chiller No.1. Fibre cement debris.  
**No Asbestos Detected ('NAD')**  
**Date:** 09/03/2018

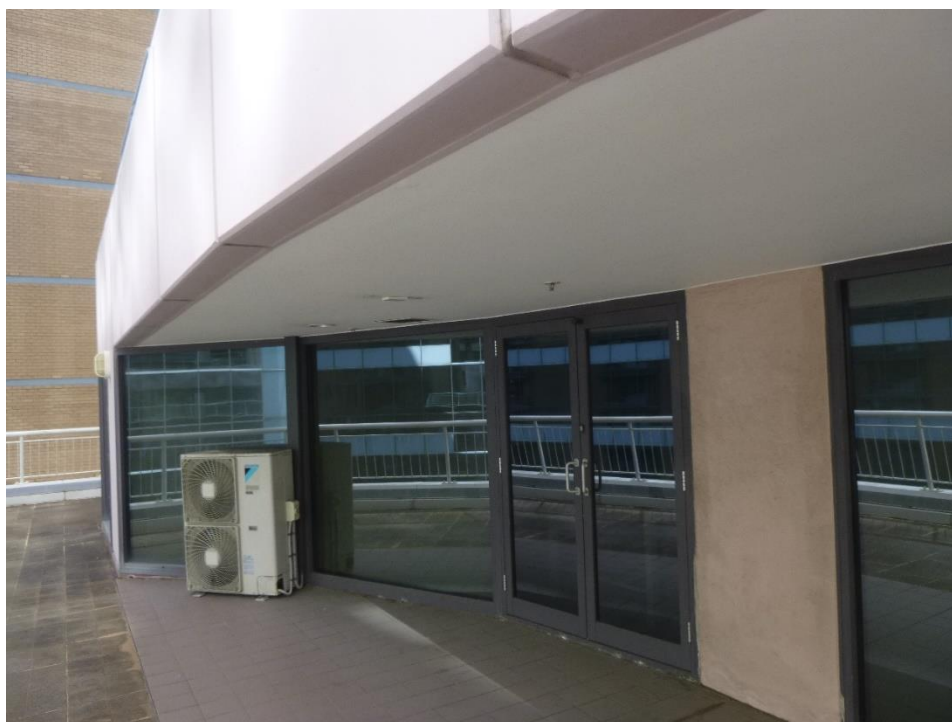
| Location<br>(Sample Identification) | Sample Position<br>/ Type | Hazard Group | Photo<br>ref: | Approx.<br>Extent | Friability | Sealed | Condition | Potential for<br>Disturbance | Risk of<br>exposure |
|---|---|---|---|---|---|---|---|---|---|
| Level 11<br>Exterior<br>Terrace area surrounding offices.<br>Western side<br>Ceiling<br>(EP0777_ACM_002) | Fibre cement<br>sheeting | Asbestos<br><br>(No Asbestos<br>Detected) | Plate<br>8 | - | - | - | - | - | - |

**Plate 8** – Level 11, exterior western terrace, ceiling – fibre cement sheeting. **NAD**  
**Date:** 09/03/2018

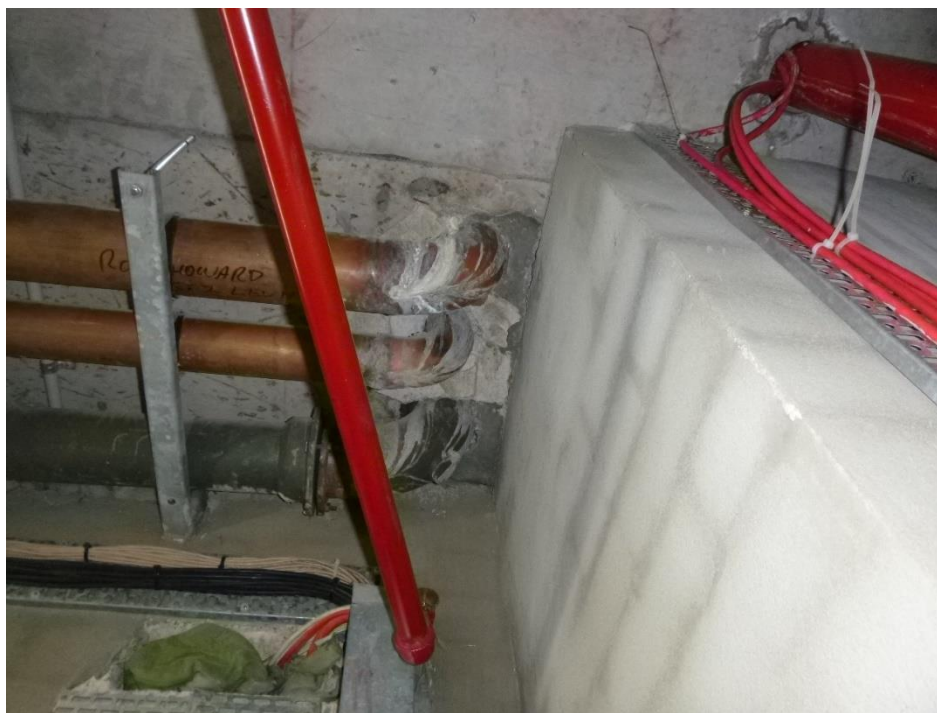
| Location<br>(Sample Identification) | Sample Position<br>/ Type | Hazard Group | Photo<br>ref: | Approx.<br>Extent | Friability | Sealed | Condition | Potential for<br>Disturbance | Risk of<br>exposure |
|---|---|---|---|---|---|---|---|---|---|
| Level 11<br>Plant room<br>Ceiling<br>Penetration – covering<br>(EP0777_ACM_003) | Fibre cement<br>sheeting | Asbestos<br>(No Asbestos<br>Detected) | Plate<br>9 | - | - | - | - | - | - |

**Plate 9** – Level 11, Plant Room, ceiling penetration, covering – fibre cement sheet. **NAD**  
Date: 09/03/2018

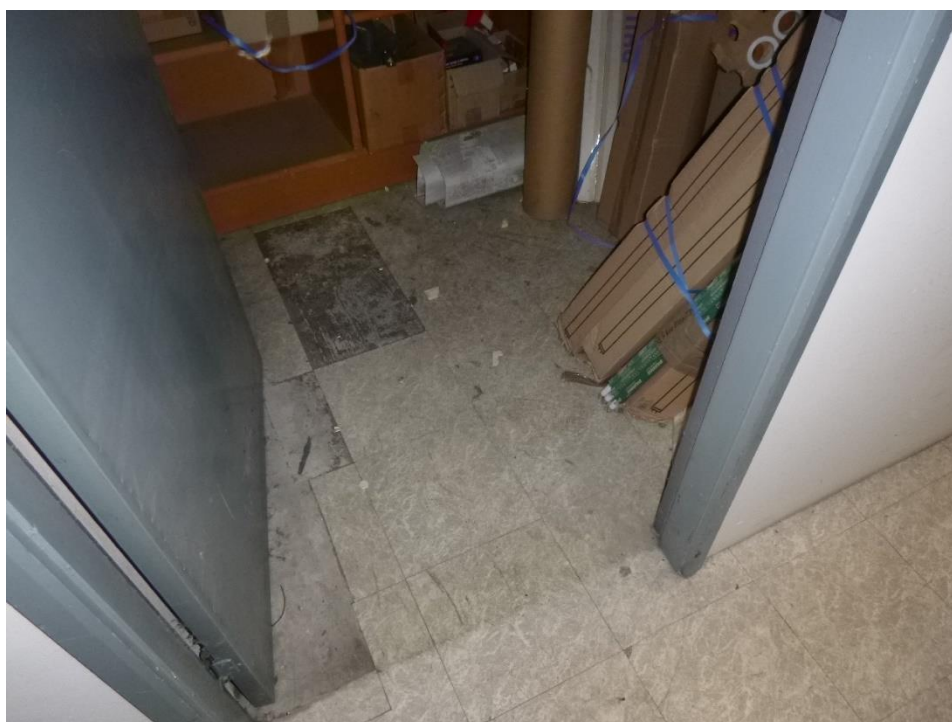
| Location<br>(Sample Identification) | Sample Position<br>/ Type | Hazard Group | Photo<br>ref: | Approx.<br>Extent | Friability | Sealed | Condition | Potential for<br>Disturbance | Risk of<br>exposure |
|---|---|---|---|---|---|---|---|---|---|
| Ground level<br>Back of House areas<br>Floor<br>(EP0777_ACM_004) | Cream speckled<br>floor coverings<br><br>- Vinyl floor<br>tiles <sup>7</sup> | Asbestos<br>(No Asbestos<br>Detected) | Plate<br>10 | - | - | - | - | - | - |

<sup>7</sup> Of the variety of vinyl floor tiles tested no samples returned positive results for the presence of asbestos, this does not mean that all vinyl floor tiles within the complex are non-asbestos-containing. Due to the variety and style of vinyl floor tiles that exist at the complex, apartments/rooms that were not tested or are not listed in this report should be inspected and assessed on an individual basis.

**Plate 10** – Ground level, back of house areas, floor coverings, cream with grey speckles vinyl floor tiles. **NAD**  
Date: 09/03/2018
