29 August 2016

J0001:AHS

21397 Asbestos Labelling Report

## **Asbestos-Containing Materials Labelling Summary for 120 Spencer Street, Melbourne, Victoria**

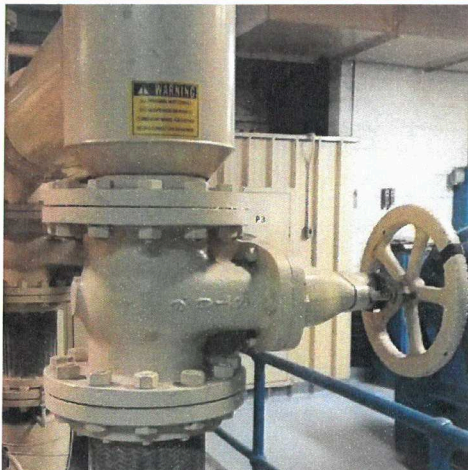
**Photo 1.** Level 23, Plant Room, Pump 1, Hot Water Piping - Gasket

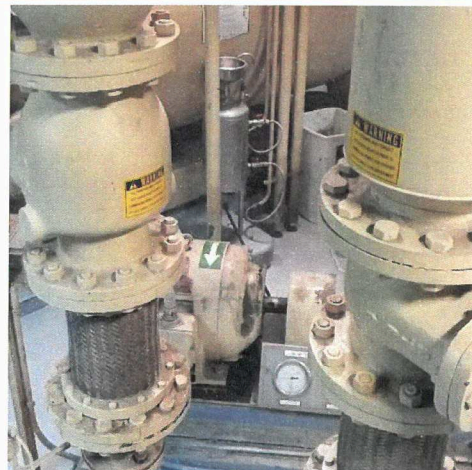
**Photo 2.** Level 23, Plant Room, Pump 1, Hot Water Piping - Gasket

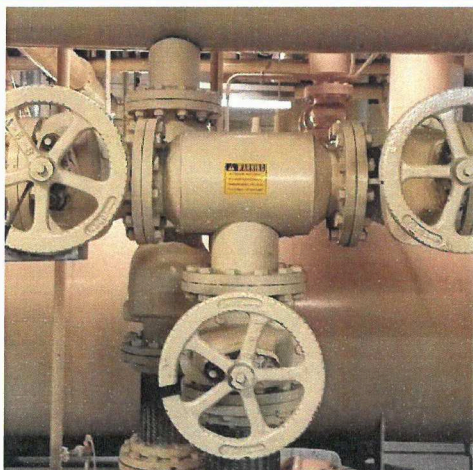
**Photo 3.** Level 23, Plant Room, Pump 1, Hot Water Piping, 3 Way Junction - Gasket

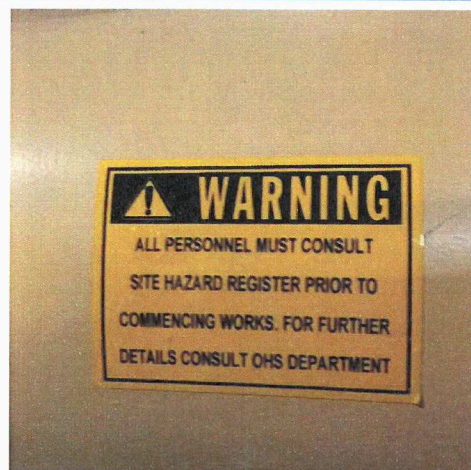
**Photo 4.** Level 23, Plant Room, Pump 1, Hot Water Pipework - Gasket

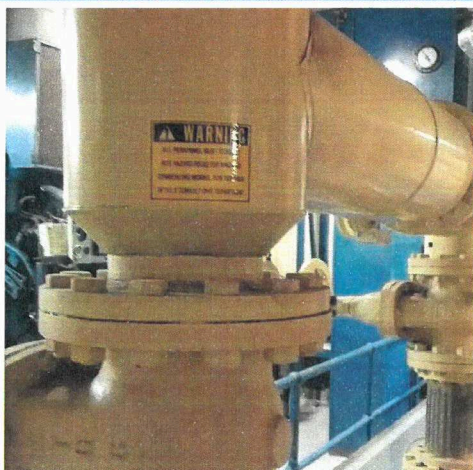
**Photo 5.** Level 23, Plant Room, Standby Pump 1, Hot Water Piping - Gasket

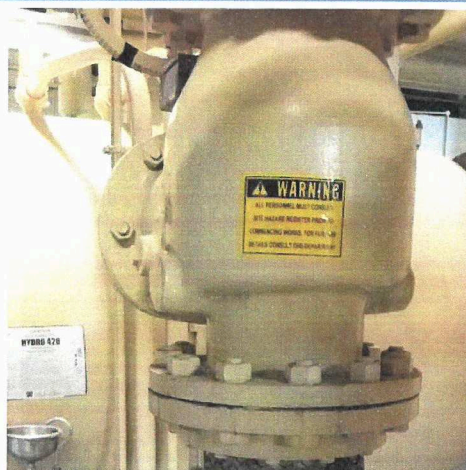
**Photo 6.** Level 23, Plant Room, Pump 2, Hot Water Piping - Gasket

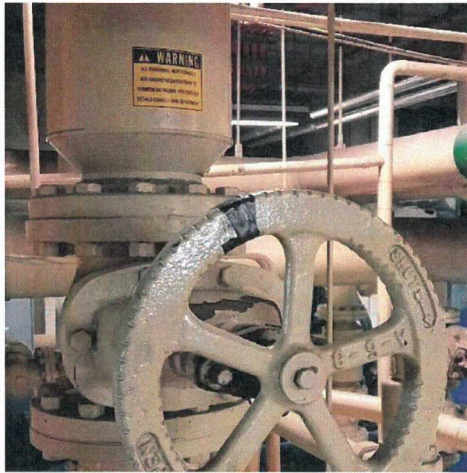
**Photo 7.** Level 23, Plant Room, Boiler 1 - Gasket

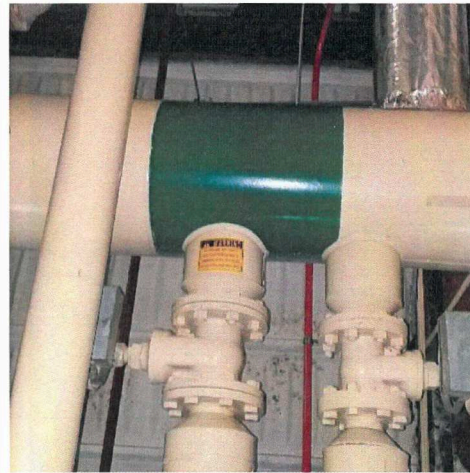
**Photo 8.** Level 23, Plant Room, Boiler 1 - Gasket

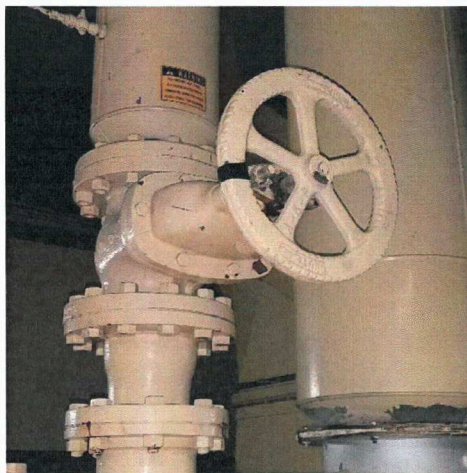
**Photo 9.** Level 23, Plant Room, Boiler 2 - Gasket

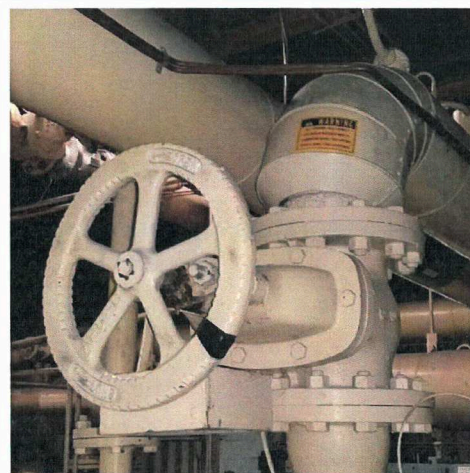
**Photo 10.** Level 23, Plant Room, Boiler 1, Hot Water Piping - Gasket

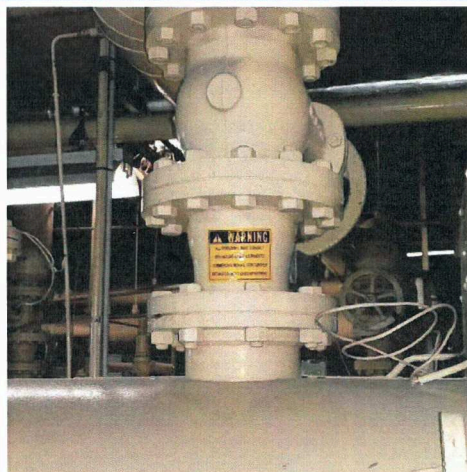
**Photo 11.** Level 23, Plant Room, Boiler 2, Hot Water Piping - Gasket

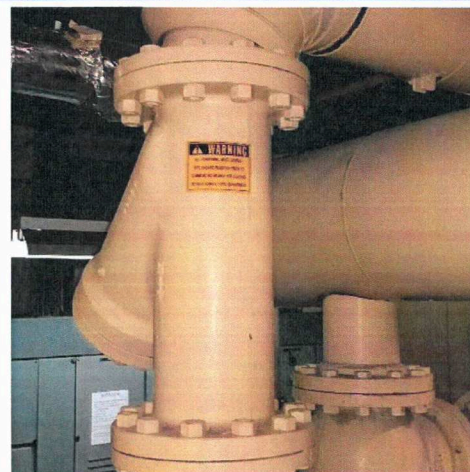
**Photo 12.** Level 23, Plant Room, Hot Water Pump 1 - Gasket

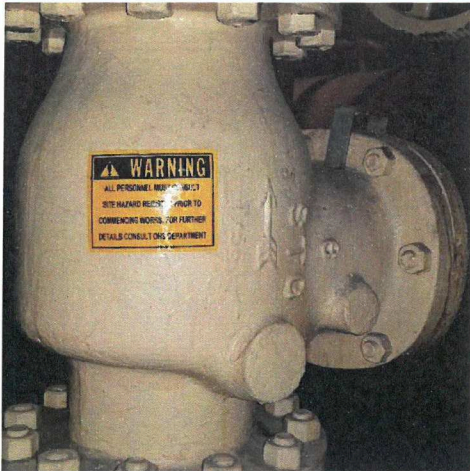
**Photo 13.** Level 23, Plant Room, Hot Water Pump 2 - Gasket

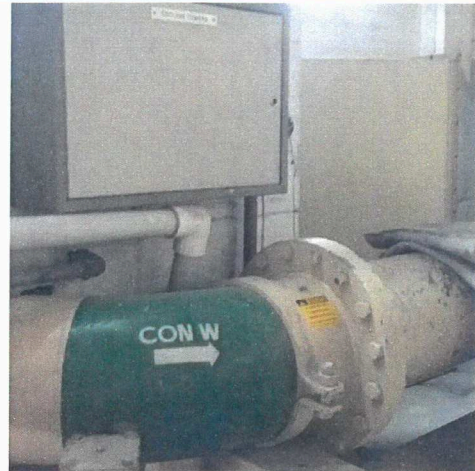
**Photo 14.** Level 23, Plant Room, Cooling Tower Piping - Gasket

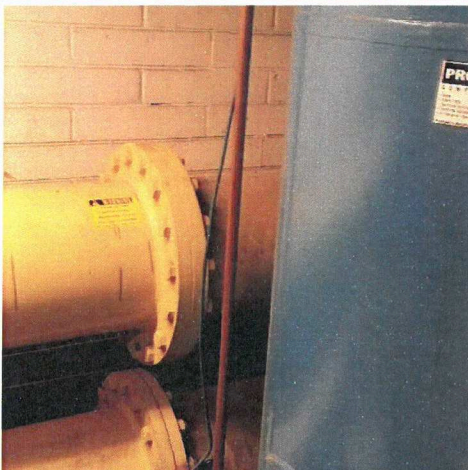
**Photo 15.** Level 23, Plant Room, Piping adjacent to Diesel Generator - Gasket

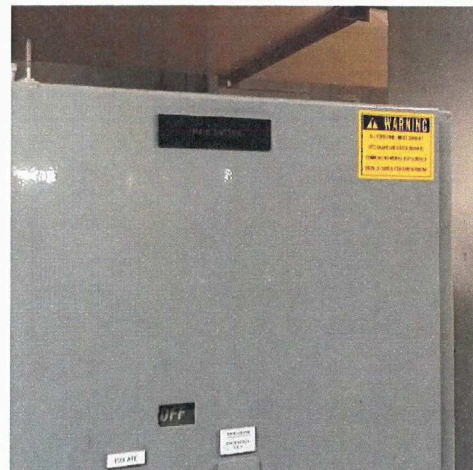
**Photo 16.** Level 23, Plant Room, Main Switchboard – Bitumous Backing Board, Fuses

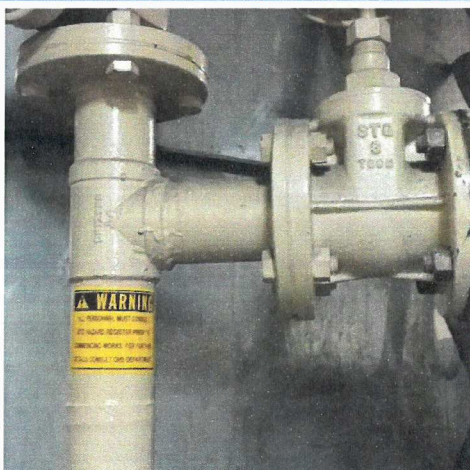
**Photo 17.** Level 23, Plant Room, Water Holding Tank Piping - Gasket

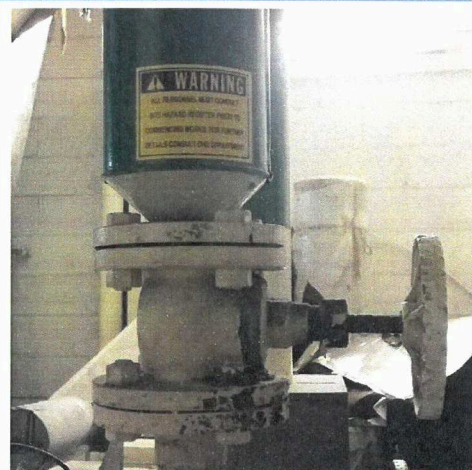
**Photo 18.** Level 23, Plant Room, Hot Water Piping - Gasket

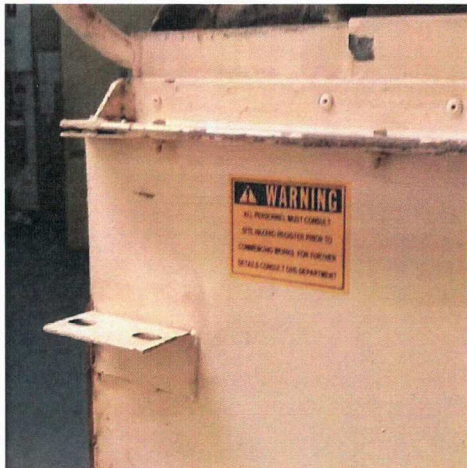
**Photo 19.** Level 23, Plant Room, West Perimeter Air Handler Unit - Mastic

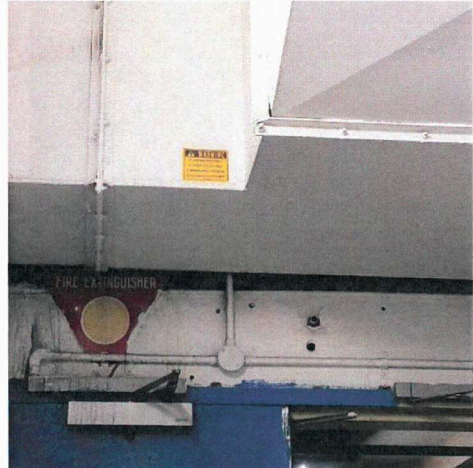
**Photo 20.** Level 23, Plant Room, Ductwork - Mastic

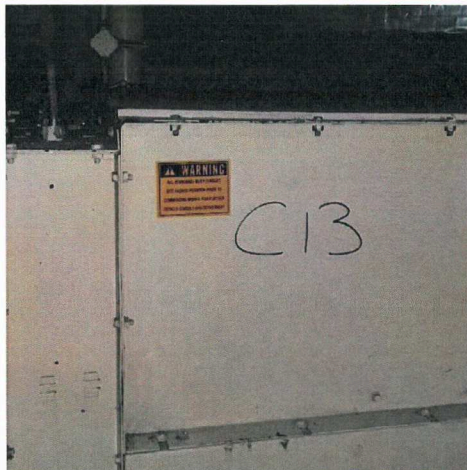
**Photo 21.** Level 23, Plant Room, Hot Water Unit - Mastic

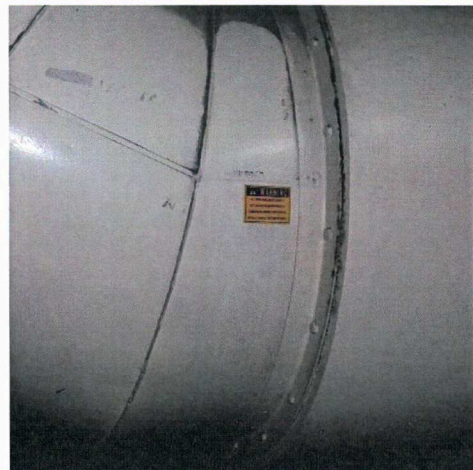
**Photo 22.** Level 23, Plant Room, Ductwork - Mastic

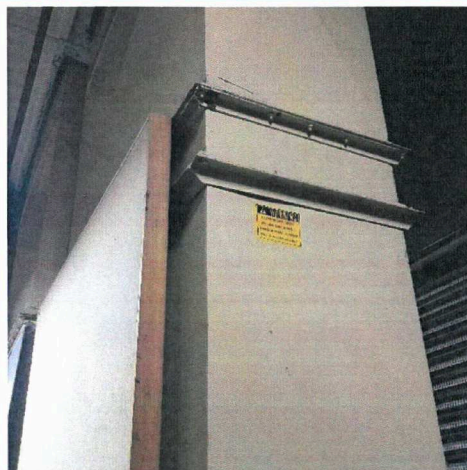
**Photo 23.** Level 23, Plant Room, Ductwork - Mastic

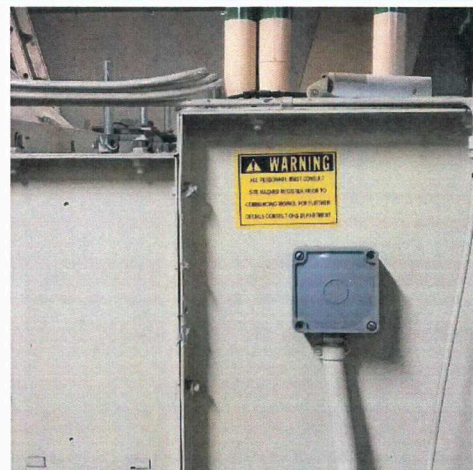
**Photo 24.** Level 23, Plant Room, Hot Water Unit - Mastic

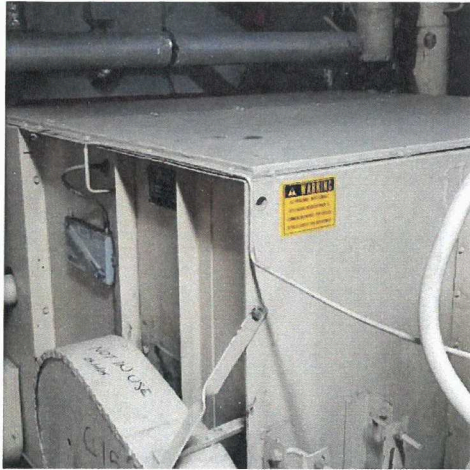
**Photo 25.** Level 23, Plant Room, C15 Unit - Mastic

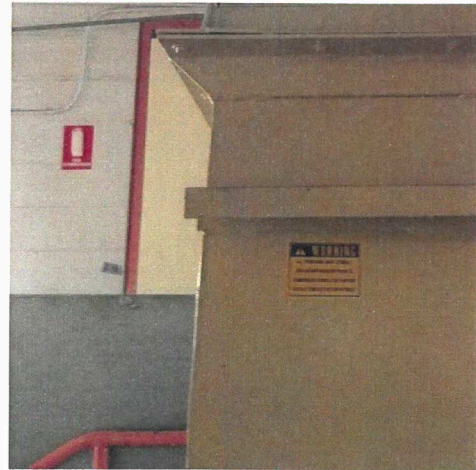
**Photo 26.** Level 23, Plant Room, Ductwork - Mastic

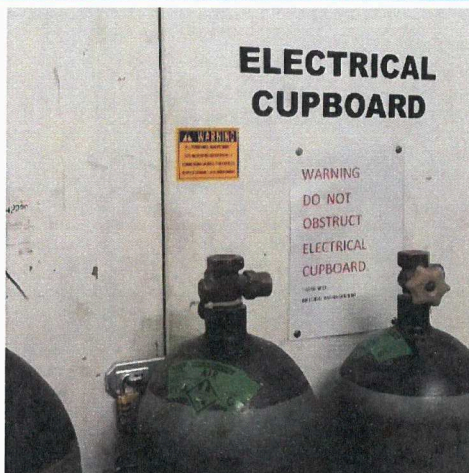
**Photo 27.** Level 23, Goods Lift, Electrical Cupboard - Bitumous Backing Board, Fuses

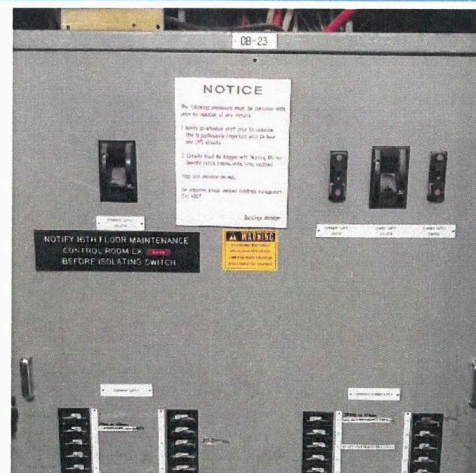
**Photo 28.** Level 23, Goods Lift, Electrical Switchboard - Bitumous Backing Board, Fuses

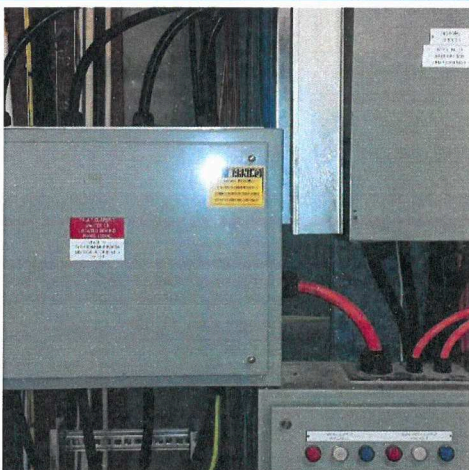
**Photo 29.** Level 19, Goods Lift, Electrical Cupboard, Switchboard - Bitumous Backing Board, Fuses

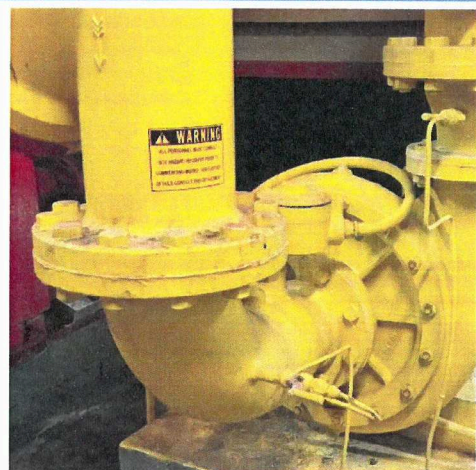
**Photo 30.** Level B2, Plant Room - Gasket

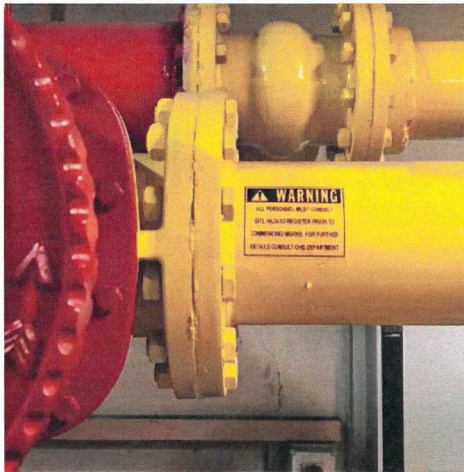
**Photo 31.** Level B2, Plant Room - Gasket

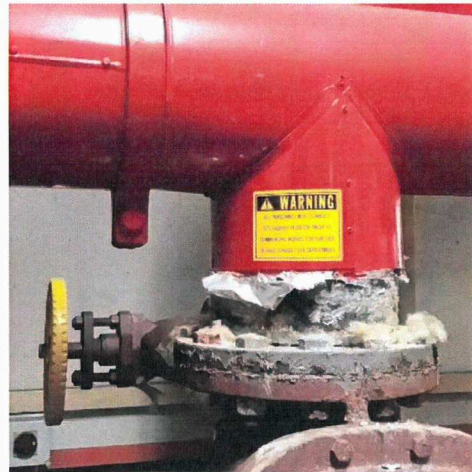
**Photo 32.** Level B2, Plant Room - Gasket

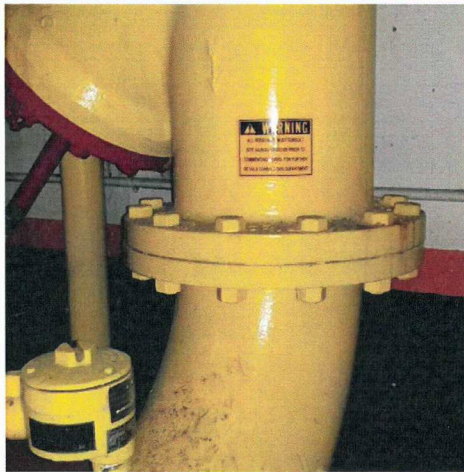
**Photo 33.** Level B2, Plant Room - Gasket

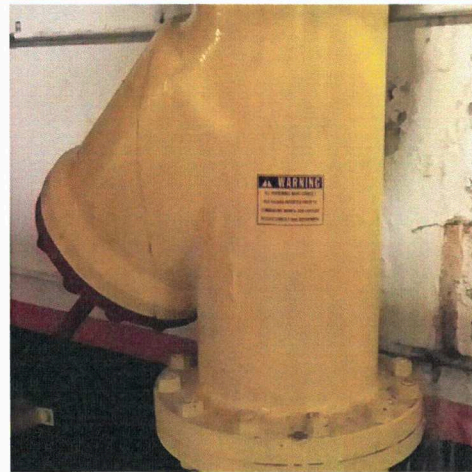
**Photo 34.** Level B2, Plant Room - Gasket

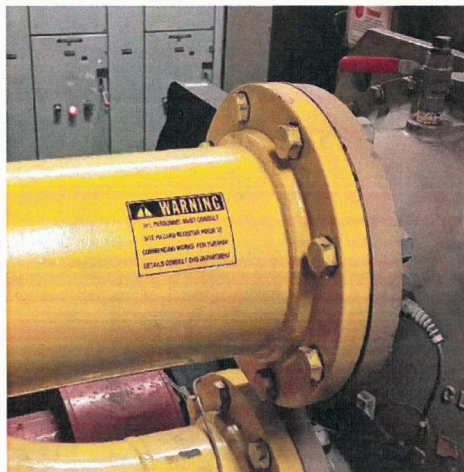
**Photo 35.** Level B2, Plant Room - Gasket

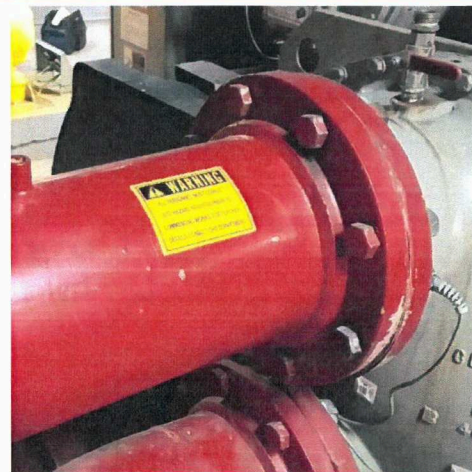
**Photo 36.** Level B2, Plant Room - Gasket

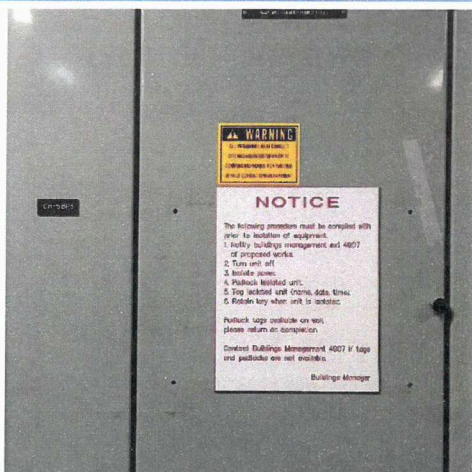
**Photo 37.** Level B2, Plant Room, Switchboard - Bitumous Backing Board, Fuses

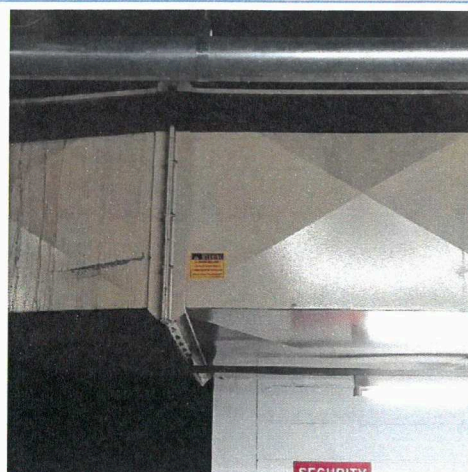
**Photo 38.** Level B1, Carpark, Ductwork - Mastic

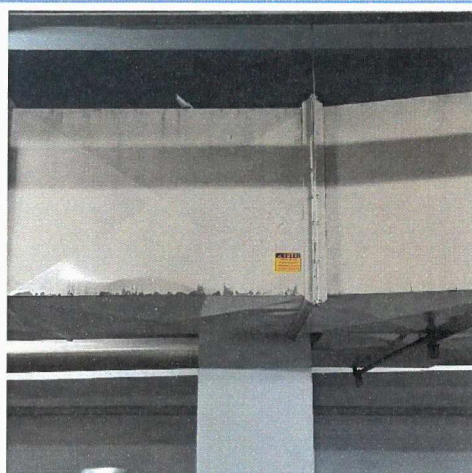
**Photo 39.** Level B1, Carpark, Ductwork - Mastic

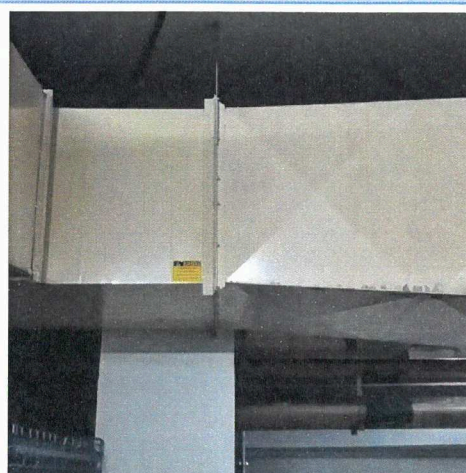
**Photo 40.** Level B1, Carpark, Ductwork - Mastic

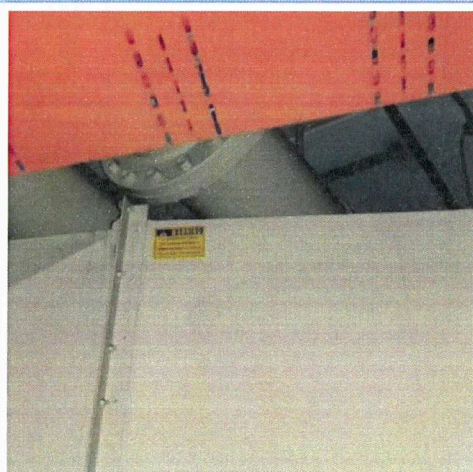
**Photo 41.** Level B1, Carpark, Ductwork - Mastic

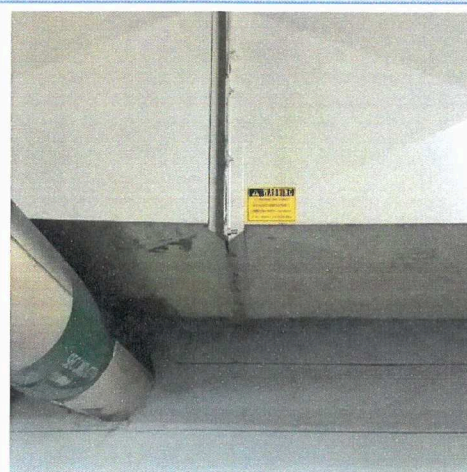
**Photo 42.** Level B1, Carpark, Ductwork - Mastic

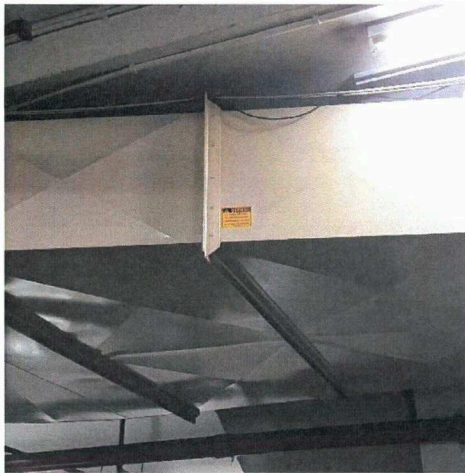
**Photo 43.** Level B1, Carpark, Ductwork - Mastic

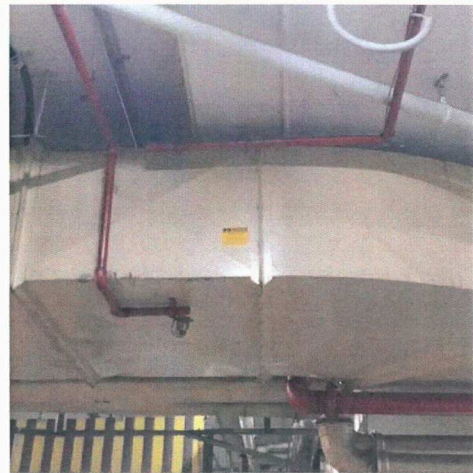
**Photo 44.** Level B1, Carpark, Ductwork - Mastic

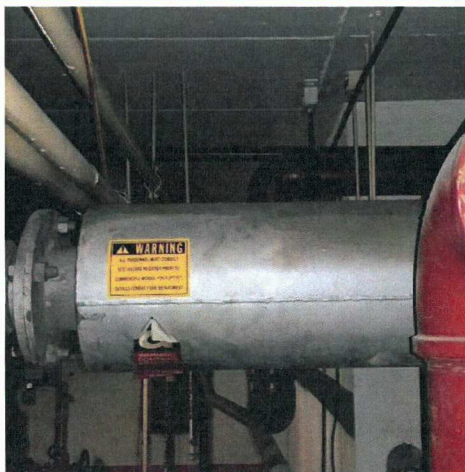
**Photo 45.** Level B2, Sprinkler Room - Gasket

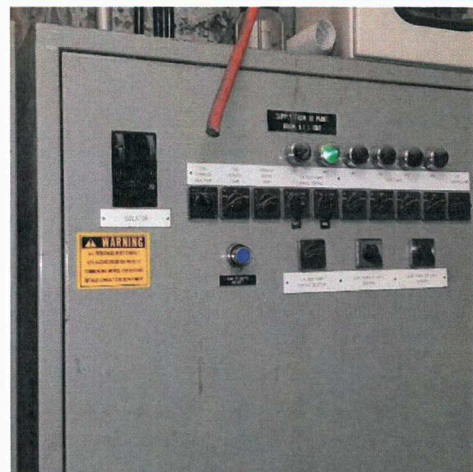
**Photo 46.** Level B1, Electrical Switchboard- Bitumous Backing Board, Fuses

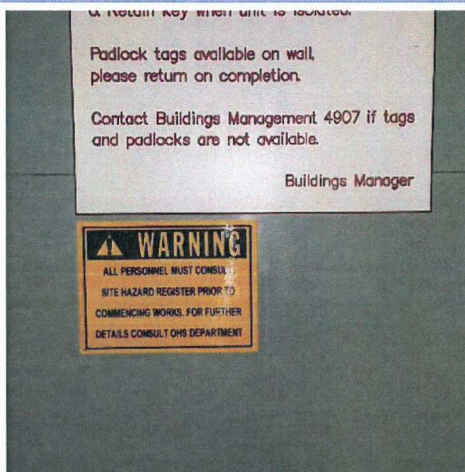
**Photo 47.** Level 9, South-West Plant Room, Electrical Switchboard - Bitumous Backing Board, Fuses

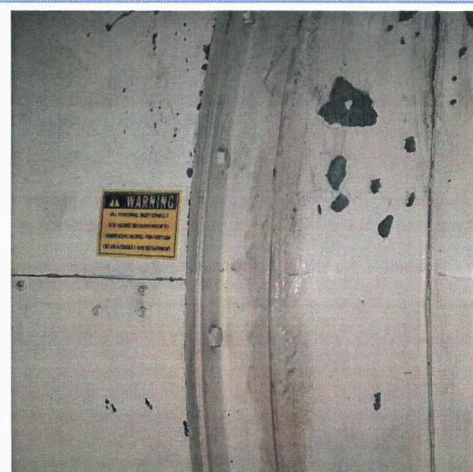
**Photo 48.** Level 9, South-West Plant Room, Ductwork - Mastic

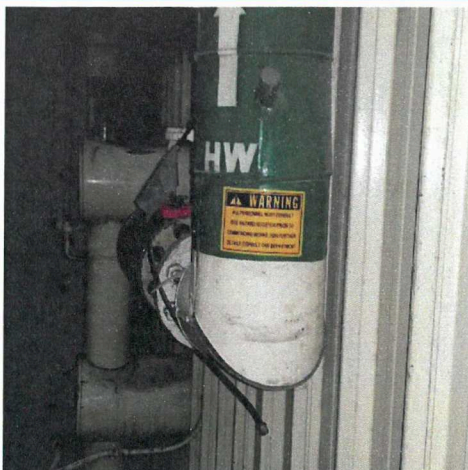
**Photo 49.** Level 9, South-West Plant Room, Hot Water Pipe - Gasket

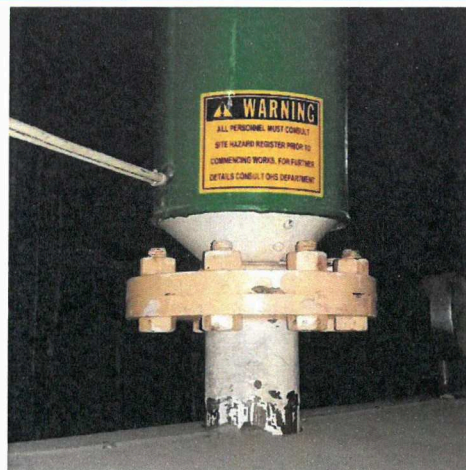
**Photo 50.** Level 9, South-West Plant Room, Hot Water Pipe - Gasket

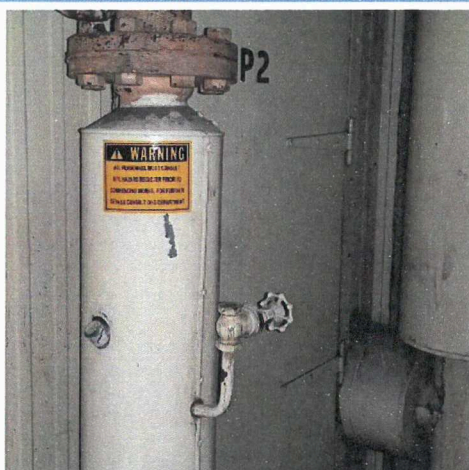
**Photo 51.** Level 9, South-West Plant Room, Hot Water Pipe - Gasket

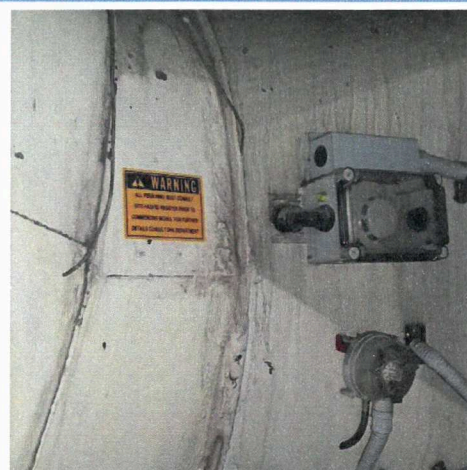
**Photo 52.** Level 9, South-West Plant Room, Ductwork - Mastic

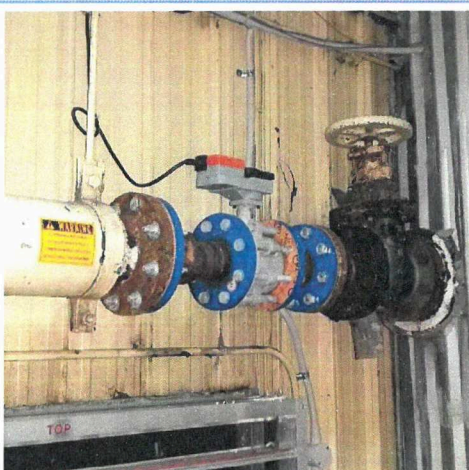
**Photo 53.** Level 9, South-West Plant Room, Air Intake Chamber - Gasket

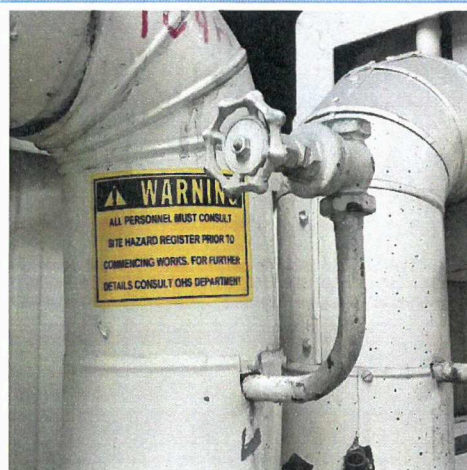
**Photo 54.** Level 9, North-East Plant Room, Hot Water Pipe - Gasket

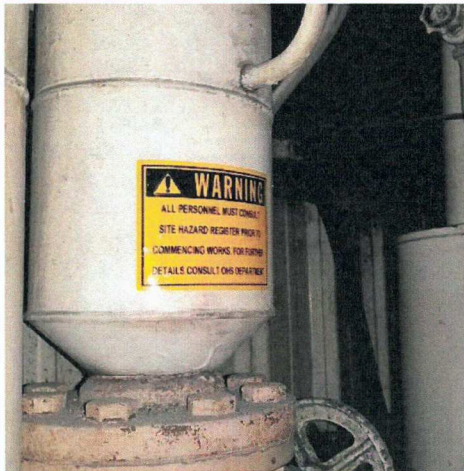
**Photo 55.** Level 9, North-East Plant Room, Hot Water Pipe - Gasket

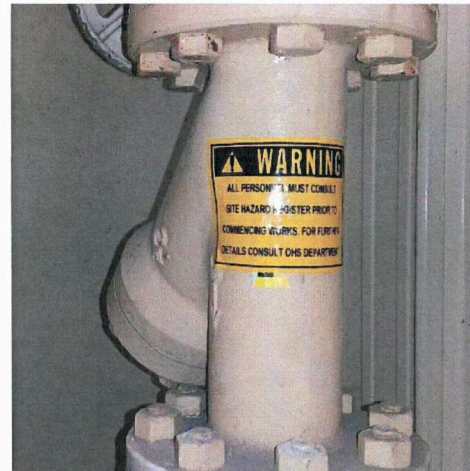
**Photo 56.** Level 9, North-East Plant Room, Hot Water Pipe - Gasket

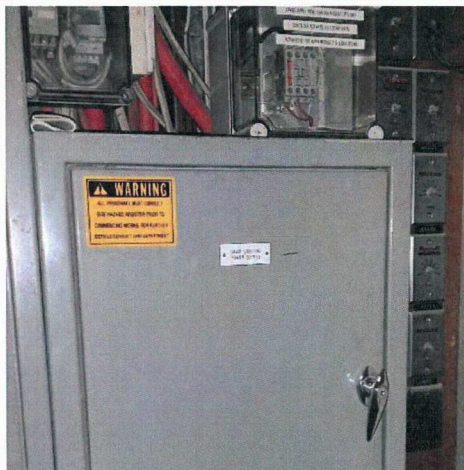
**Photo 57.** Ground Level, Goods Lift, Electrical Switchboard - Bitumous Backing Board, Fuses
