# COMPLIANCE ASBESTOS RE-INSPECTION AND RISK ASSESSMENT

NOVEMBER 2021

J033447

ROCKHAMPTON NORTH CAMPUS\_Building 001 - Chancellery  
Bruce Highway  
ROCKHAMPTON NORTH QLD  
4700

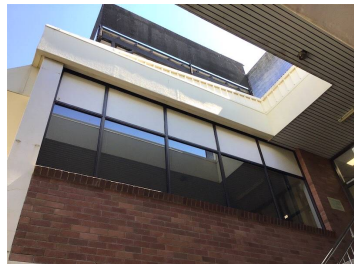
Location	001 Chancellery - Ground Floor - External - Infill panels - Fibre cement sheet - North elevation - above staircase

Hazard Type	Asbestos	Material Assessment		Disturbance Assessment		
Friability	Non-friable	Product Type	1	Occupancy		0
Sample No.	Visual	Extent of damage	0	Disturbance		1
Result	Assumed Positive Unknown or Crocidolite	Surface Treatment	1	Exposure		0
		Asbestos Type	3	Maintenance		0
Item Number	1	Material Score	5	Disturbance Score		1
		Priority Score	6	Very Low		
No Additional Photographic Evidence Available

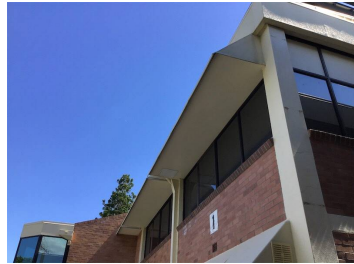
Location		001 Chancellery - Ground Floor - External - Sunhood ceiling - Fibre cement sheet - East, West & South elevations

Hazard Type		Asbestos		Material Assessment			Disturbance Assessment					
Friability		Non-friable		Product Type			1		Occupancy		0	
Sample No.		As 2-771 {AO000133}		Extent of damage			0		Disturbance		1	
Result		Strongly Assumed Positive Chrysotile		Surface Treatment			1		Exposure		0	
				Asbestos Type			1		Maintenance		0	
Item Number		2		Material Score			3		Disturbance Score		1	
				Priority Score			4		Very Low			
No Additional Photographic Evidence Available

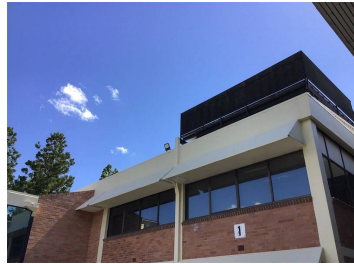
Location		001 Chancellery - Ground Floor - External - Sunhood roof & gable - Fibre cement sheet - East, West & South elevations			
Hazard Type		Asbestos		Material Assessment	
Friability		Non-friable		Disturbance Assessment	
Sample No.		As 2-772 {AO000134}		Occupancy	
Result		Strongly Assumed Positive Chrysotile		0	
Item Number		6		Disturbance	
		Surface Treatment		1	
		Asbestos Type		0	
		Material Score		1	
		Priority Score		Very Low	
No Additional Photographic Evidence Available

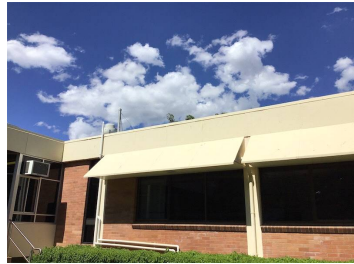
Location		001 Chancellery - Ground Floor - External - Fascia - Fibre cement sheet - East, West & South elevations

Hazard Type		Asbestos		Material Assessment			Disturbance Assessment					
Friability		Non-friable		Product Type			1		Occupancy		0	
Sample No.		As 2-772 {AO000134}		Extent of damage			0		Disturbance		1	
Result		Strongly Assumed Positive Chrysotile		Surface Treatment			1		Exposure		0	
				Asbestos Type			1		Maintenance		0	
Item Number		7		Material Score			3		Disturbance Score		1	
				Priority Score			4		Very Low			
No Additional Photographic Evidence Available

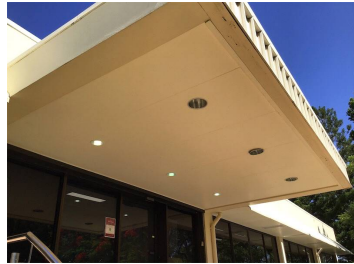
Location		001 Chancellery - Ground Floor - External - Awning - Fibre cement sheet - West elevation - entrance

Hazard Type		Asbestos	Material Assessment		Disturbance Assessment		
Friability		Non-friable	Product Type	1	Occupancy		0
Sample No.		2-773 (AO000135)	Extent of damage	0	Disturbance		1
Result		Positive Chrysotile	Surface Treatment	1	Exposure		0
			Asbestos Type	1	Maintenance		0
Item Number		8	Material Score	3	Disturbance Score		1
			Priority Score	4	Very Low		
No Additional Photographic Evidence Available

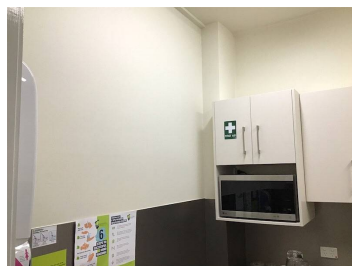
Location		001 Chancellery - Ground Floor - Kitchen - Walls - Fibre cement sheet - North, East & West elevations

Hazard Type		Asbestos	Material Assessment		Disturbance Assessment		
Friability		Non-friable	Product Type	1	Occupancy		0
Sample No.		3-993 (AO000136)	Extent of damage	0	Disturbance		1
Result		Positive Chrysotile	Surface Treatment	1	Exposure		0
			Asbestos Type	1	Maintenance		0
Item Number		9	Material Score	3	Disturbance Score		1
			Priority Score	4	Very Low		
No Additional Photographic Evidence Available

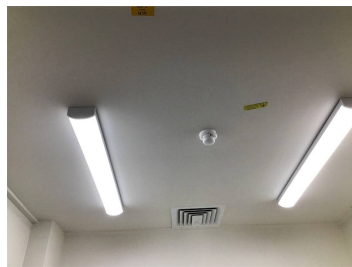
Location		001 Chancellery - Ground Floor - Kitchen - Ceiling - Fibre cement sheet - Throughout

Hazard Type		Asbestos	Material Assessment		Disturbance Assessment		
Friability		Non-friable	Product Type	1	Occupancy		0
Sample No.		3-995 (AO000137)	Extent of damage	0	Disturbance		1
Result		Positive Chrysotile	Surface Treatment	1	Exposure		0
			Asbestos Type	1	Maintenance		0
Item Number		10	Material Score	3	Disturbance Score		1
			Priority Score	4	Very Low		
No Additional Photographic Evidence Available

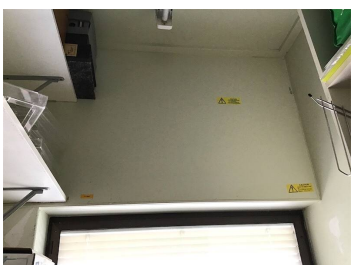
Location		001 Chancellery - Ground Floor - Store - Infill panel - Fibre cement sheet - East elevation - above window

Hazard Type		Asbestos	Material Assessment		Disturbance Assessment		
Friability		Non-friable	Product Type	1	Occupancy		0
Sample No.		3-994 (AO000138)	Extent of damage	0	Disturbance		1
Result		Positive Chrysotile	Surface Treatment	1	Exposure		0
			Asbestos Type	1	Maintenance		0
Item Number		11	Material Score	3	Disturbance Score		1
			Priority Score	4	Very Low		
No Additional Photographic Evidence Available

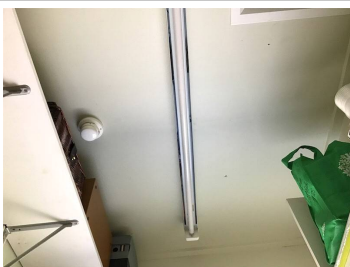
Location		001 Chancellery - Ground Floor - Store - Ceiling - Fibre cement sheet - Throughout

Hazard Type		Asbestos	Material Assessment		Disturbance Assessment		
Friability		Non-friable	Product Type	1	Occupancy		0
Sample No.		As 3-995 (AO000137)	Extent of damage	0	Disturbance		1
Result		Strongly Assumed Positive Chrysotile	Surface Treatment	1	Exposure		0
			Asbestos Type	1	Maintenance		0
Item Number		12	Material Score	3	Disturbance Score		1
			Priority Score	4	Very Low		
No Additional Photographic Evidence Available

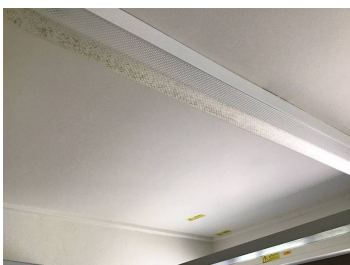
Location		001 Chancellery - Ground Floor - Toilet - Ceiling - Fibre cement sheet - Throughout

Hazard Type		Asbestos	Material Assessment		Disturbance Assessment		
Friability		Non-friable	Product Type	1	Occupancy		0
Sample No.		As 3-995 (AO000137)	Extent of damage	0	Disturbance		2
Result		Strongly Assumed Positive Chrysotile	Surface Treatment	1	Exposure		0
			Asbestos Type	1	Maintenance		0
Item Number		13	Material Score	3	Disturbance Score		2
			Priority Score	5	Very Low		
No Additional Photographic Evidence Available

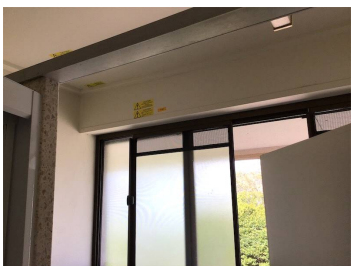
Location		001 Chancellery - Ground Floor - Toilet - Infill panel - Fibre cement sheet - East elevation - above window				
Hazard Type		Asbestos	Material Assessment		Disturbance Assessment	
Friability		Non-friable	Product Type	1	Occupancy	0
Sample No.		3-996 (AO000139)	Extent of damage	0	Disturbance	1
Result		Positive Chrysotile	Surface Treatment	1	Exposure	0
			Asbestos Type	1	Maintenance	0
Item Number		14	Material Score	3	Disturbance Score	1
			Priority Score	4	Very Low	
No Additional Photographic Evidence Available

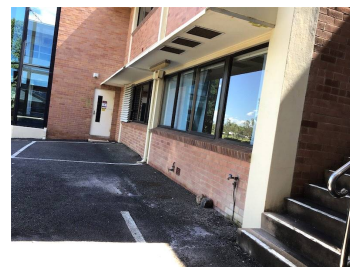
Location		001 Chancellery - 1st Floor - External - Sunhood ceiling - Fibre cement sheet - East elevation				
Hazard Type		Asbestos	Material Assessment		Disturbance Assessment	
Friability		Non-friable	Product Type	1	Occupancy	0
Sample No.		2-771 (AO000133)	Extent of damage	0	Disturbance	1
Result		Positive Chrysotile	Surface Treatment	1	Exposure	0
			Asbestos Type	1	Maintenance	0
Item Number		4	Material Score	3	Disturbance Score	1
			Priority Score	4	Very Low	
No Additional Photographic Evidence Available

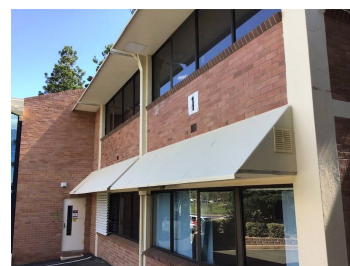
Location		001 Chancellery - 1st Floor - External - Sunhood roof & gable - Fibre cement sheet - East elevation				
Hazard Type		Asbestos	Material Assessment		Disturbance Assessment	
Friability		Non-friable	Product Type	1	Occupancy	1
Sample No.		2-772 (AO000134)	Extent of damage	0	Disturbance	0
Result		Positive Chrysotile	Surface Treatment	1	Exposure	0
			Asbestos Type	1	Maintenance	0
Item Number	5	Material Score	3	Disturbance Score		1
		Priority Score	4	Very Low		
No Additional Photographic Evidence Available

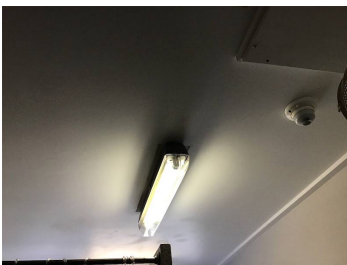
Location		001 Chancellery - 1st Floor - Toilet - Ceiling - Fibre cement sheet - Throughout				
Hazard Type		Asbestos	Material Assessment		Disturbance Assessment	
Friability		Non-friable	Product Type	1	Occupancy	0
Sample No.		2-757 (AO000140)	Extent of damage	0	Disturbance	1
Result		Positive Chrysotile	Surface Treatment	1	Exposure	0
			Asbestos Type	1	Maintenance	0
Item Number		15	Material Score	3	Disturbance Score	1
			Priority Score	4	Very Low	
No Additional Photographic Evidence Available
