# COMPLIANCE ASBESTOS RE-INSPECTION AND RISK ASSESSMENT

NOVEMBER 2021

J033448

ROCKHAMPTON NORTH CAMPUS\_Building 002 - Student Admin  
Bruce Highway  
ROCKHAMPTON NORTH QLD  
4700

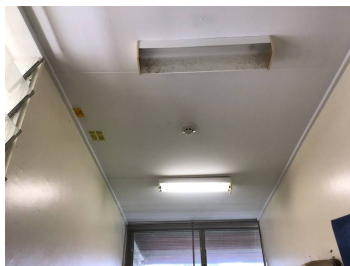
Location		002 Student Administration - Lower Ground Level - Male Bathroom - Ceiling - Fibre cement sheet - Throughout

Hazard Type		Asbestos	Material Assessment		Disturbance Assessment		
Friability		Non-friable	Product Type	1	Occupancy		0
Sample No.		2-775 {AO000141}	Extent of damage	0	Disturbance		1
Result		Positive Chrysotile	Surface Treatment	1	Exposure		0
			Asbestos Type	1	Maintenance		0
Item Number		1	Material Score	3	Disturbance Score		1
			Priority Score	4	Very Low		
No Additional Photographic Evidence Available

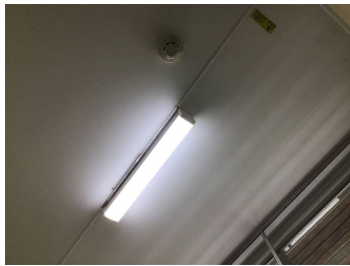
Location		002 Student Administration - Lower Ground Level - Female Bathroom - Ceiling - Fibre cement sheet - Throughout

Hazard Type		Asbestos	Material Assessment		Disturbance Assessment		
Friability		Non-friable	Product Type	1	Occupancy		0
Sample No.		2-757 {AO000143}	Extent of damage	0	Disturbance		1
Result		Positive Chrysotile	Surface Treatment	1	Exposure		0
			Asbestos Type	1	Maintenance		0
Item Number		2	Material Score	3	Disturbance Score		1
			Priority Score	4	Very Low		
No Additional Photographic Evidence Available

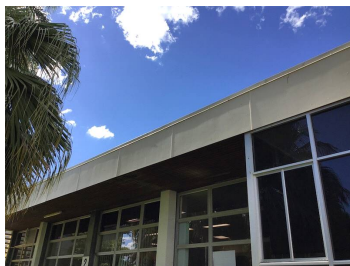
Location		002 Student Administration - Lower Ground Level - External - Fascia - Fibre cement sheet - East, West & North elevations

Hazard Type		Asbestos	Material Assessment		Disturbance Assessment		
Friability		Non-friable	Product Type	1	Occupancy		0
Sample No.		2-758 (AO000147)	Extent of damage	0	Disturbance		1
Result		Positive Chrysotile	Surface Treatment	1	Exposure		0
			Asbestos Type	1	Maintenance		0
Item Number		5	Material Score	3	Disturbance Score		1
			Priority Score	4	Very Low		
No Additional Photographic Evidence Available

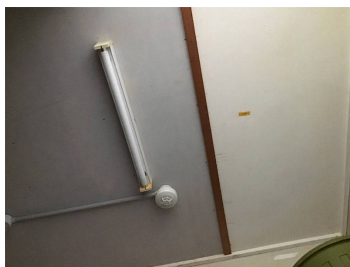
Location		002 Student Administration - Lower Ground Level - Cleaners - Ceiling - Fibre cement sheet - Throughout

Hazard Type		Asbestos	Material Assessment		Disturbance Assessment		
Friability		Non-friable	Product Type	1	Occupancy		0
Sample No.		2-761 (AO000142)	Extent of damage	0	Disturbance		2
Result		Positive Chrysotile	Surface Treatment	1	Exposure		0
			Asbestos Type	1	Maintenance		0
Item Number		3	Material Score	3	Disturbance Score		2
			Priority Score	5	Very Low		
No Additional Photographic Evidence Available

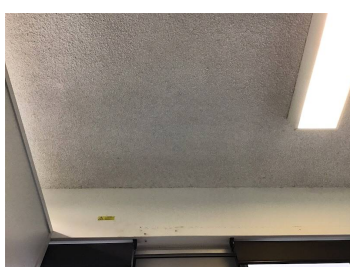
Location		002 Student Administration - Ground Floor - Office - Ceiling - Fibre cement sheet - Throughout

Hazard Type		Asbestos	Material Assessment		Disturbance Assessment		
Friability		Non-friable	Product Type	1	Occupancy		0
Sample No.		Visual	Extent of damage	0	Disturbance		1
Result		Assumed Positive Unknown or Crocidolite	Surface Treatment	1	Exposure		0
			Asbestos Type	3	Maintenance		0
Item Number		4	Material Score	5	Disturbance Score		1
			Priority Score	6	Very Low		
No Additional Photographic Evidence Available

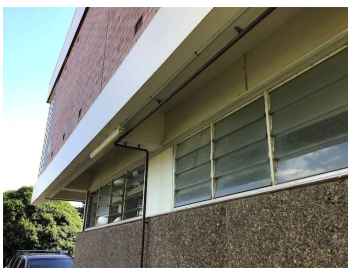
Location		002 Student Administration - Ground Floor - External - Infill panel - Fibre cement sheet - East elevation - above windows				
Hazard Type		Asbestos	Material Assessment		Disturbance Assessment	
Friability		Non-friable	Product Type	1	Occupancy	0
Sample No.		2-766 (AO000146)	Extent of damage	0	Disturbance	1
Result		Positive Chrysotile	Surface Treatment	1	Exposure	0
			Asbestos Type	1	Maintenance	0
Item Number		6	Material Score	3	Disturbance Score	1
			Priority Score	4	Very Low	
No Additional Photographic Evidence Available
