## ASBESTOS CONTAINING MATERIALS SURVEY REPORT

Campus Security  
Building 003  
Rockhampton North

Report Number 622.10968.00000/0040-R01-ASR-Blg003

27 December 2017

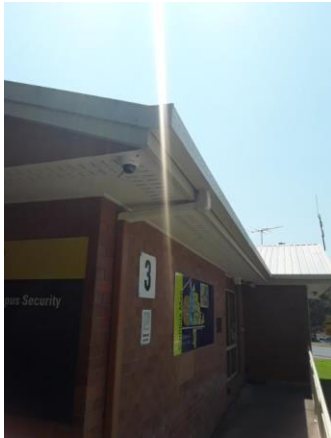
Sample No./ Visual Observation	Photo	Location			Analysis
		Int / Ext Floor Specific Location	Material Application	Extent	Result
1-309

External All eaves	Eave lining , Fibrous Cement	45m <sup>2</sup>	NAD
