**ASBESTOS CONTAINING MATERIALS
SURVEY REPORT**

**Benke Studio/Drama Studio
Rockhampton North**

Report Number 622.10968.00000/0040-R01-ASR-BLD 004

7 December 2017

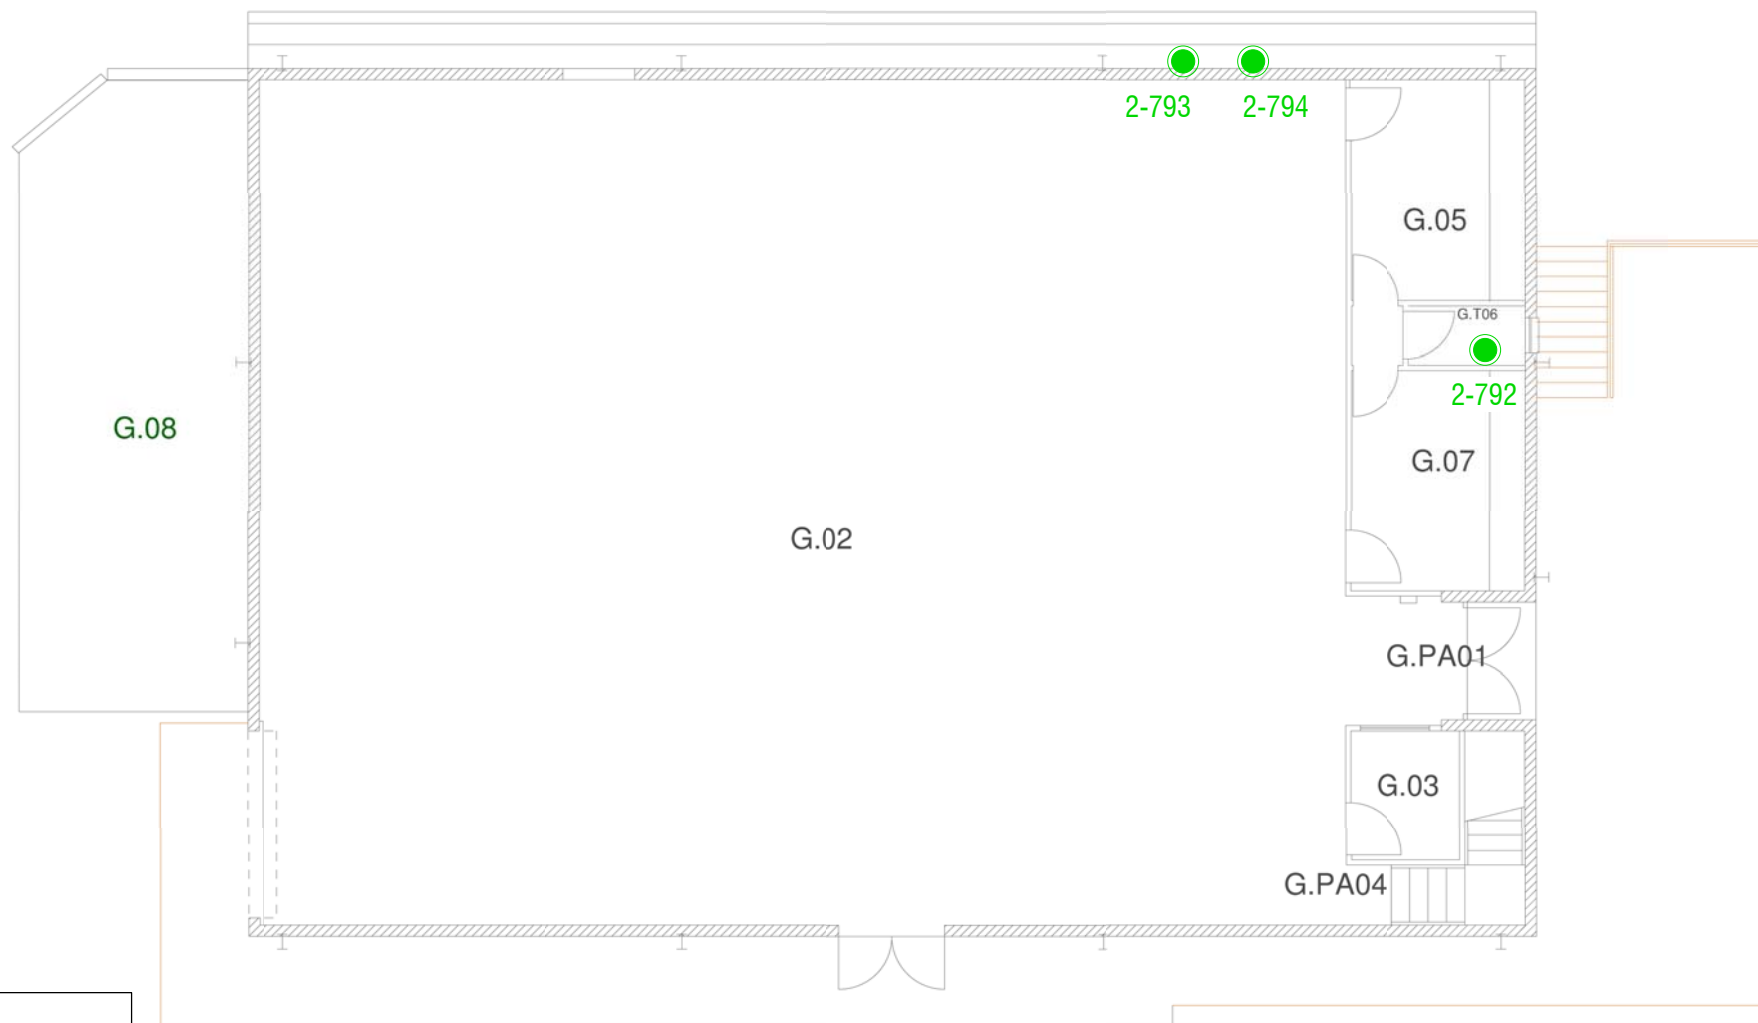
Building No:	004
Inspection Date:	Sept / Oct 2017
Inspected By:	NC
Figure No.:	SLR62210968-RN-004G-01
Drawn By:	LF
Drawn Date:	9/11/17

- Sample location
No Asbestos Detected
