ASBESTOS CONTAINING MATERIALS SURVEY REPORT

Arthur Appleton Building
Building 005
Rockhampton North

Report Number 622.10968.00000/0040-R01-ASR-Bld 005

7 December 2017

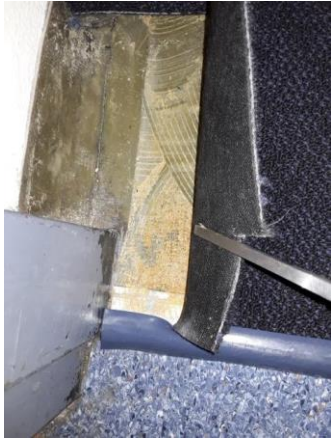
Ground Floor G.06	Vinyl sheet , Vinyl Products	103m²	NAD
2-835

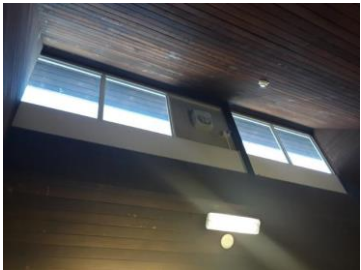
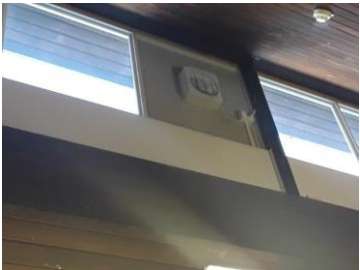
Location:	Ground Floor G.T.15 TOILET - EASTERN ELEVATION - UPPER INFILL PANELS	Material Application	Upper infill panel - western elevation , Fibrous Cement	Extent:	3 m ²	Sample Number	Assumed
Main Photo		Close Up Photo		Product Type Asbestos reinforced composites etc. (1) Condition Good (0) Surface Treatment Sealed (0) Asbestos Type Assumed Asbestos (3) Recommendation: No action required

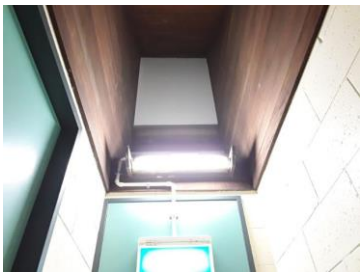
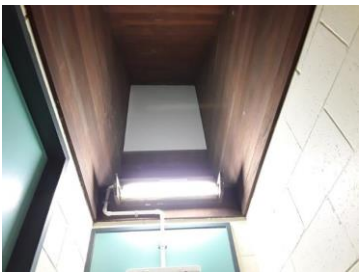
Material Score 4 Risk Very Low			
Location:	Ground Floor G.T.14 MALE TOILET -AIRLOCK - EASTERN ELEVATION - UPPER INFILL PANEL	Material Application	Upper infill panel - western elevation , Fibrous Cement	Extent:	2 m ²	Sample Number	Assumed
Main Photo		Close Up Photo		Product Type Asbestos reinforced composites etc. (1) Condition Good (0) Surface Treatment Sealed (0) Asbestos Type Assumed Asbestos (3) Recommendation: No action required

Material Score 4 Risk Very Low

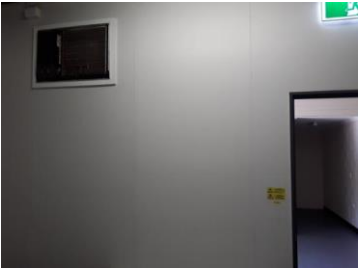
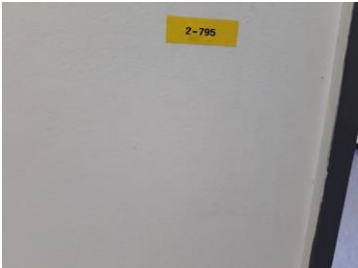
Location:	Ground Floor G.16	Material Application	Wall sheeting western elevation , Fibrous Cement	Extent:	7 m²	Sample Number	2-795
Main Photo		Close Up Photo		Product Type	Asbestos reinforced composites etc. (1)	Material Score

Condition	Good (0)	2	
				Surface Treatment	Sealed (0)	Risk	
				Asbestos Type	Chrysotile (1)	Very Low	
				Recommendation:	No action required

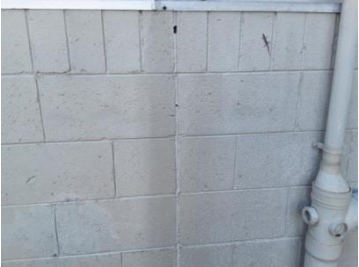
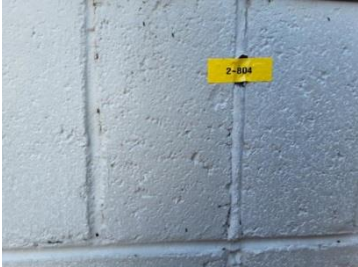
Location:	3rd Floor EXTERNAL. ROOM 2.08. EASTERN ELEVATION	Material Application	Articulation mastic to rock block walls, Bituminous Product	Extent:	3.5 lin m	Sample Number	2-804
Main Photo		Close Up Photo		Product Type	Asbestos reinforced composites etc. (1)	Material Score

Condition	Good (0)	3	
				Surface Treatment	Sealed (1)	Risk	
				Asbestos Type	Chrysotile (1)	Very Low	
				Recommendation:	No action required		
Location:	3rd Floor EXTERNAL	Material Application	Articulation mastic joins to concrete fascias . all elevations and all levels ., Bituminous Product	Extent:	1 lin m	Sample Number	2-804
Main Photo		Close Up Photo		Product Type	Asbestos reinforced composites etc. (1)	Material Score

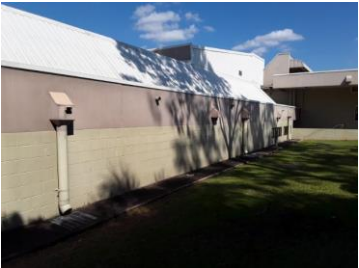
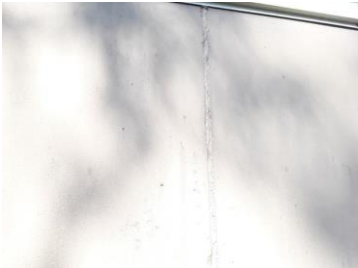
Condition	Good (0)	3	
				Surface Treatment	Sealed (1)	Risk	
				Asbestos Type	Chrysotile (1)	Very Low	
				Recommendation:	No action required
