ASBESTOS CONTAINING MATERIALS SURVEY REPORT

Greig Turner Building
Building 006
Rockhampton North

Report Number 622.10968.00000/0040-R01-ASR-Bld006

27 December 2017

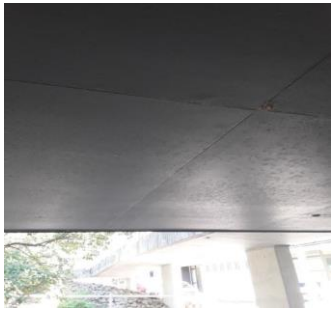
All External eaves	Eave lining , Fibrous Cement	70m ²	NAD
1-324

Sample No.	Description	Analysis Result
1-323	Fibre cement	Organic Fibre
1-324	Fibre cement	Organic Fibre

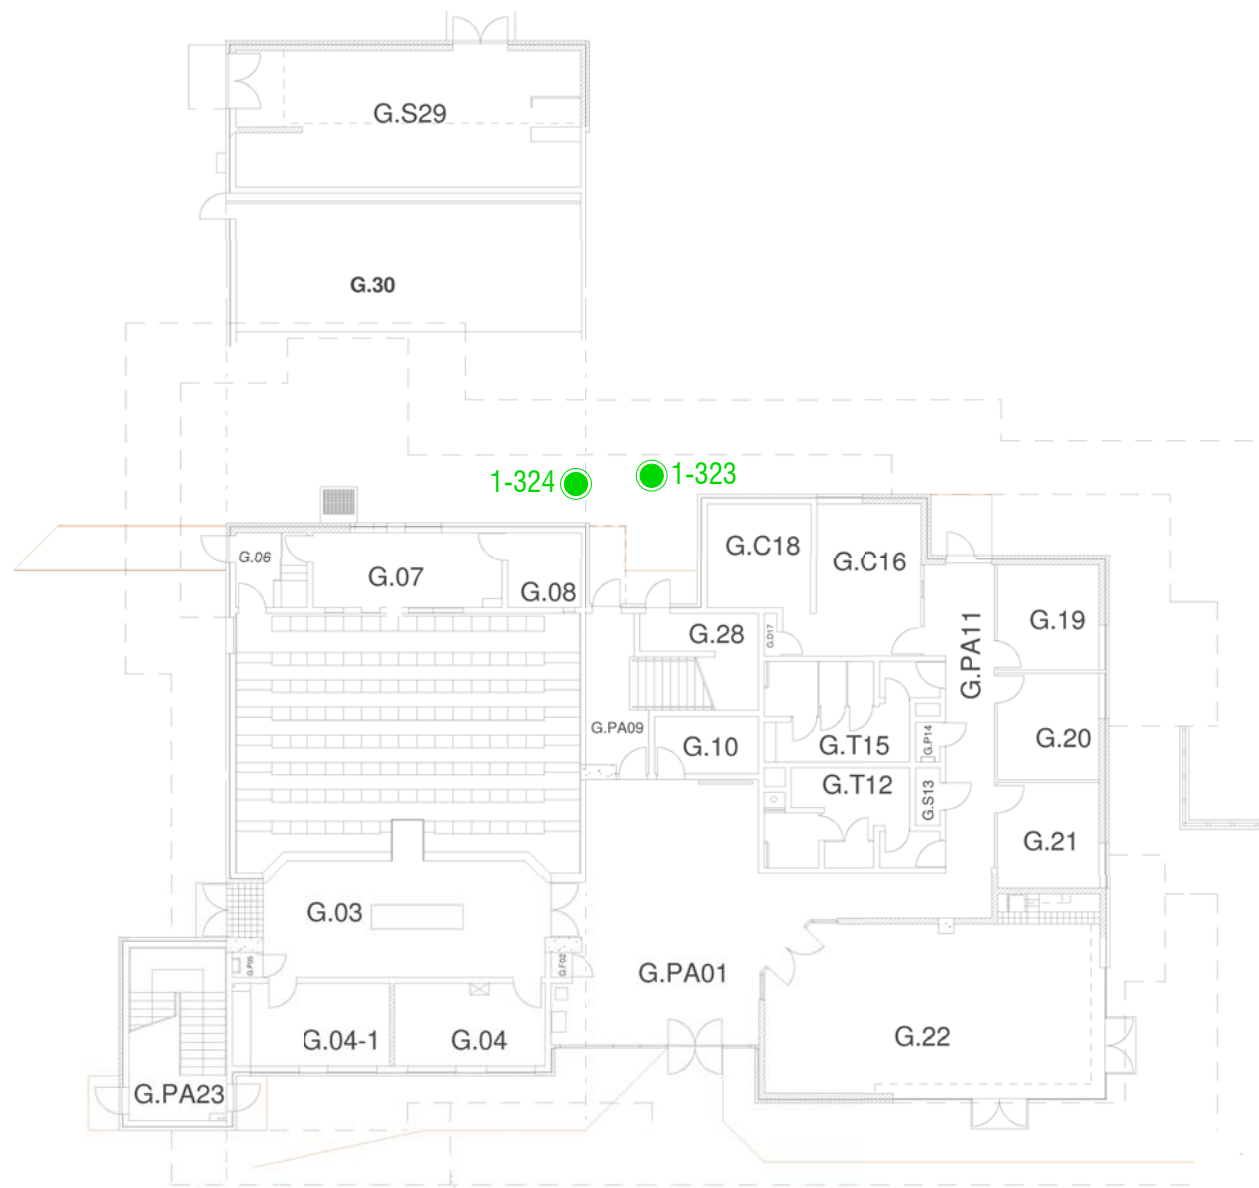
Building No:	06
Inspection Date:	Sept / Oct 2017
Inspected By:	NC / JH / SA
Figure No.:	SLR62210968-RN-06G-01
Drawn By:	LF
Drawn Date:	18/1/18

Sample location.
No Asbestos Detected
