COMPLIANCE ASBESTOS RE-INSPECTION AND RISK ASSESSMENT

NOVEMBER 2021

J033449

ROCKHAMPTON NORTH CAMPUS_Building 007 - Applied Science A
Bruce Highway
ROCKHAMPTON NORTH QLD
4700

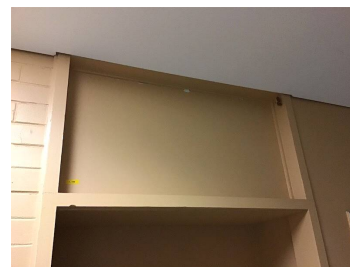
Location		Thozert Building 007 Applied Science - Ground Floor - Main Corridor - Above doorways to GT06, GT07, GT08, GT09 & Water bubbler - Infill panel - Fibre cement sheet			
Hazard Type	Asbestos	Material Assessment		Disturbance Assessment	
Friability	Non-friable	Product Type	1	Occupancy	1
Sample No.	2-769 {AO000148}	Extent of damage	0	Disturbance	1
Result	Positive Chrysotile	Surface Treatment	1	Exposure	0
		Asbestos Type	1	Maintenance	0
Item Number	2	Material Score	3	Disturbance Score	2
		Priority Score	5	Very Low

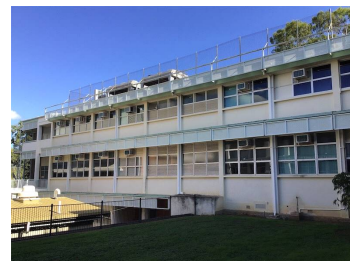
Location		Thozert Building 007 Applied Science - 1st Floor - External - North & South elevation - Above windows - Infill panel - Fibre cement sheet			
Hazard Type	Asbestos	Material Assessment		Disturbance Assessment	
Friability	Non-friable	Product Type	1	Occupancy	0
Sample No.	As 2-781 {AO000151}	Extent of damage	0	Disturbance	0
Result	Strongly Assumed Positive Chrysotile	Surface Treatment	1	Exposure	0
		Asbestos Type	1	Maintenance	0
Item Number	9	Material Score	3	Disturbance Score	0
		Priority Score	3	Very Low

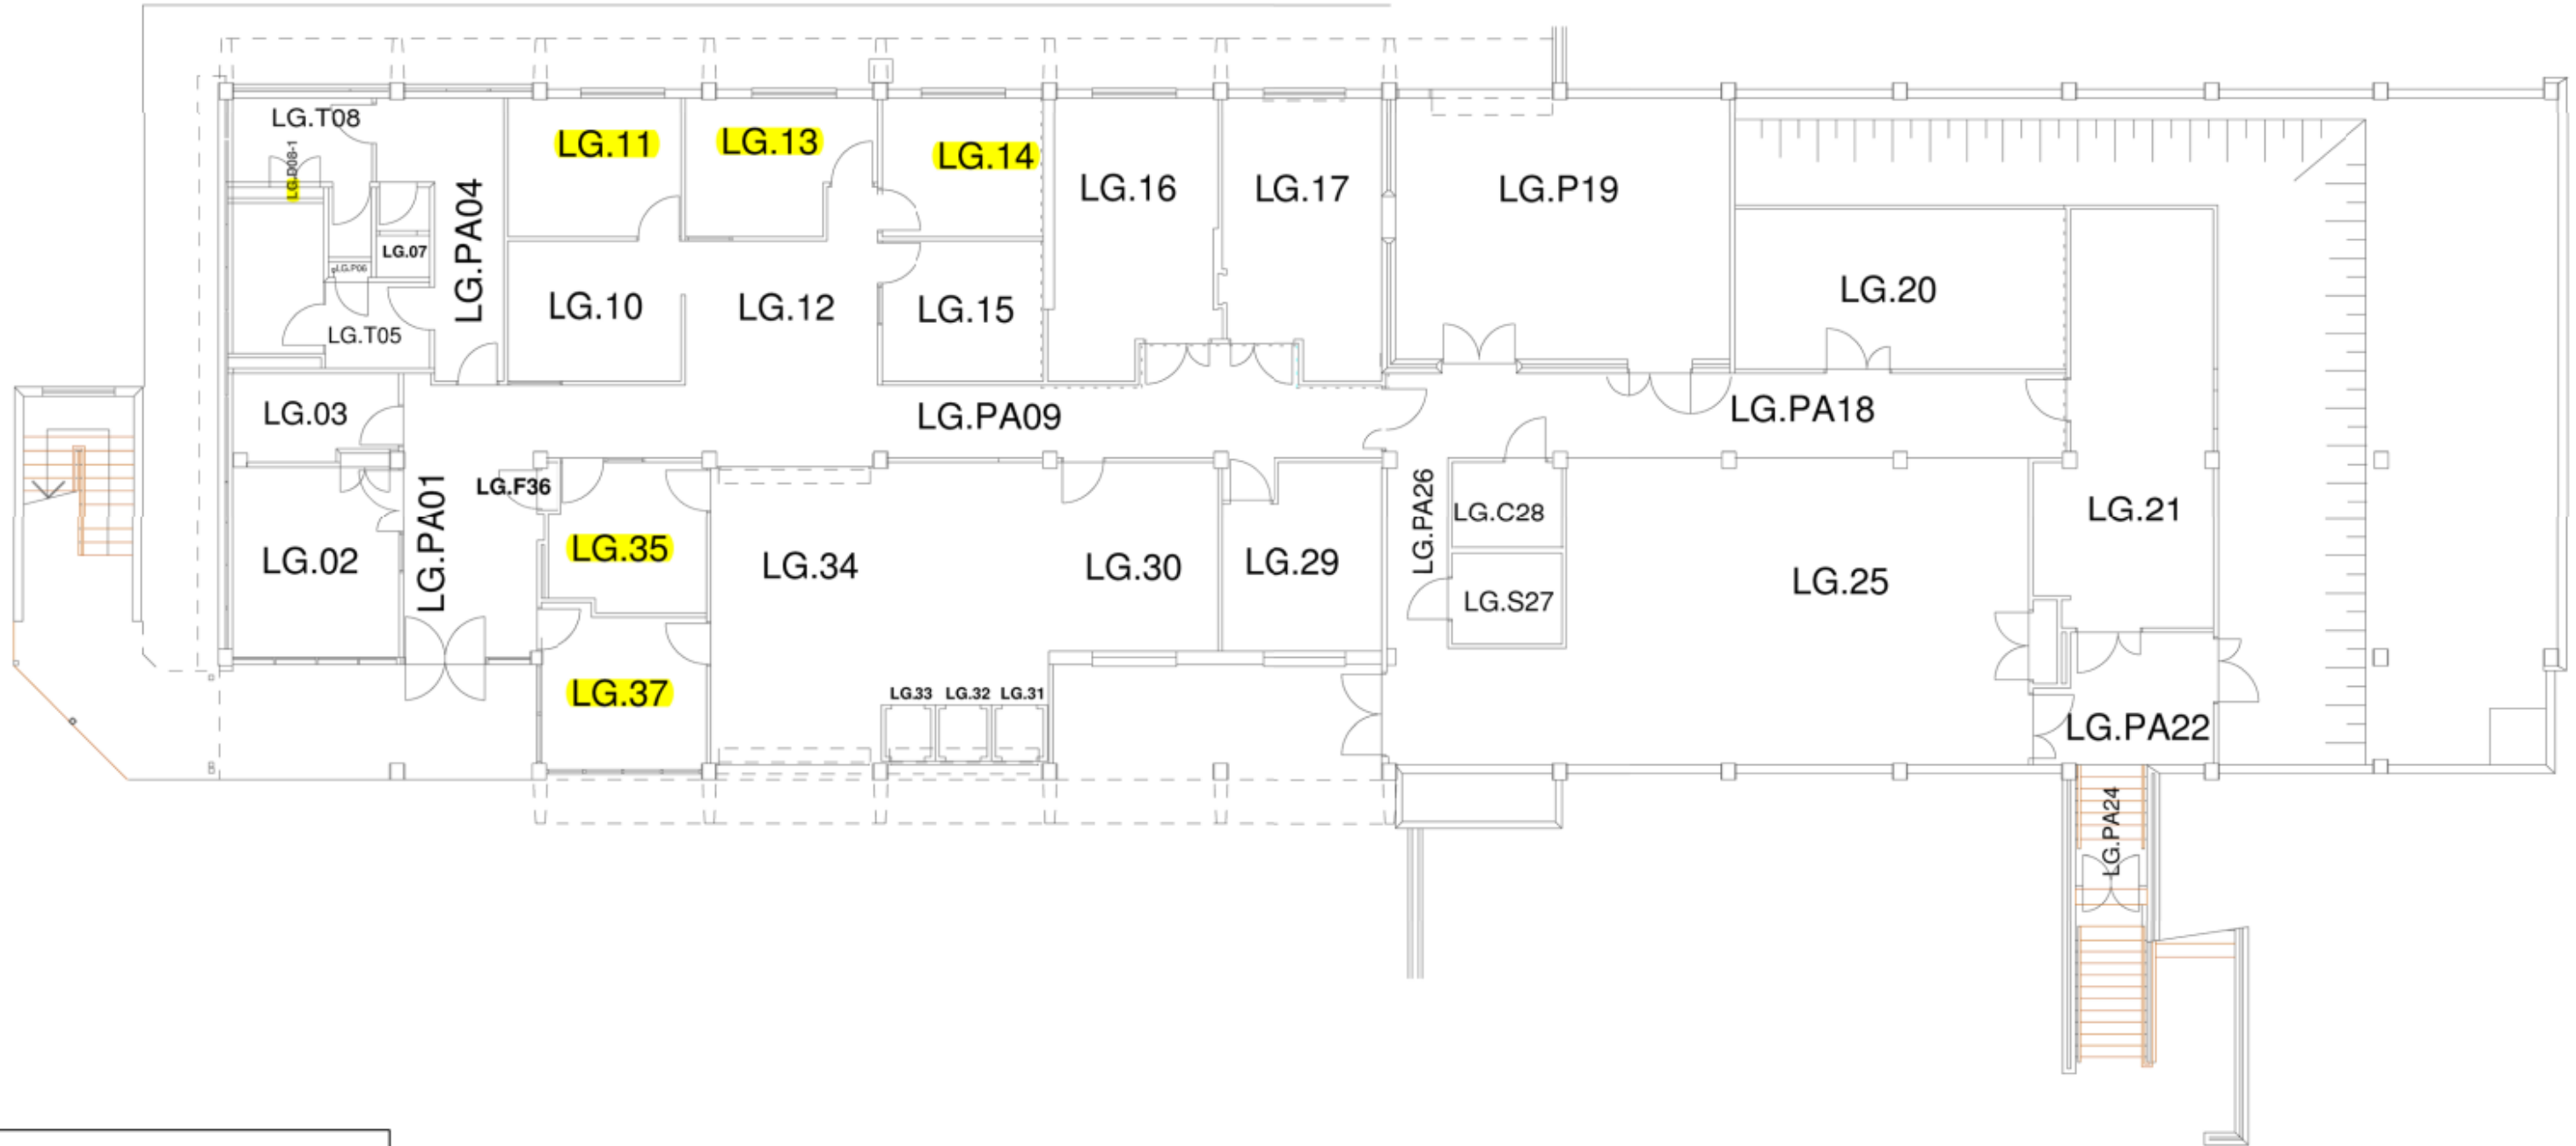
Assumed textured coating to external walkway
ceilings

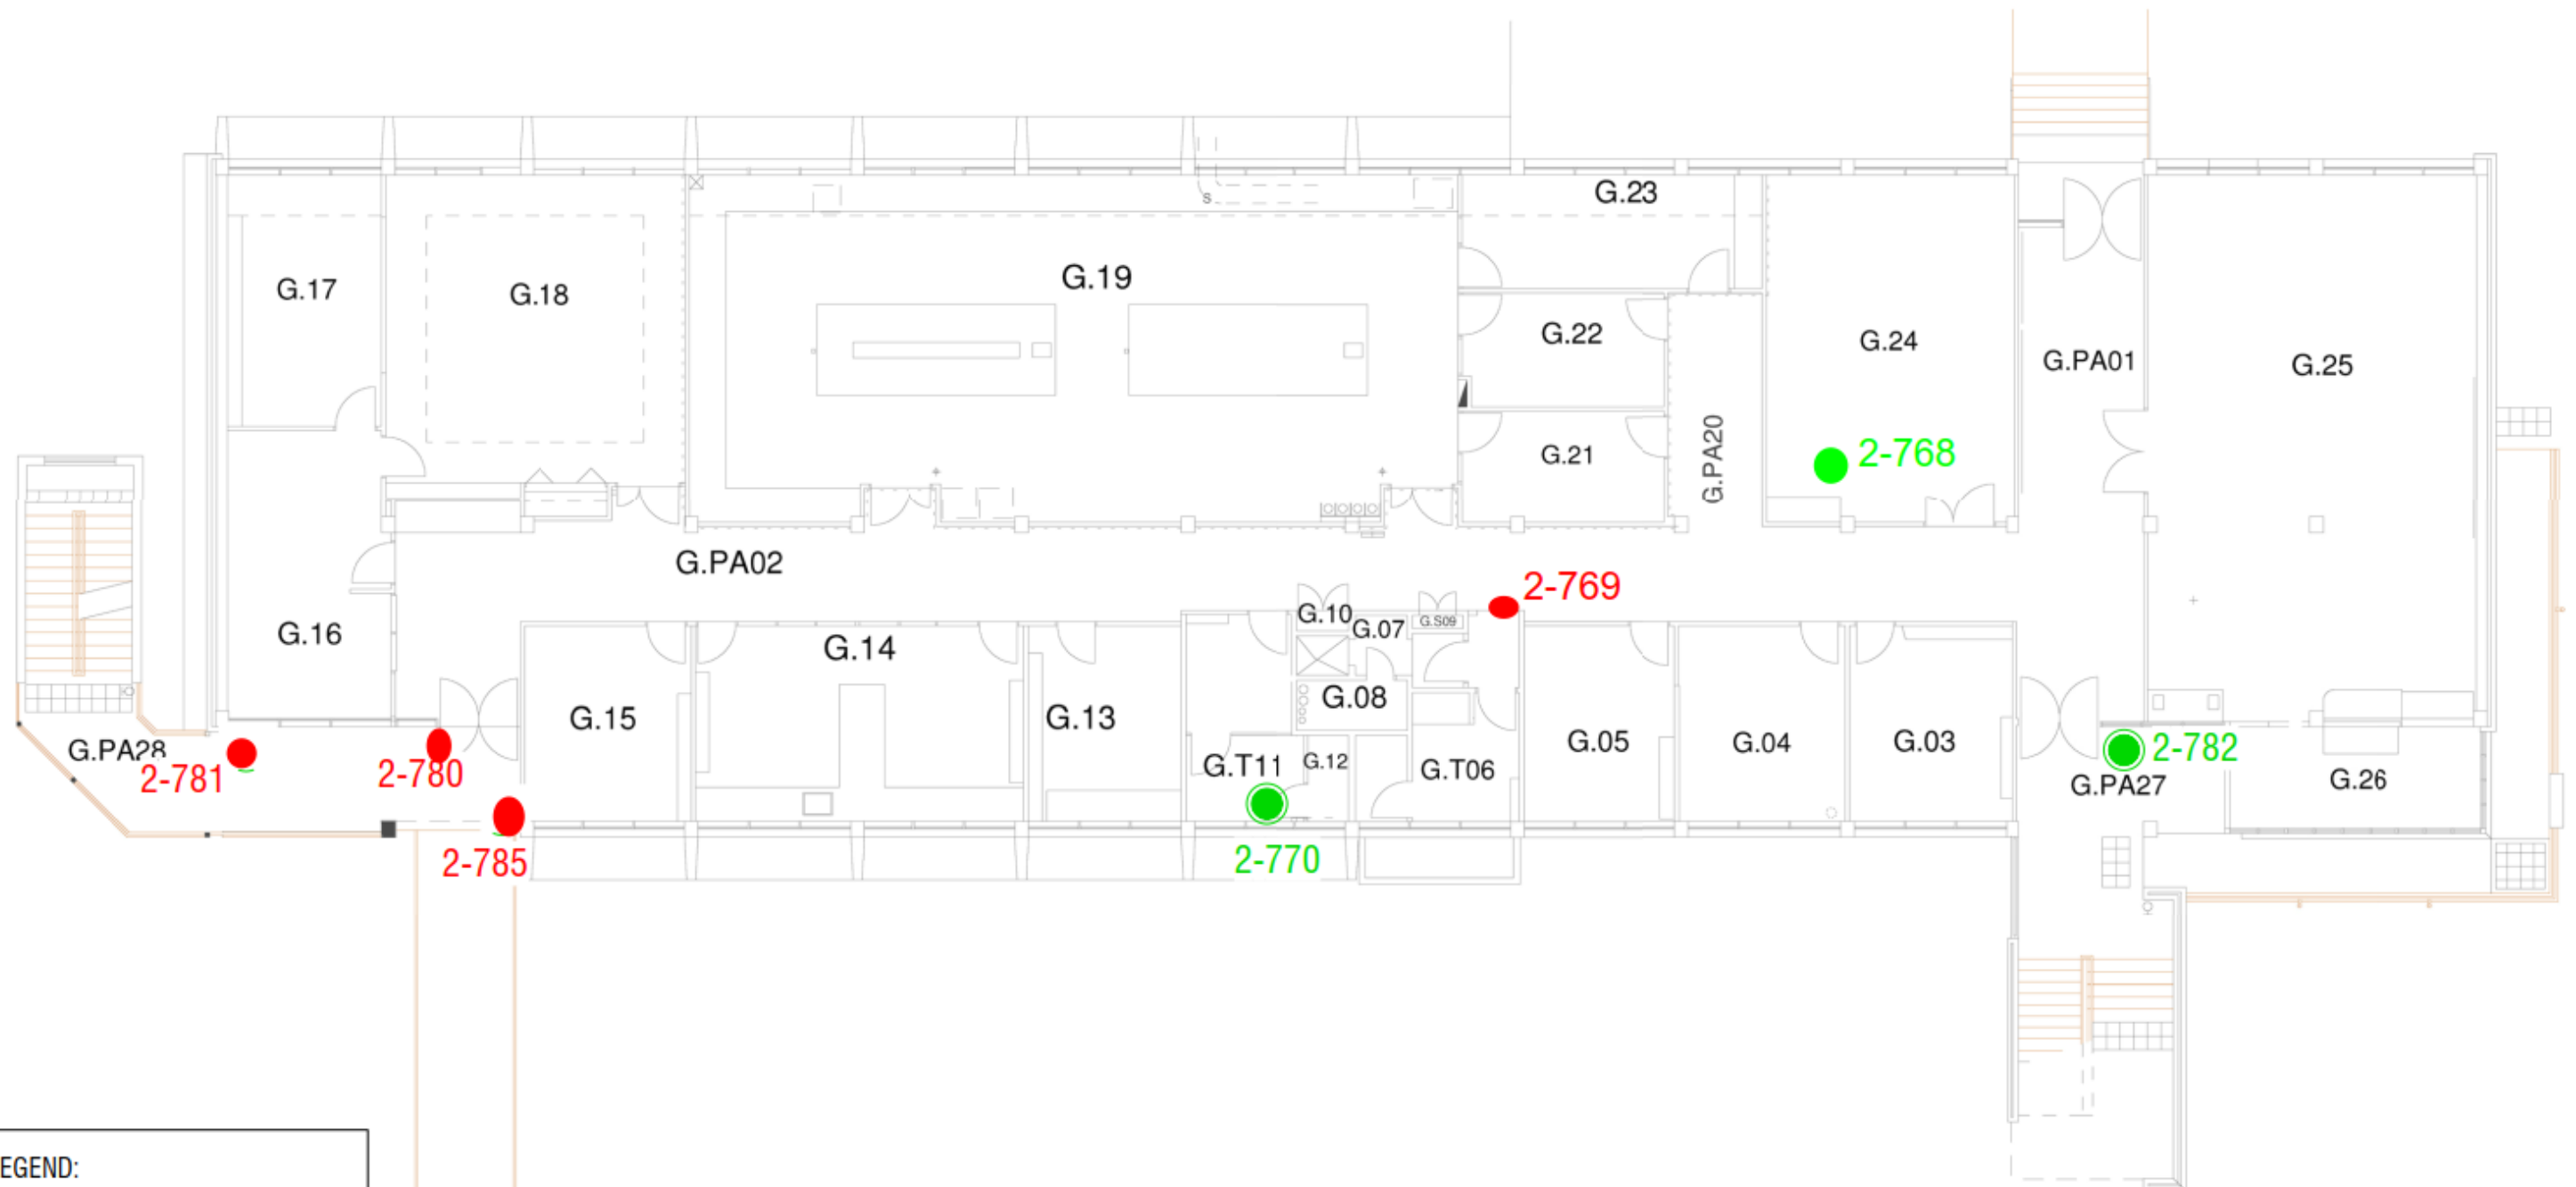
Assumed textured coating to external
walkway ceilings
