COMPLIANCE ASBESTOS RE-INSPECTION AND RISK ASSESSMENT

NOVEMBER 2021

J033450

ROCKHAMPTON NORTH CAMPUS_Building 008 - Applied Science B
Bruce Highway
ROCKHAMPTON NORTH QLD
4700

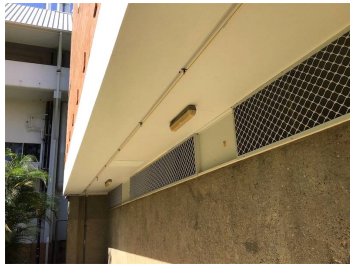
| Location | | 008 Applied Science - Lower Ground Level - External - Soffit - Fibre cement sheet - East elevation | | | | | |
| Sample No. | | 2-827 {AO000153} | Extent of damage | 0 | Disturbance | | 1 |
| | | | Priority Score | 5 | Very Low | | |

| Item No | Location / Description | Hazard Type | Sample No. | Item Status | Est. Extent | Current Label | Condition | Friability | Disturbance Risk | Material Risk | Control Priority | Recommended Action | Record of Works |
|---|--|---|---|---|---|---|---|---|---|---|---|---|---|
| | Soffit -Fibre cement sheet | Asbestos | 2-827 {AO000153} | Identified, Positive | 18m ² | No | Good Condition | Non-friable | Very Low | Low | P4 | Manage In Situ | |

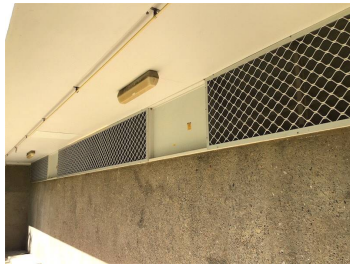
| Location | | 008 Applied Science - Lower Ground Level - External - Infill panel - Fibre cement sheet - East elevation - between windows | | | | | |
| Sample No. | | 2-826 {AO000154} | Extent of damage | 0 | Disturbance | | 1 |
| | | | Priority Score | 4 | Very Low | | |

| Item No | Location / Description | Hazard Type | Sample No. | Item Status | Est. Extent | Current Label | Condition | Friability | Disturbance Risk | Material Risk | Control Priority | Recommended Action | Record of Works |
|---|--|---|---|---|---|---|---|---|---|---|---|---|---|
| | Infill panel -Fibre cement sheet | Asbestos | 2-826 {AO000154} | Identified, Positive | 2m ² | No | Good Condition | Non-friable | Very Low | Very Low | P4 | Manage In Situ | |

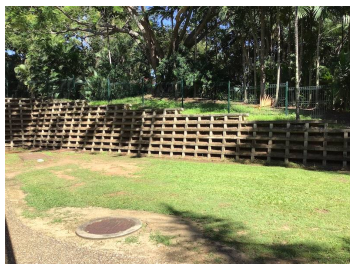
| Location | | 008 Applied Science - Lower Ground Level - External - Packers - Fibre cement sheet - Retaining wall - North elevation | | | | | |
| Sample No. | | 2-824 {AO000155} | Extent of damage | 0 | Disturbance | | 0 |
| | | | Priority Score | 5 | Very Low | | |

| Item No | Location / Description | Hazard Type | Sample No. | Item Status | Est. Extent | Current Label | Condition | Friability | Disturbance Risk | Material Risk | Control Priority | Recommended Action | Record of Works |
|---|--|---|---|---|---|---|---|---|---|---|---|---|---|
| | Packers -Fibre cement sheet | Asbestos | 2-824 {AO000155} | Identified, Positive | 1m ² | No | Good Condition | Non-friable | Very Low | Low | P4 | Manage In Situ | |

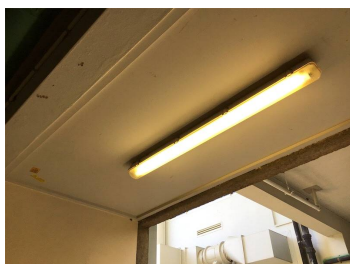
| Location | 008 Applied Science - Lower Ground Level - External - Ceiling - Fibre cement sheet - Breezeway - South elevation | | | | | |
| Sample No. | As 2-790 (AO000156) | Extent of damage | 0 | Disturbance | | 1 |
| | | Priority Score | 4 | Very Low | | |

| Item No | Location / Description | Hazard Type | Sample No. | Item Status | Est. Extent | Current Label | Condition | Friability | Disturbance Risk | Material Risk | Control Priority | Recommended Action | Record of Works |
|---|--|---|---|---|---|---|---|---|---|---|---|---|---|
| | Ceiling -Fibre cement sheet | Asbestos | As 2-790 {AO000156} | Strongly Assumed, Positive | 3m ² | No | Good Condition | Non-friable | Very Low | Very Low | P4 | Manage In Situ | |

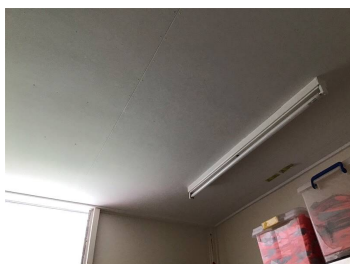
| Location | 008 Applied Science - Lower Ground Level - Store - Ceiling - Fibre cement sheet - Throughout | | | | | |
| Sample No. | 2-790 {AO000156} | Extent of damage | 0 | Disturbance | | 1 |
| | | Priority Score | 4 | Very Low | | |

| Item No | Location / Description | Hazard Type | Sample No. | Item Status | Est. Extent | Current Label | Condition | Friability | Disturbance Risk | Material Risk | Control Priority | Recommended Action | Record of Works |
|---|---|---|---|---|---|---|---|---|---|---|---|---|---|
| | Ceiling -Fibre cement sheet | Asbestos | 2-790 {AO000156} | Identified, Positive | 9m ² | No | Good Condition | Non-friable | Very Low | Very Low | P4 | Manage In Situ | |

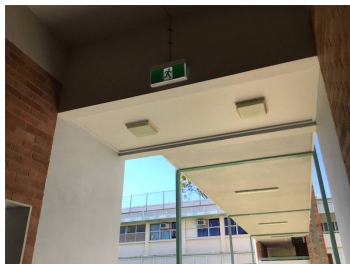
| Location | | 008 Applied Science - Ground Floor - External - Ceiling - Fibre cement sheet - Breezeway - South elevation | | | | | |
| Sample No. | | Visual | Extent of damage | 0 | Disturbance | | 1 |
| | | | Priority Score | 6 | Very Low | | |

| Item No | Location / Description | Hazard Type | Sample No. | Item Status | Est. Extent | Current Label | Condition | Friability | Disturbance Risk | Material Risk | Control Priority | Recommended Action | Record of Works |
|---|---|---|---|---|---|---|---|---|---|---|---|--|---|
| | Ceiling -Fibre cement sheet | Asbestos | Visual | Assumed, Positive | 6m ² | No | Good Condition | Non-friable | Very Low | Low | P4 | Conduct Further Investigations/Sampling Prior to Disturbance | |

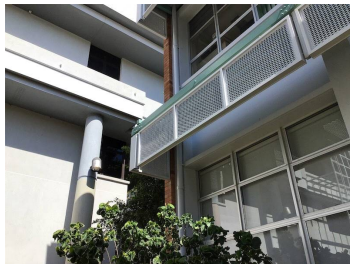
| Location | | 008 Applied Science - Ground Floor - External - Vent pipe - Moulded cement - South elevation | | | | | |
| Sample No. | | 2-828 (AO000152) | Extent of damage | 0 | Disturbance | | 1 |
| | | | Priority Score | 4 | Very Low | | |

| Item No | Location / Description | Hazard Type | Sample No. | Item Status | Est. Extent | Current Label | Condition | Friability | Disturbance Risk | Material Risk | Control Priority | Recommended Action | Record of Works |
|---|--|---|---|---|---|---|---|---|---|---|---|---|---|
| | Vent pipe -Moulded cement | Asbestos | 2-828 {AO000152} | Identified, Positive | 61m | No | Good Condition | Non-friable | Very Low | Very Low | P4 | Manage In Situ | |

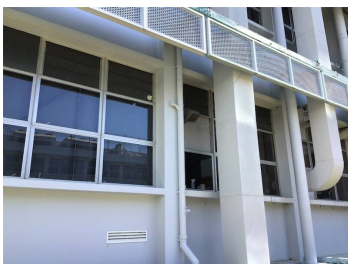
| Location | 008 Applied Science - Ground Floor - External - Vent pipe - Moulded cement - South elevation | | | | | |
| Sample No. | As 2-828 {AO000152} | Extent of damage | 0 | Disturbance | | 1 |
| | | Priority Score | 4 | Very Low | | |

| Item No | Location / Description | Hazard Type | Sample No. | Item Status | Est. Extent | Current Label | Condition | Friability | Disturbance Risk | Material Risk | Control Priority | Recommended Action | Record of Works |
|---|--|---|---|---|---|---|---|---|---|---|---|---|---|
| | Vent pipe -Moulded cement | Asbestos | As 2-828 {AO000152} | Strongly Assumed, Positive | 6lm | No | Good Condition | Non-friable | Very Low | Very Low | P4 | Manage In Situ | |

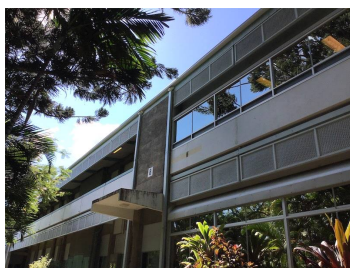
| Location | | 008 Applied Science - 1st Floor - External - Soffit - Fibre cement sheet - North elevation | | | | | |
| Sample No. | | Visual | Extent of damage | 0 | Disturbance | | 1 |
| | | | Priority Score | 6 | Very Low | | |

| Item No | Location / Description | Hazard Type | Sample No. | Item Status | Est. Extent | Current Label | Condition | Friability | Disturbance Risk | Material Risk | Control Priority | Recommended Action | Record of Works |
|---|--|---|---|---|---|---|---|---|---|---|---|---|---|
| | Soffit -Fibre cement sheet | Asbestos | Visual | Assumed, Positive | 12m ² | No | Good Condition | Non-friable | Very Low | Low | P4 | Manage In Situ | |

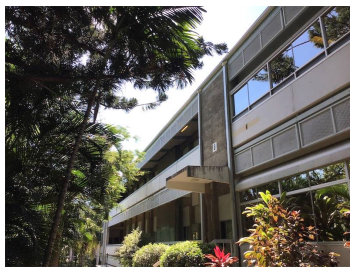
| Location | | 008 Applied Science - 1st Floor - External - Fascia - Fibre cement sheet - North elevation | | | | | |
| Sample No. | | Visual | Extent of damage | 0 | Disturbance | | 1 |
| | | | Priority Score | 6 | Very Low | | |

| Item No | Location / Description | Hazard Type | Sample No. | Item Status | Est. Extent | Current Label | Condition | Friability | Disturbance Risk | Material Risk | Control Priority | Recommended Action | Record of Works |
|---|--|---|---|---|---|---|---|---|---|---|---|---|---|
| | Fascia -Fibre cement sheet | Asbestos | Visual | Assumed, Positive | 20m ² | No | Good Condition | Non-friable | Very Low | Low | P4 | Manage In Situ | |

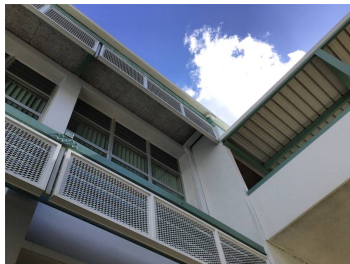
| Location | | 008 Applied Science - 1st Floor - External - Soffit - Fibre cement sheet - South elevation | | | | | |
| Sample No. | | Visual | Extent of damage | 0 | Disturbance | | 1 |

| Item No | Location / Description | Hazard Type | Sample No. | Item Status | Est. Extent | Current Label | Condition | Friability | Disturbance Risk | Material Risk | Control Priority | Recommended Action | Record of Works |
|---|--|---|---|---|---|---|---|---|---|---|---|---|---|
| | Soffit -Fibre cement sheet | Asbestos | Visual | Assumed, Positive | 12m ² | No | Good Condition | Non-friable | Very Low | Low | P4 | Manage In Situ | |
