ASBESTOS CONTAINING MATERIALS SURVEY REPORT

Postgraduate Research Building
Building 009
Rockhampton North

Report Number 622.10968.00000/0040-R01-ASR0Bld009

27 December 2017

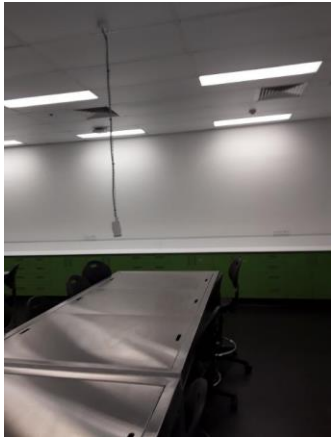
External Room G.14	Internal wall, Fibrous Cement	70m ²	NAD

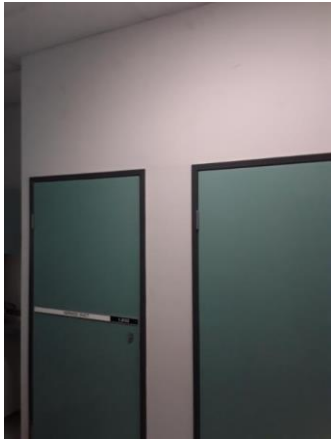
1st Floor Room 1.PA02	Internal wall, Fibrous Cement	12m²	NAD
1-327

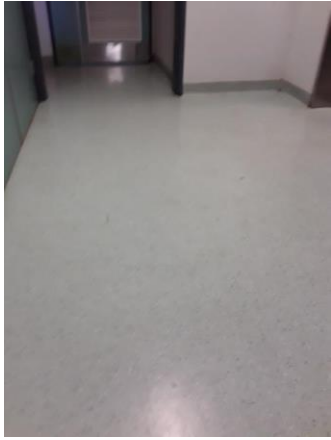
1st Floor Throughout All Levels building 9	Vinyl floor, Vinyl Products	20m²	NAD

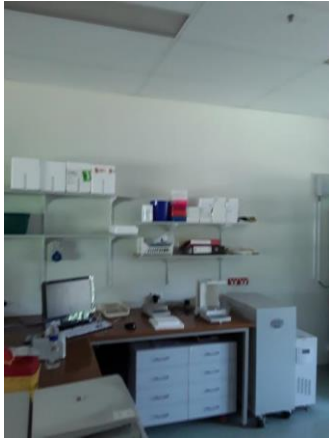
1st Floor Room 1.09	Internal north, east west walls, Fibrous Cement	45m ²	NAD
1-329

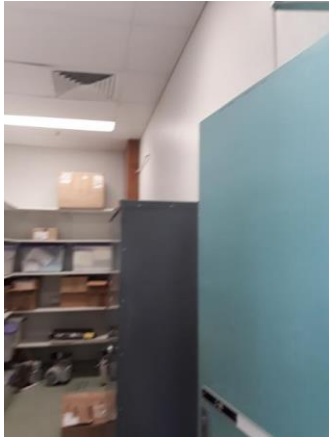
1st Floor Room 1.05	Internal wall, Fibrous Cement	8m ²	NAD

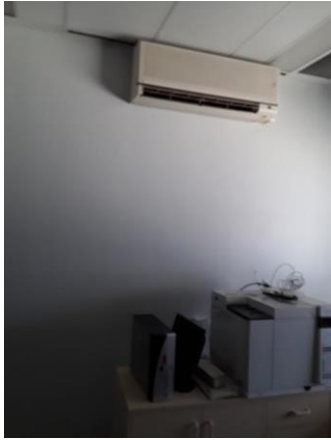
1st Floor Room 1.07	Internal walls, Fibrous Cement	10m ²	NAD
1-330	 	External External eaves to ground floor south side	Eave lining , Fibrous Cement	130m ²	NAD

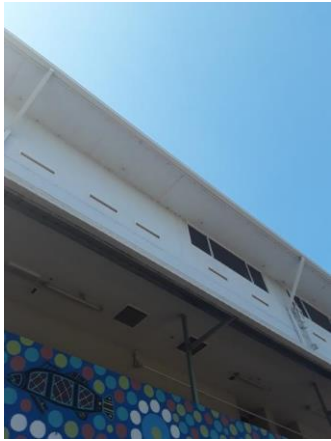
External eaves to third floor all sides	Eave lining , Fibrous Cement	200m ²	NAD
1-331	 	External eaves to first floor West side	Eave lining , Fibrous Cement	130m ²	NAD

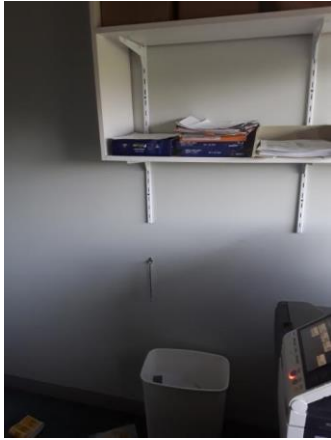
2nd Floor Room 2.04	Internal wall, Fibrous Cement	8m ²	NAD
Similar to 1-332

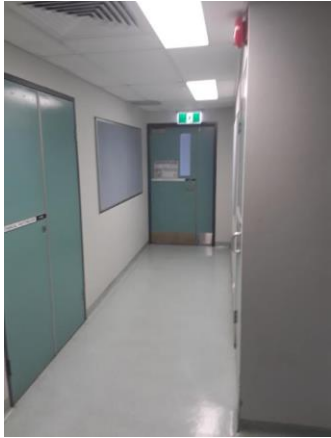
2nd Floor Level 2	All internal walls, Fibrous Cement	400m ²	NAD

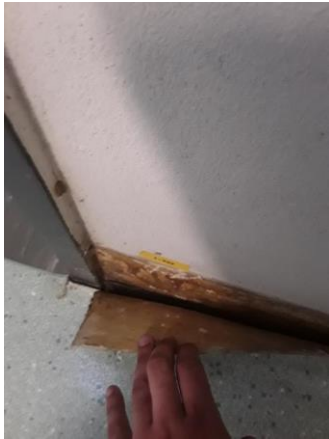
Ground Floor Throughout All Levels building 9	Vinyl floor adhesive, Suspected Asbestos		NAD
