# COMPLIANCE ASBESTOS RE-INSPECTION AND RISK ASSESSMENT

NOVEMBER 2021

J033451

ROCKHAMPTON NORTH CAMPUS\_Building 010 - Library  
Bruce Highway  
ROCKHAMPTON NORTH QLD  
4700

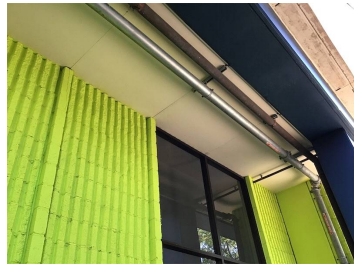
Location		010 Library - Ground Floor - External - Soffits - Fibre cement sheet - All elevations

Hazard Type		Asbestos	Material Assessment		Disturbance Assessment		
Friability		Non-friable	Product Type	1	Occupancy		0
Sample No.		Visual	Extent of damage	0	Disturbance		1
Result		Assumed Positive Unknown or Crocidolite	Surface Treatment	1	Exposure		0
			Asbestos Type	3	Maintenance		0
Item Number		1	Material Score	5	Disturbance Score		1
			Priority Score	6	Very Low		
No Additional Photographic Evidence Available

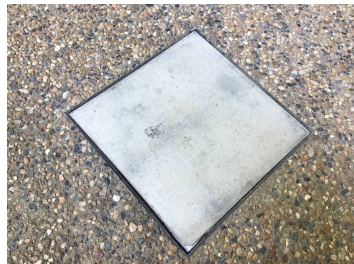
Location		010 Library - Ground Floor - External - Data pit - Moulded cement - South elevation

Hazard Type		Asbestos	Material Assessment		Disturbance Assessment		
Friability		Non-friable	Product Type	1	Occupancy		0
Sample No.		1-543 (AO000157)	Extent of damage	0	Disturbance		1
Result		Positive Chrysotile	Surface Treatment	1	Exposure		0
			Asbestos Type	1	Maintenance		0
Item Number		3	Material Score	3	Disturbance Score		1
			Priority Score	4	Very Low		
No Additional Photographic Evidence Available

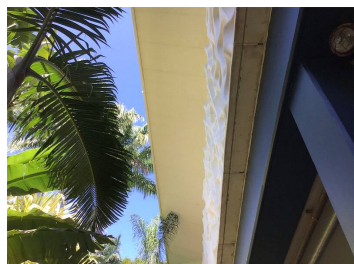
Location		010 Library - 1st Floor - External - Soffits - Fibre cement sheet - All elevations

Hazard Type		Asbestos	Material Assessment		Disturbance Assessment		
Friability		Non-friable	Product Type	1	Occupancy		0
Sample No.		Visual	Extent of damage	0	Disturbance		1
Result		Assumed Positive Unknown or Crocidolite	Surface Treatment	1	Exposure		0
			Asbestos Type	3	Maintenance		0
Item Number	2	Material Score	5	Disturbance Score	1		
		Priority Score	6	Very Low			
No Additional Photographic Evidence Available

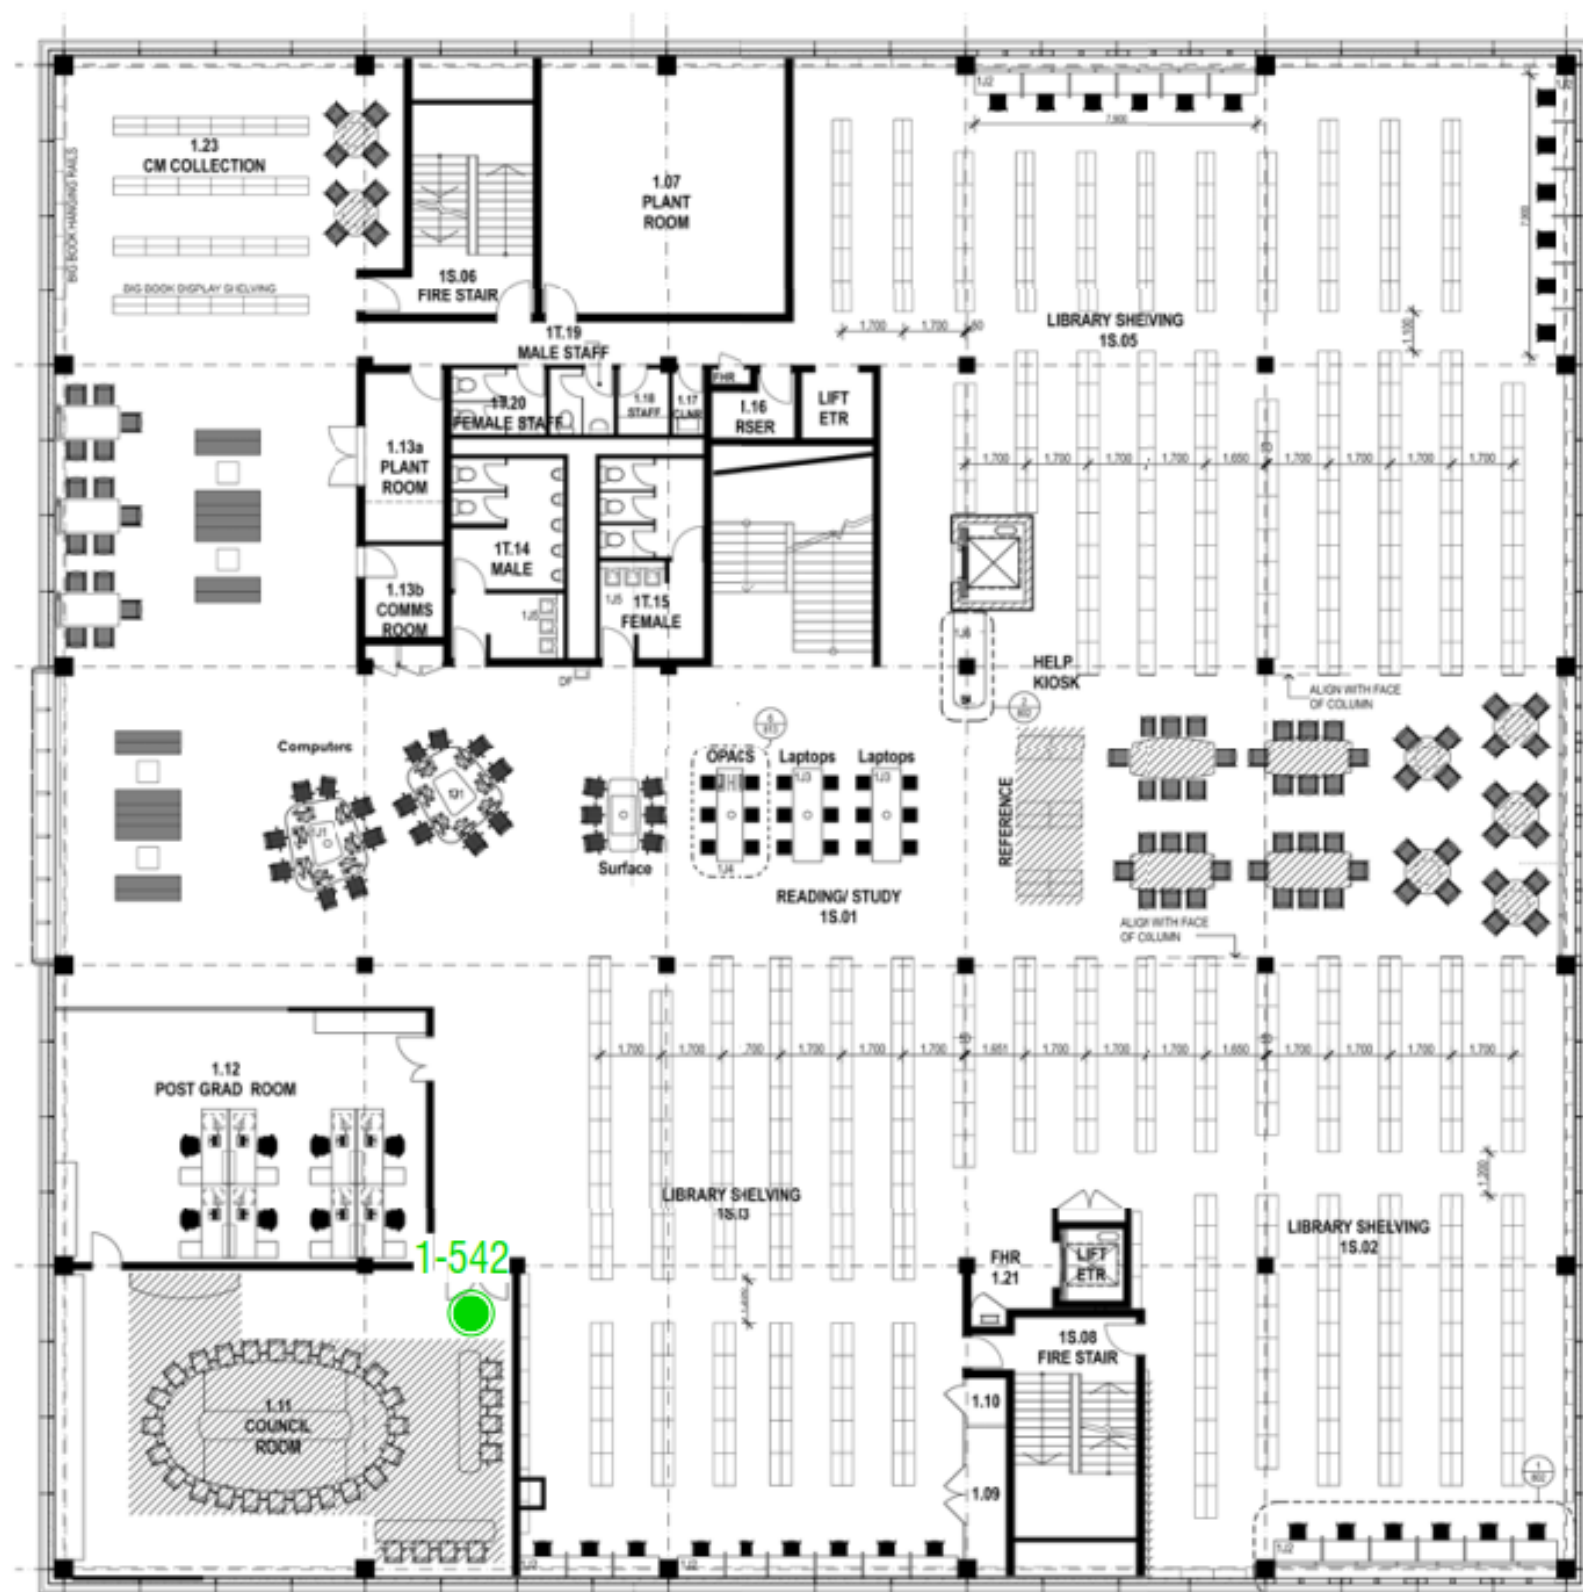
AREA: Library 010 - Level One

Assumed soffits on all levels
