## ASBESTOS CONTAINING MATERIALS SURVEY REPORT

CQU International  
Building 011  
Rockhampton North

Report Number 622.10968.00000/0040-R01-ASR-Bld 011

7 December 2017

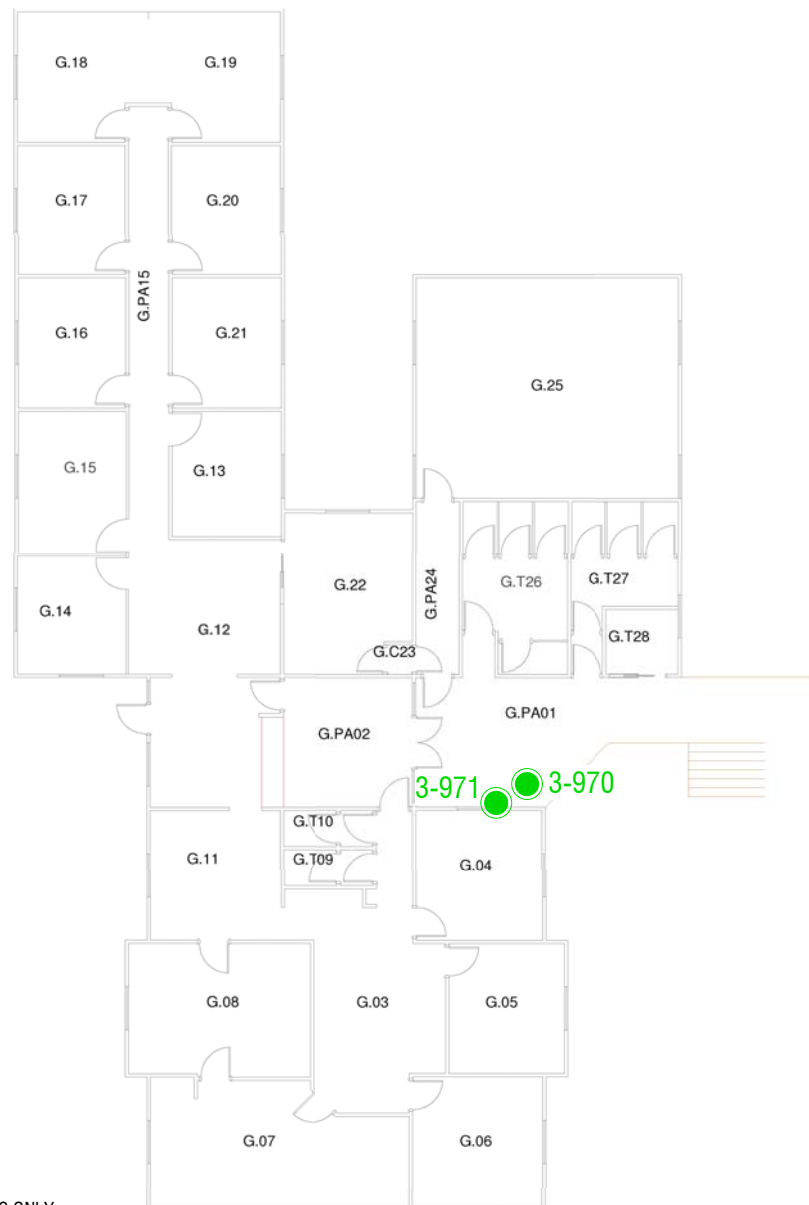
Building No:	011
Inspection Date:	Sept / Oct 2017
Inspected By:	NC
Figure No.:	SLR62210968-RN-011G-01
Drawn By:	LF
Drawn Date:	6/11/17

1st Floor SOFFIT AND WALKWAY	Soffit and walkway sheeting - all elevations , Fibrous Cement	45m²	NAD
3-971

1st Floor WINDOW INFILL PANEL	Window infill panel - south elevation , Fibrous Cement	0.5m²	NAD
