**ASBESTOS CONTAINING MATERIALS
SURVEY REPORT**

**Building 13 Language Centre
Rockhampton North**

Report Number 622.10968.00000/0040-R01-ASR-BLD 13

7 December 2017

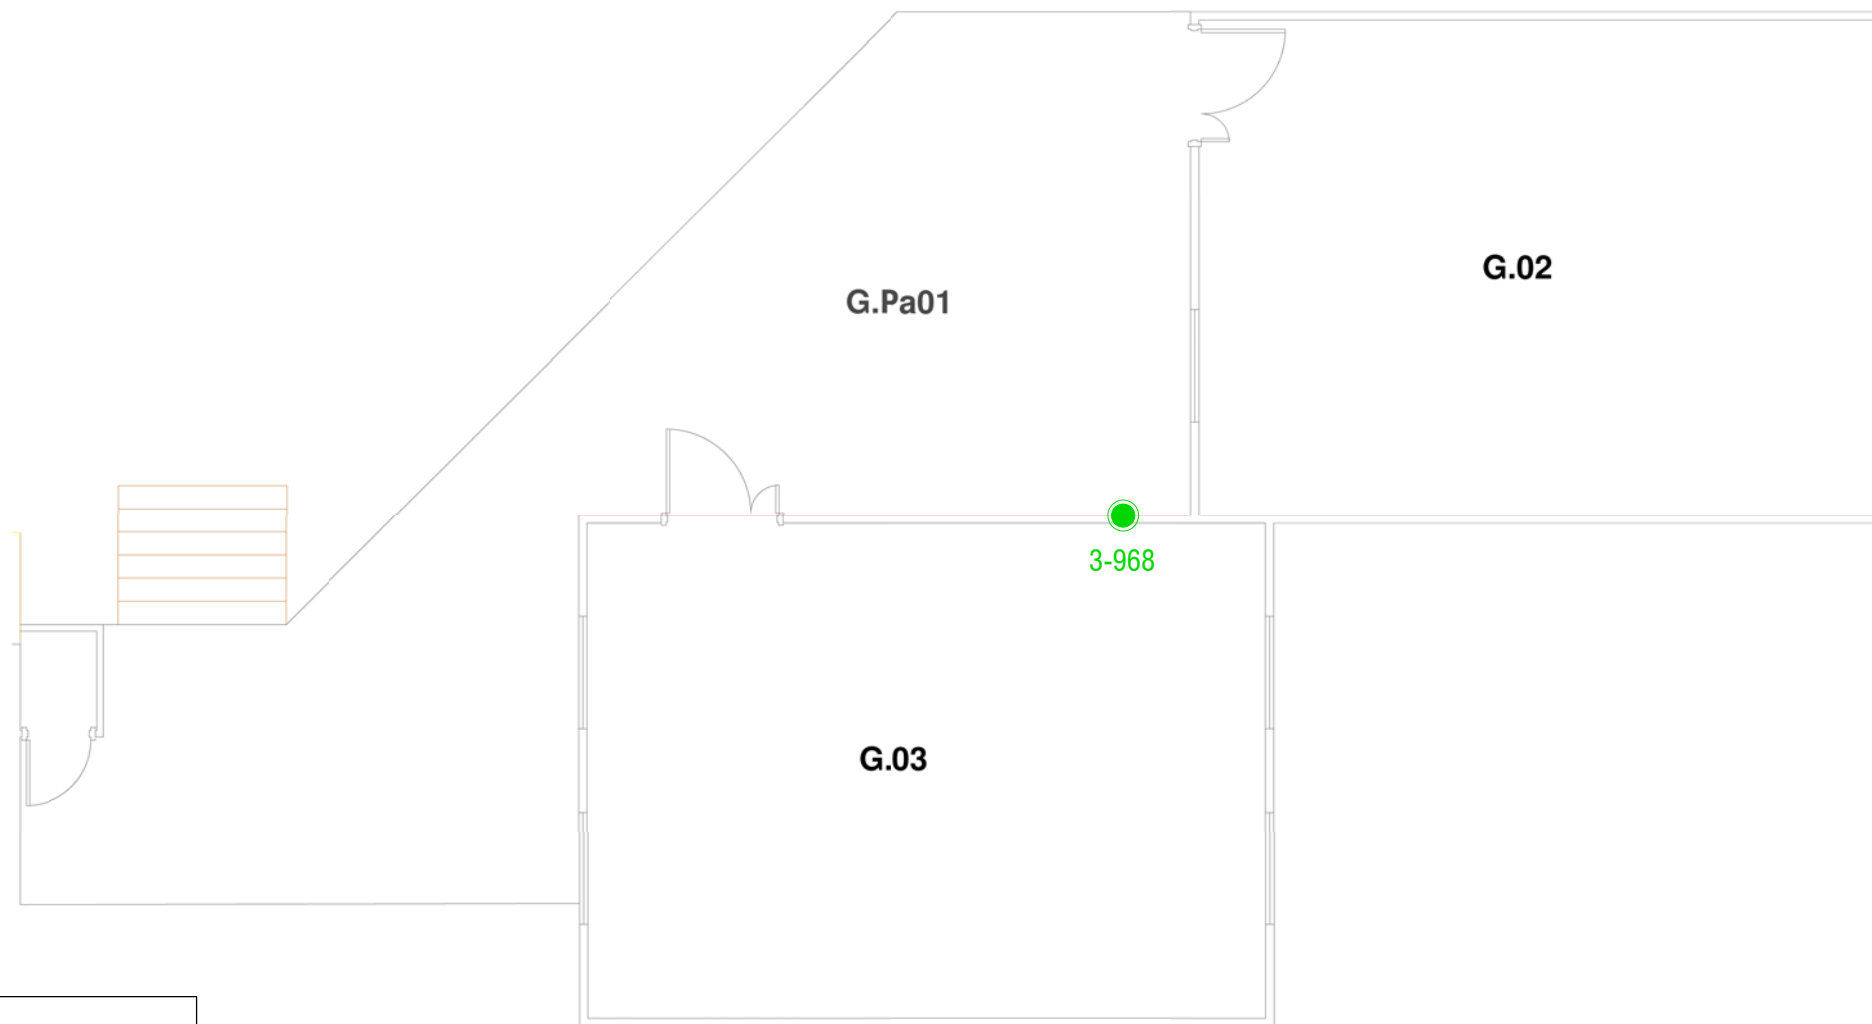
Building No:	
Inspection Date:	Sept / Oct 2017
Inspected By:	
Figure No.:	SLR62210968-RN-020-01
Drawn By:	LF
Drawn Date:	9/11/17

1st Floor SOFFIT AND WALKWAY	Soffit and walkway sheeting - all elevations, Fibrous Cement	55m ²	NAD

● Sample location
No Asbestos Detected
