COMPLIANCE ASBESTOS RE-INSPECTION AND RISK ASSESSMENT

NOVEMBER 2021

J033452

ROCKHAMPTON NORTH CAMPUS_Building 015 - Animal House
Bruce Highway
ROCKHAMPTON NORTH QLD
4700

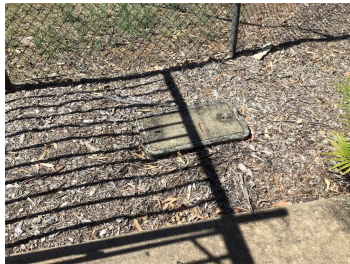
Location		015 Animal House - Ground Floor - External - Communication pit - Moulded cement - North elevation - adj front gate

Hazard Type		Asbestos	Material Assessment		Disturbance Assessment				
Friability		Non-friable	Product Type		1		Occupancy	0	
Sample No.		3-974 {AO000158}	Extent of damage		0		Disturbance	1	
Result		Positive Chrysotile		Surface Treatment			1	Exposure	0
				Asbestos Type			1	Maintenance	0
Item Number		1		Material Score			3	Disturbance Score	1
				Priority Score			4	Very Low	
No Additional Photographic Evidence Available

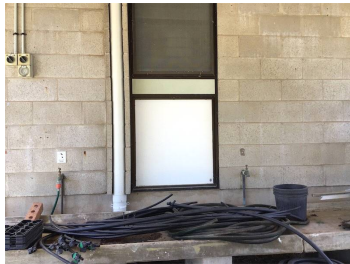
Location		015 Animal House - Ground Floor - External - Infill panels - Fibre cement sheet - All elevations - window and door infills

Hazard Type		Asbestos	Material Assessment		Disturbance Assessment		
Friability		Non-friable	Product Type	1	Occupancy		0
Sample No.		3-976 {AO000159}	Extent of damage	0	Disturbance		1
Result		Positive Chrysotile	Surface Treatment	1	Exposure		0
			Asbestos Type	1	Maintenance		0
Item Number		2	Material Score	3	Disturbance Score		1
			Priority Score	4	Very Low		
No Additional Photographic Evidence Available
