ASBESTOS CONTAINING MATERIALS SURVEY REPORT

Biology Laboratories
Building 017
Rockhampton North

Report Number 622.10968.00000/0040-R01-ASR-Bld017

27 December 2017

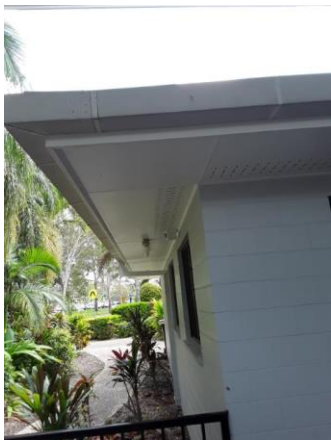
Eaves - all sides	Eave lining , Fibrous Cement	110m ²	NAD

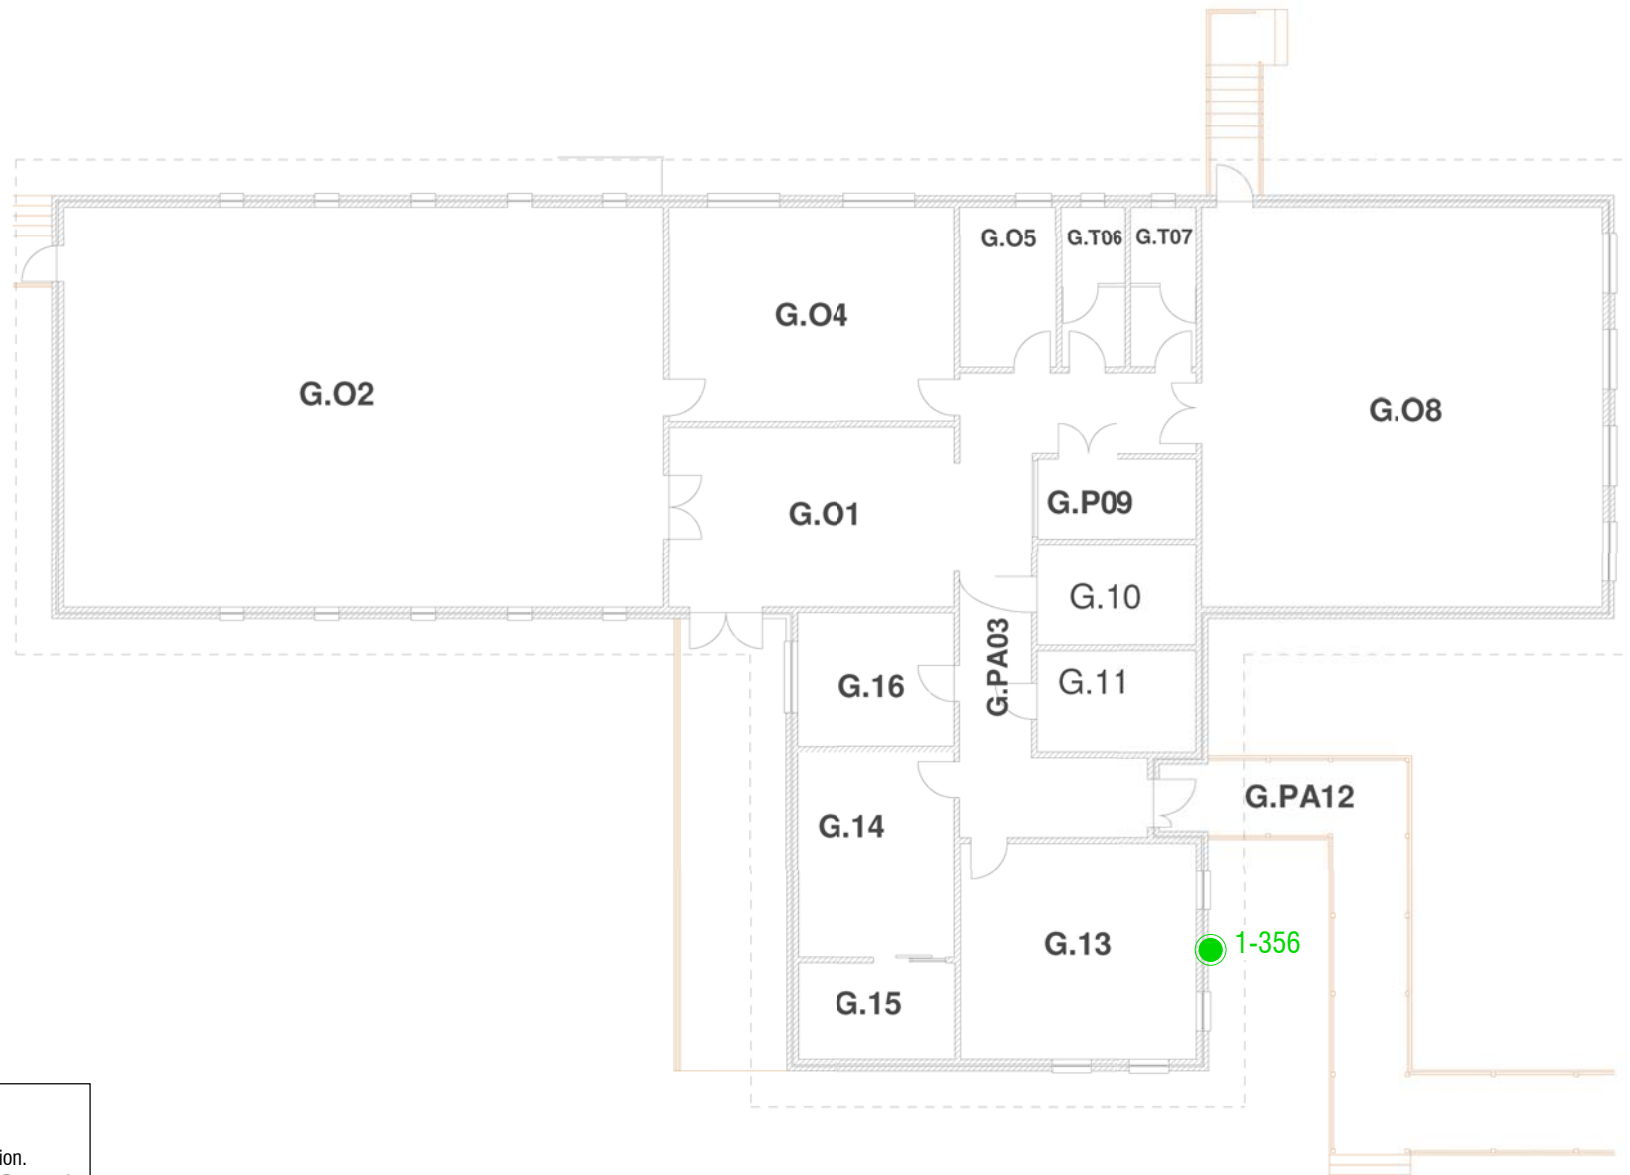
Sample location.
No Asbestos Detected
