ASBESTOS CONTAINING MATERIALS SURVEY REPORT

Health Science
Building 018
Rockhampton North

Report Number 622.10968.00000/0040-R01-ASR-Bld18

27 December 2017

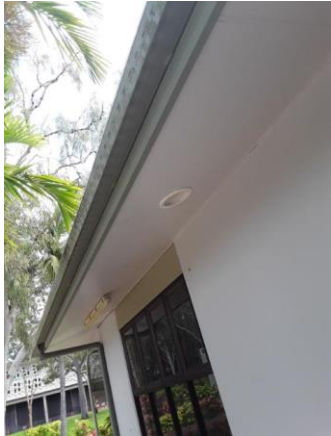
External All External eaves	Eave lining , Fibrous Cement	140m ²	NAD

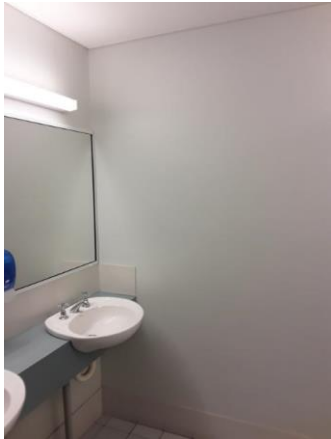
Ground Floor Toilet G.T 38	Internal walls, Fibrous Cement	45m²	NAD
Similar to 1-363

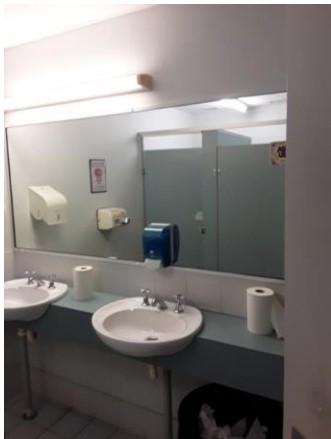
Ground Floor Toilet G.T 39	Internal walls, Fibrous Cement	45m²	NAD

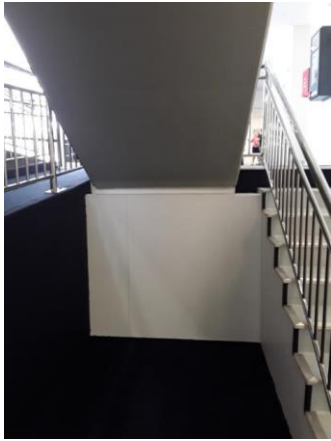
Basement Foyer below stairs	Internal wall, Fibrous Cement	2m ²	NAD
1-365

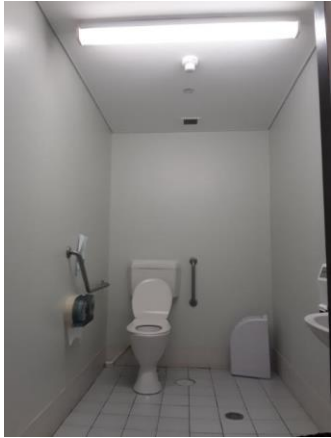
Basement Disabled toilet LG.T02	Internal walls, Fibrous Cement	12m ²	NAD

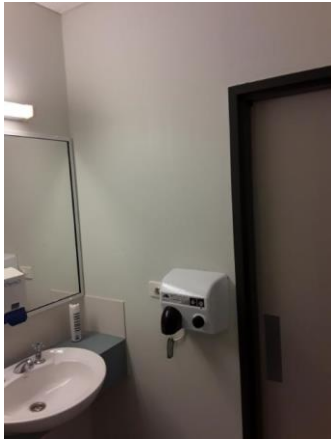
Ground Floor Male toilet 1.T07	Internal wall, Fibrous Cement	36m²	NAD
Similar to 1-366

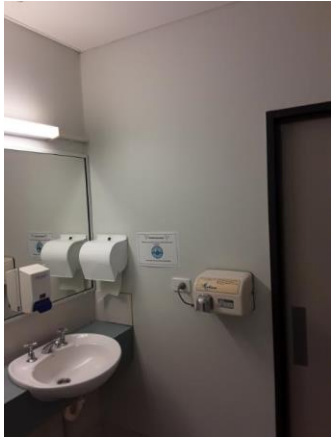
Ground Floor Female toilet 1.T06	Internal wall, Fibrous Cement	36m²	NAD

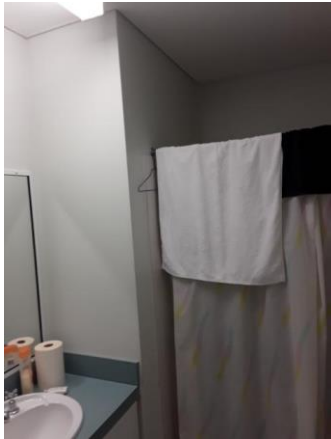
Ground Floor Shower 1.05	Internal wall, Fibrous Cement	18m ²	NAD
