ASBESTOS CONTAINING MATERIALS SURVEY REPORT

Ron Young Building
Building 19
Rockhampton North

Report Number 622.10968.00000/0040-R02-ASR-Bld19

27 December 2017

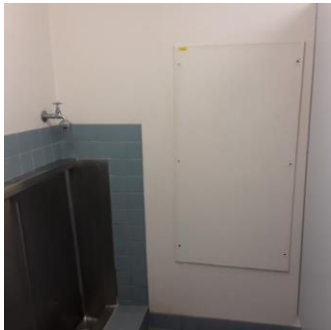
1st Floor MALE TOILET 1.T 22	Infill panel. northern wall., Fibrous Cement	1no	NAD

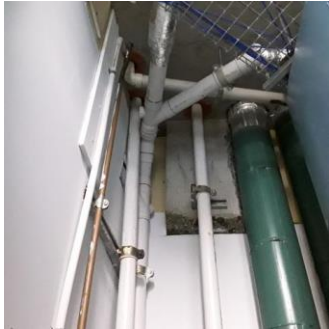
2nd Floor PLANT ROOM (LOCATED WEST OF ROOM 2.33)	Southwestern elevation. fill material surrounding pvc pipe (soil pipe), Insulation	LESS THAN 1m ²	NAD
Similar to 1-552

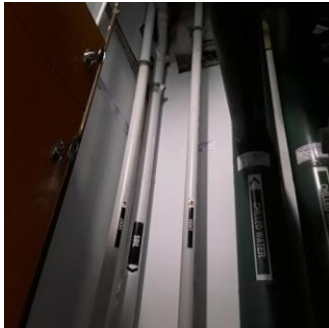
2nd Floor PLANT ROOM (LOCATED WEST OF ROOM 2.33)	Southwestern elevation. fill material surrounding pvc pipes (vent pipes), Insulation	LESS THAN 1m ²	NAD

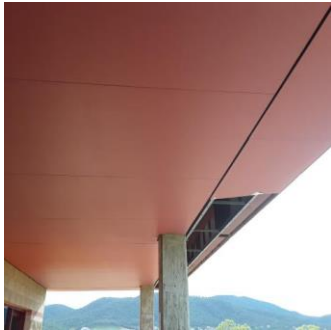
3rd Floor BALCONY OUTSIDE 3.32 COMMON ROOM	Ceiling sheeting, Fibrous Cement	30m²	NAD
Similar to 1-553

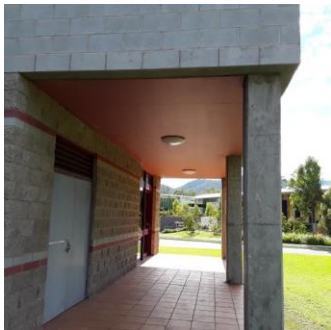
Ground Floor EXTERNAL. OUTSIDE A/C PLANT ROOM G.P46. SOUTHERN ELEVATION.	Ceiling lining, Fibrous Cement	36	NAD

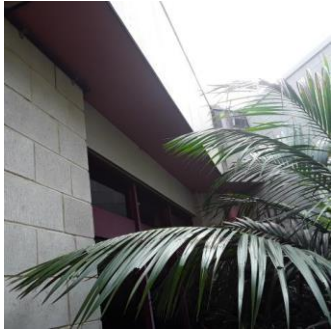
Ground Floor EXTERNAL. ABOVE DOORS AND WINDOWS	All elevations. infill panels, Fibrous Cement	20m²	NAD
1-556

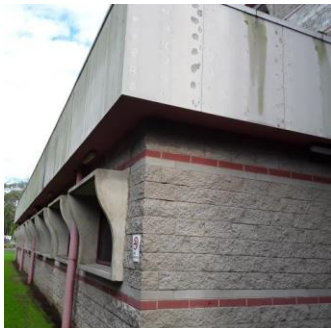
Ground Floor EXTERNAL	Soffits, Fibrous Cement	150lin m	NAD

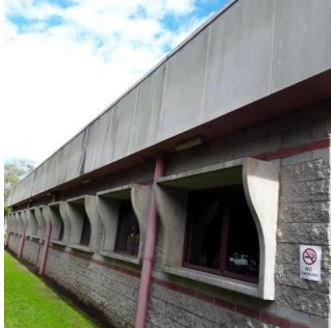
Ground Floor EXTERNAL	Vertical fascia, Fibrous Cement	150lin m	NAD
