ASBESTOS CONTAINING MATERIALS SURVEY REPORT

Flammable Liquids Store
Building 020
Rockhampton North

Report Number 622.10968.00000/0040-R01-ASR-Bld020

7 December 2017

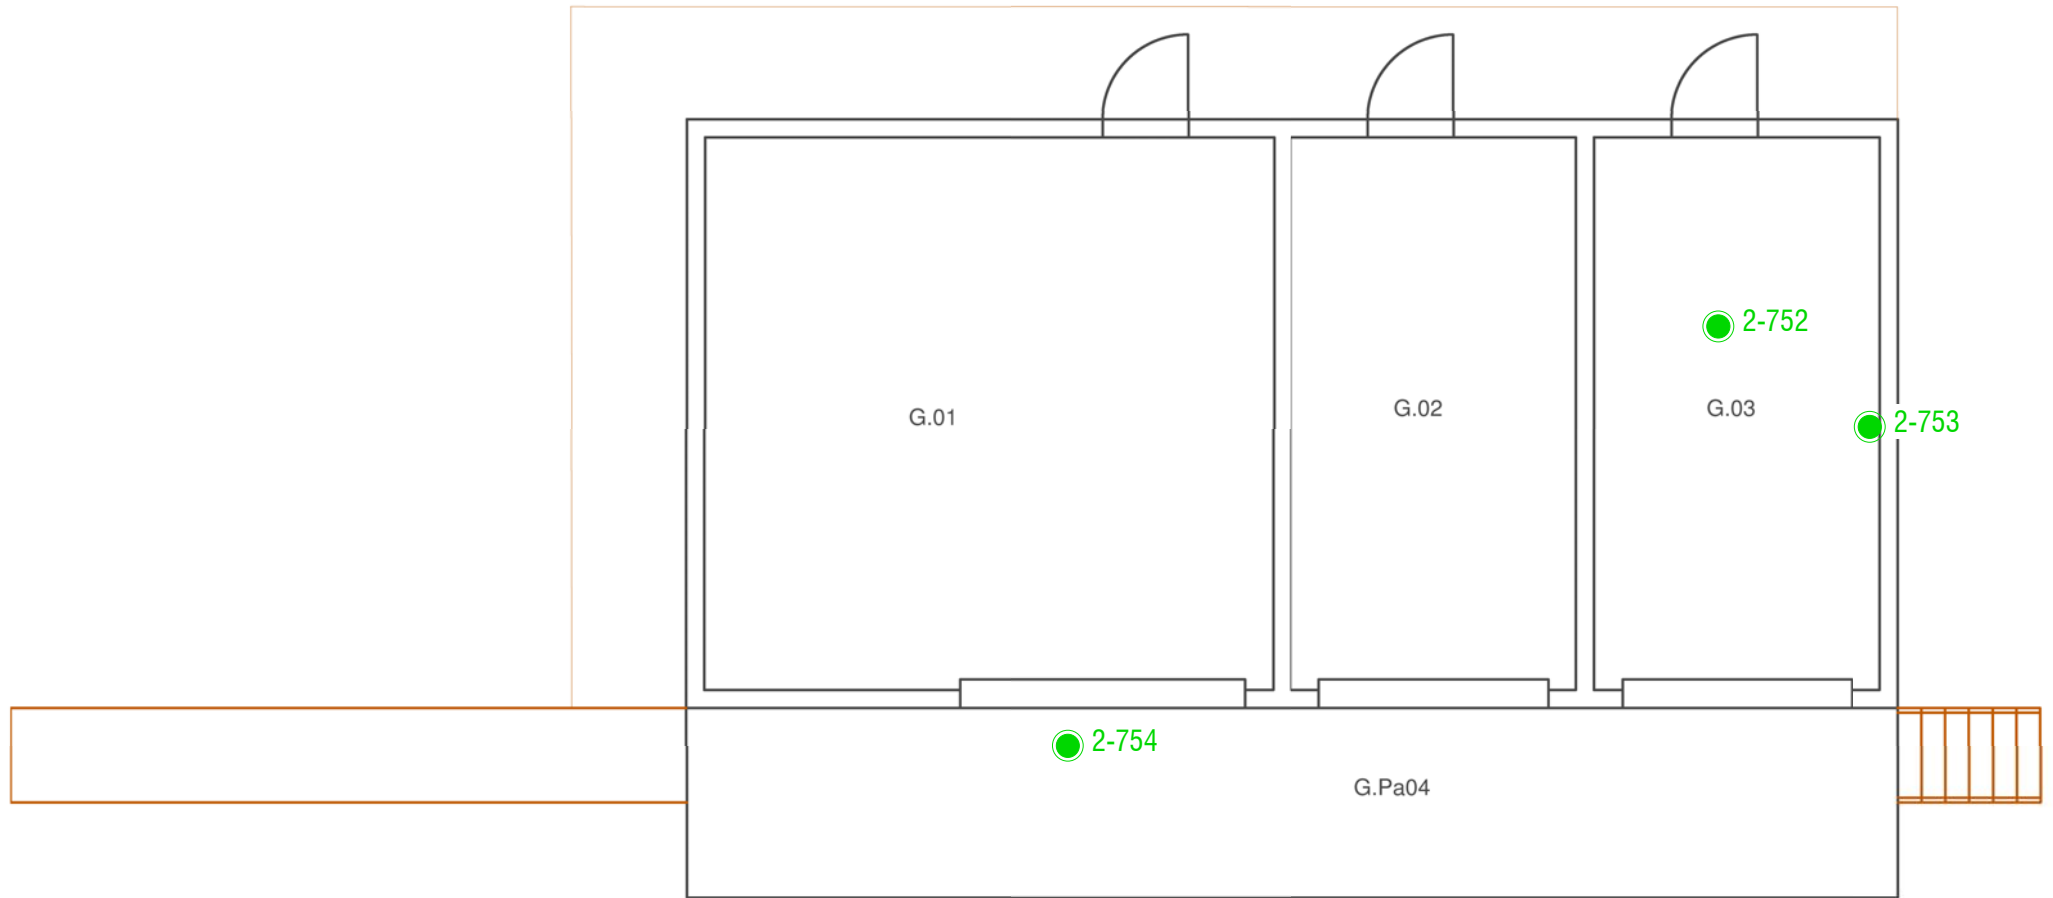
Site Plan

● Sample location
No Asbestos Detected
