ASBESTOS CONTAINING MATERIALS SURVEY REPORT

Facilities Workshop
Building 021
Rockhampton North

Report Number 622.10968.00000/0040-R01-ASR

2 December 2017

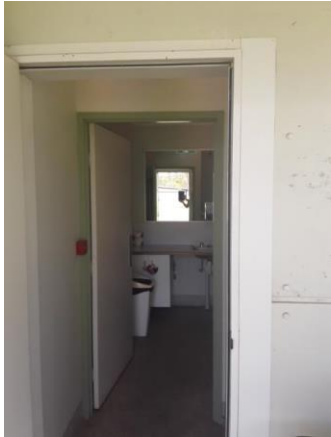
Sample No./ Visual Observation	Photo	Location			Analysis
		Int / Ext Floor Specific Location	Material Application	Extent	Result
1-424

Ground Floor Male toilet G.T07	Internal walls, Fibrous Cement	30m²	NAD

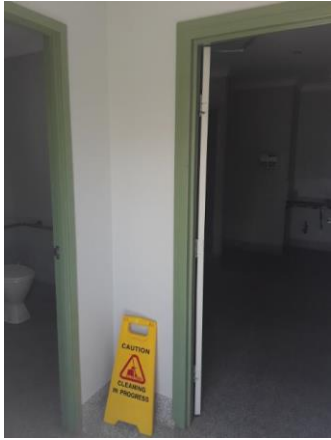
Sample No./ Visual Observation	Photo	Location			Analysis
		Int / Ext Floor Specific Location	Material Application	Extent	Result
Similar to 1-424

Ground Floor Male toilet G.T03	Internal walls, Fibrous Cement	35m²	NAD
1-425

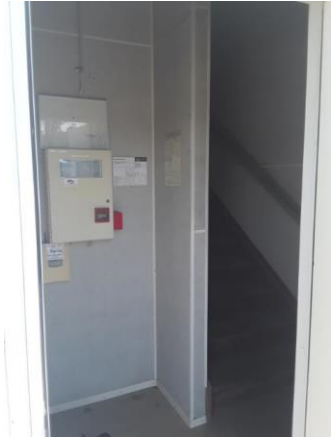
Ground Floor Entry foyer and stairs	Internal walls, Fibrous Cement	50m²	NAD

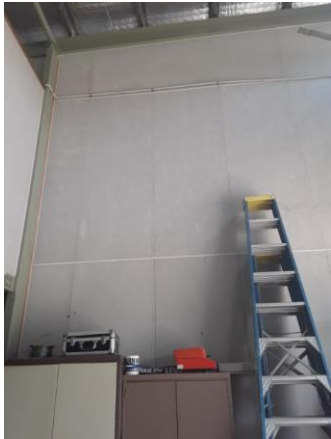
Sample No./ Visual Observation	Photo	Location			Analysis
		Int / Ext Floor Specific Location	Material Application	Extent	Result
Similar to 1-425

Ground Floor Electricians workshop side wall	Internal wall, Fibrous Cement	45m²	NAD
1-426

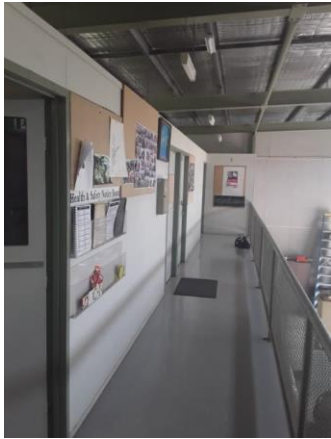
1st Floor Level 1 offices and hallway	Internal walls, Fibrous Cement	60m²	NAD

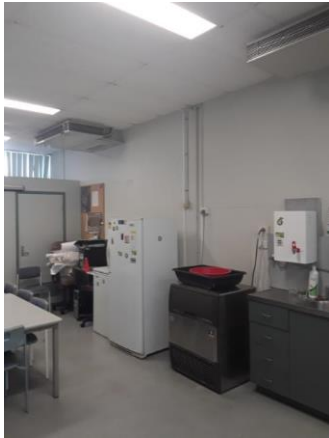
Sample No./ Visual Observation	Photo	Location			Analysis
		Int / Ext Floor Specific Location	Material Application	Extent	Result
Similar to 1-426

1st Floor Level 1 lunchroom	Internal walls, Fibrous Cement	40m ²	NAD
1-427

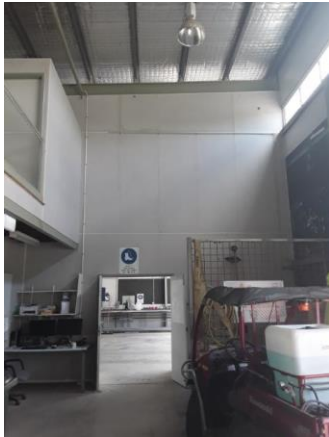
Ground Floor Bldg 21 A	All internal walls, Fibrous Cement	150m ²	NAD
