COMPLIANCE ASBESTOS RE-INSPECTION AND RISK ASSESSMENT

NOVEMBER 2021

J033453

ROCKHAMPTON NORTH CAMPUS_Building 024 - Engineering Workshop
Bruce Highway
ROCKHAMPTON NORTH QLD
4700

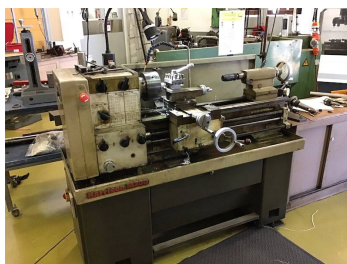
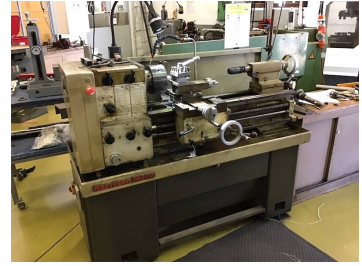
Location		024 Engineering Workshop - Ground Floor - Workshop - Brake pads - Friction material - Central - 1 Machine Harrison M300 (Lathes)				
Hazard Type		Asbestos	Material Assessment		Disturbance Assessment	
Friability		Non-friable	Product Type	2	Occupancy	0
Sample No.		Visual	Extent of damage	0	Disturbance	1
Result		Assumed Positive Unknown or Crocidolite	Surface Treatment	1	Exposure	0
			Asbestos Type	3	Maintenance	0
Item Number		3	Material Score	6	Disturbance Score	1
			Priority Score	7	Very Low	
No Additional Photographic Evidence Available

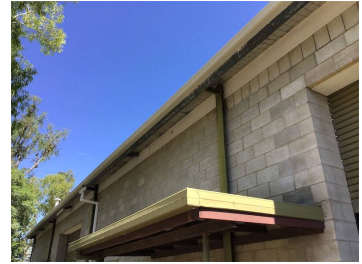
Location		024 Engineering Workshop - 1st Floor - External - Infill panels - Fibre cement sheet - North & South elevation - below roof				
Hazard Type		Asbestos	Material Assessment		Disturbance Assessment	
Friability		Non-friable	Product Type	1	Occupancy	0
Sample No.		Visual	Extent of damage	0	Disturbance	1
Result		Assumed Positive Unknown or Crocidolite	Surface Treatment	1	Exposure	0
			Asbestos Type	3	Maintenance	0
Item Number		1	Material Score	5	Disturbance Score	1
			Priority Score	6	Very Low	
No Additional Photographic Evidence Available

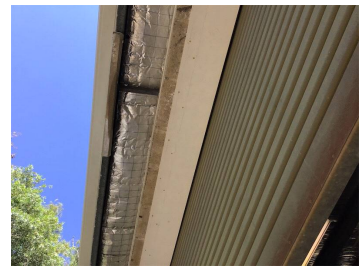
Location		024 Engineering Workshop - 1st Floor - External - Infill panels - Fibre cement sheet - All elevations - Above roller doors									
Hazard Type		Asbestos		Material Assessment		Disturbance Assessment					
Friability		Non-friable		Product Type		1		Occupancy		0	
Sample No.		Visual		Extent of damage		0		Disturbance		1	
Result		Assumed Positive Unknown or Crocidolite		Surface Treatment		1		Exposure		0	
				Asbestos Type		3		Maintenance		0	
Item Number		2		Material Score		5		Disturbance Score		1	
				Priority Score		6		Very Low			
No Additional Photographic Evidence Available

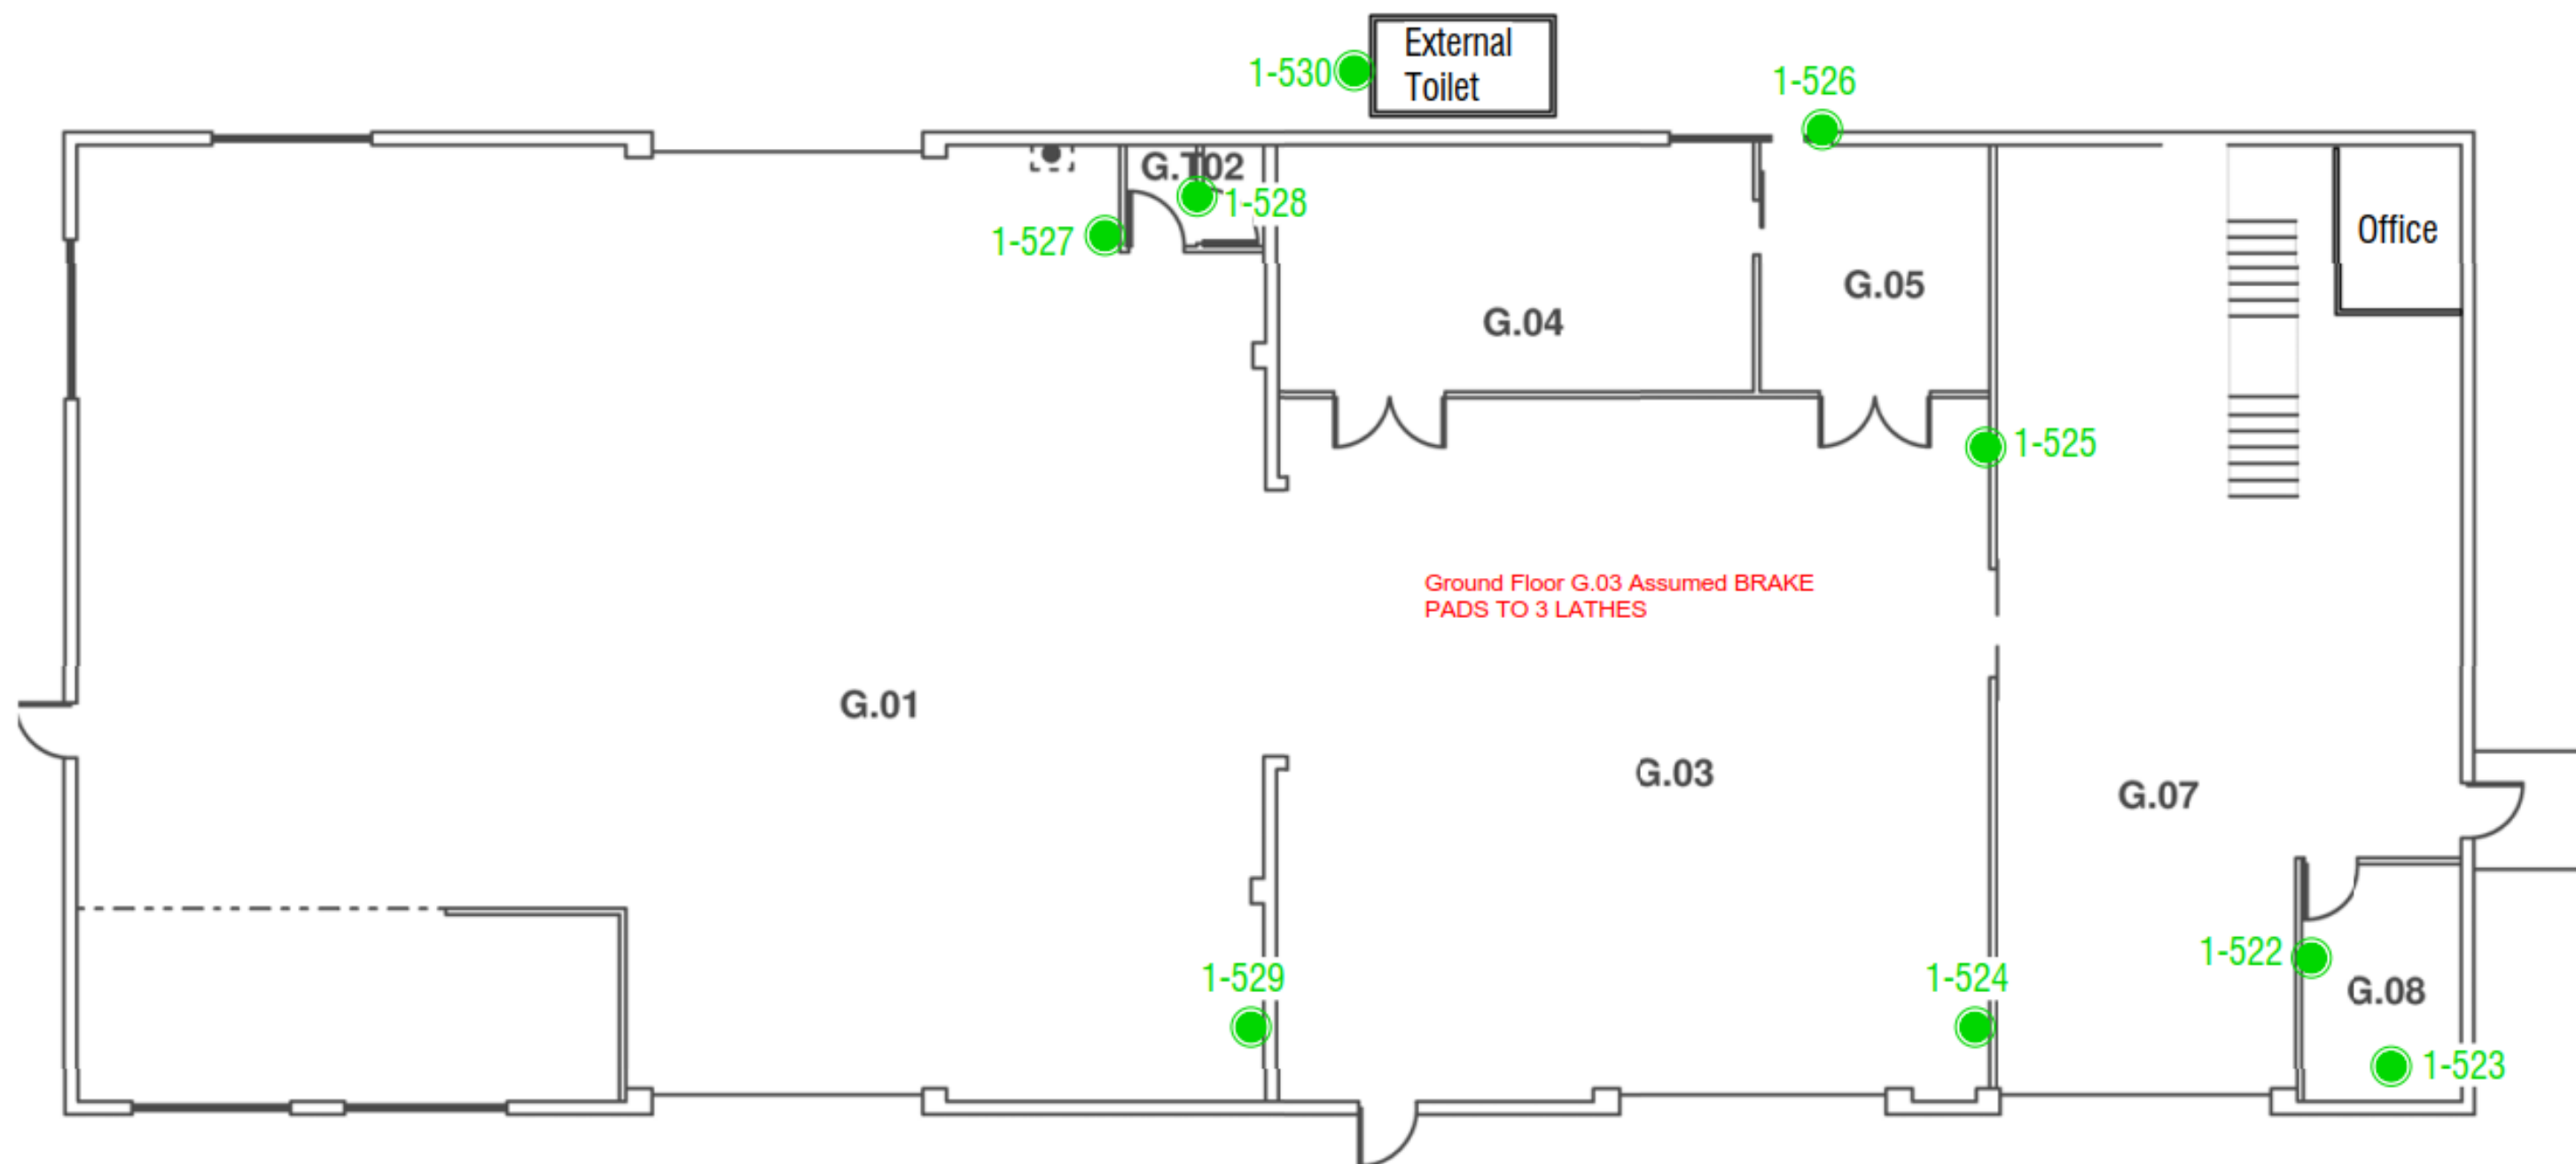
AREA: Engineer Workshop 024 - Ground Level

ASSUMED EXTERNAL SHEETING TO UPPER WALL
AREA ON THE NORTHERN AND SOUTHERN
ELEVATIONS
