## ASBESTOS CONTAINING MATERIALS SURVEY REPORT

Fitness Centre  
Building 025  
Rockhampton North

Report Number 622.10968.00000/0040-R01-ASR-Bld25

27 December 2017

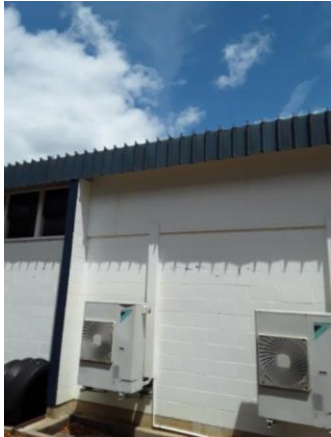
External west wall	External cladding, Fibrous Cement	1m <sup>2</sup>	NAD

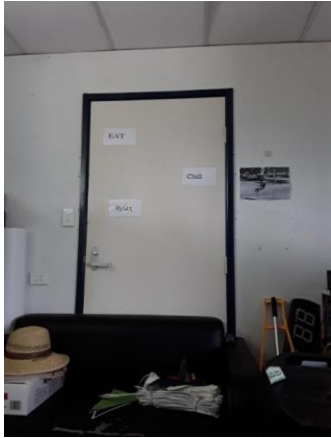
Ground Floor Storeroom behind reception	Internal walls, Fibrous Cement	12m <sup>2</sup>	NAD

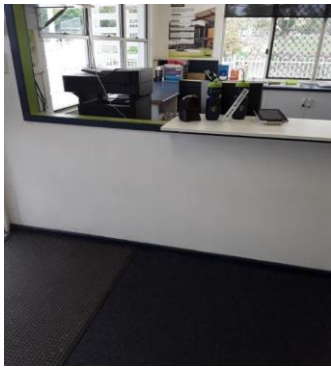
Ground Floor Reception counter	Internal walls, Fibrous Cement	10m <sup>2</sup>	NAD
