ASBESTOS CONTAINING MATERIALS SURVEY REPORT

Covered Basketball Court
Building 027
Rockhampton North

Report Number 622.10968.00000/0040-R01-ASR-Bld27

27 December 2017

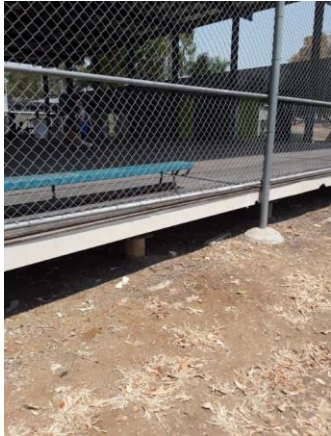
Ground Floor cladding to all sides	Fascia lining, Fibrous Cement	10m ²	NAD

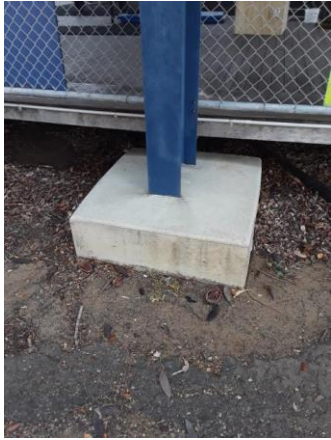
Ground Floor Columns to left of structure	Concrete pier, Fibrous Cement	15m ³	NAD
