ASBESTOS CONTAINING MATERIALS SURVEY REPORT

Engineering B
Building 028
Rockhampton North

Report Number 622.10968.00000/0040-R01-ASR-Bld28

27 December 2017

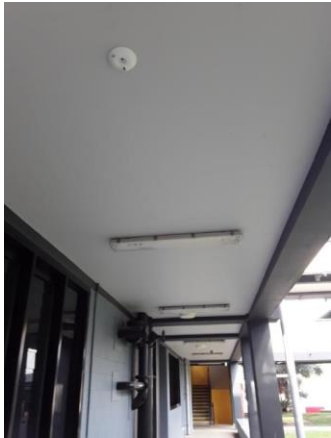
Ground Floor Walkway	Ceiling above walkway, Fibrous Cement	90m²	NAD

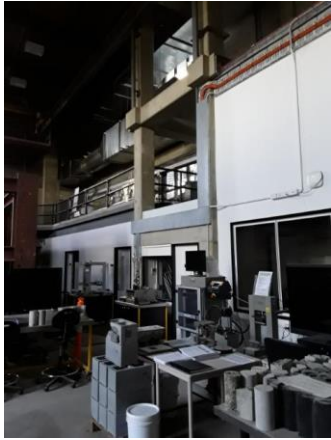
Basement LG.01	Internal wall to lg.02, lg.03, lg.04, Fibrous Cement	45m²	NAD
1-453

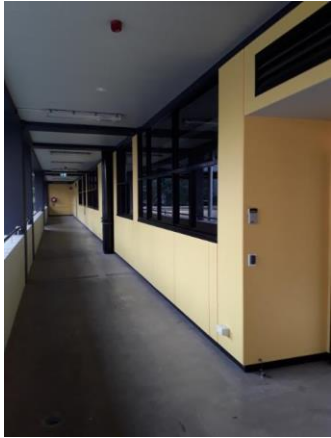
1st Floor Walkway	Cladding to balcony , Fibrous Cement	50m²	NAD

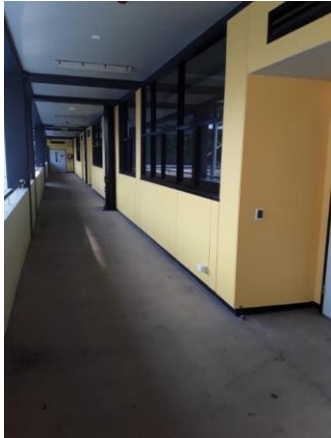
2nd Floor Walkway	Cladding to balcony , Fibrous Cement	50m²	NAD
1-454

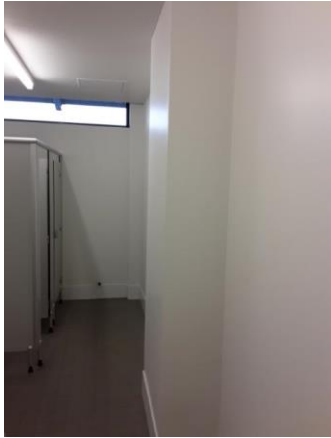
1st Floor Bathrooms 1T.03, 02, 01	Ceiling, Fibrous Cement	35m²	NAD

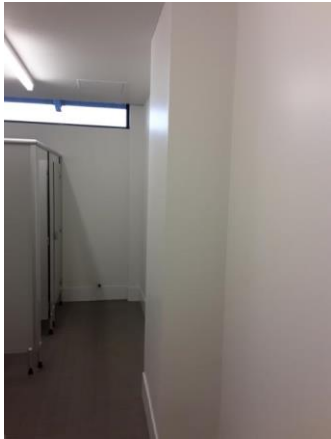
1st Floor Bathrooms 2T .07, 06, 05	Ceiling, Fibrous Cement	35m²	NAD
1-455

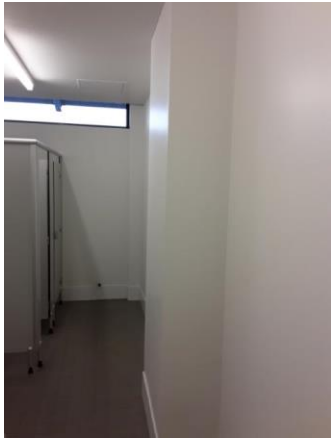
1st Floor Bathrooms 1T.03, 02, 01	Internal walls, Fibrous Cement	55m²	NAD

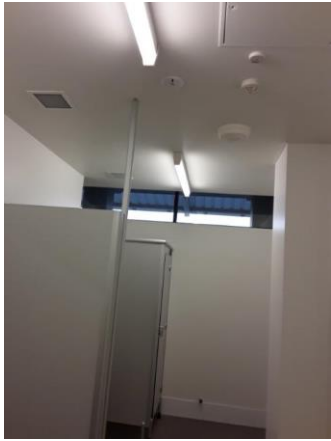
1st Floor Bathrooms 2T .07, 06, 05	Internal walls, Fibrous Cement	55m ²	NAD
