ASBESTOS CONTAINING MATERIALS SURVEY REPORT

Engineering C
Building 029
Rockhampton North

Report Number 622.10968.00000/0040-R01-ASR-Bld 029

2 December 2017

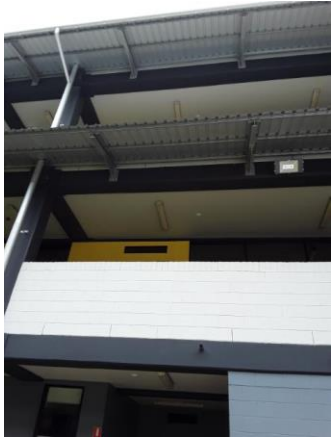
External Eaves and walkway ceiling	Eave lining , Fibrous Cement	180m ²	NAD

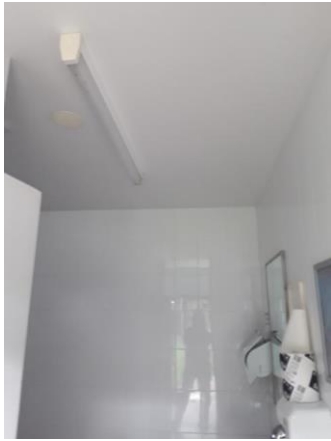
Ground Floor Bathroom G T.10	Ceiling, Fibrous Cement	12m²	NAD
Similar to 1-449

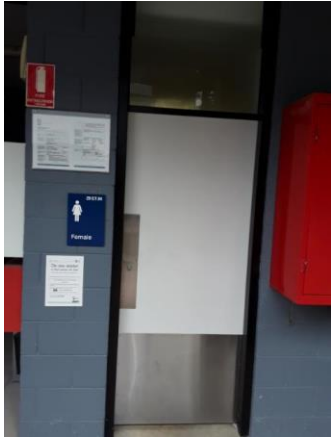
Ground Floor Bathroom G T.04, T.03	Ceiling, Fibrous Cement	12m²	NAD

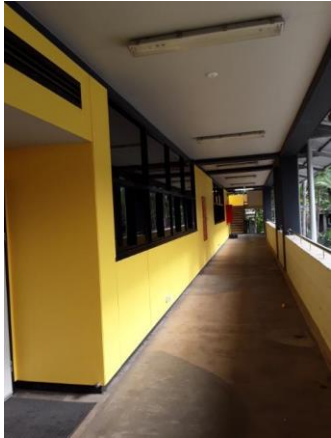
1st Floor Walkway	Cladding to balcony , Fibrous Cement	50m²	NAD
Similar to 1-450

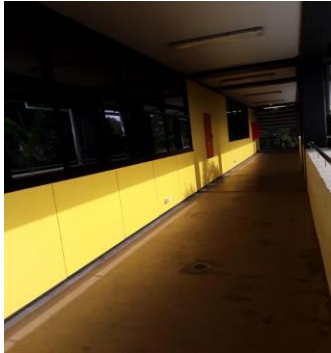
2nd Floor Walkway	Cladding to balcony , Fibrous Cement	50m²	NAD
