ASBESTOS CONTAINING MATERIALS SURVEY REPORT

Engineering A
Building 030
Rockhampton North

Report Number 622.10968.00000/0040-R01-ASR-Bld 030

28 November 2017

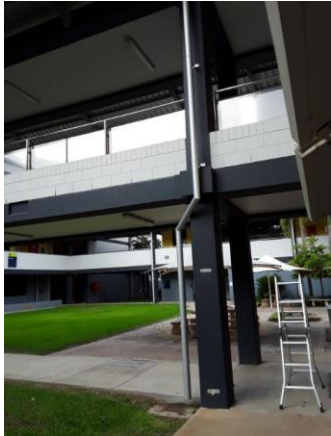
External Eaves and walkway ceiling	Eave lining , Fibrous Cement	280m ²	NAD
