ASBESTOS CONTAINING MATERIALS SURVEY REPORT

Nulloo Yumba
Building 031
Rockhampton North

Report Number 622.10968.00000/0040-R01-ASR-Bld031

28 November 2017

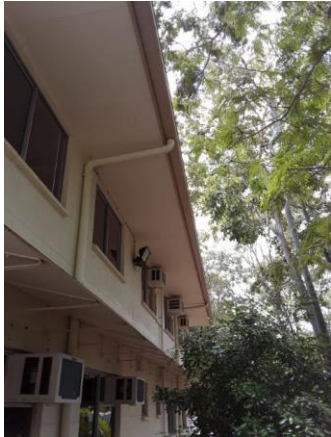
External All External eaves	Eave lining , Fibrous Cement	80m ²	NAD

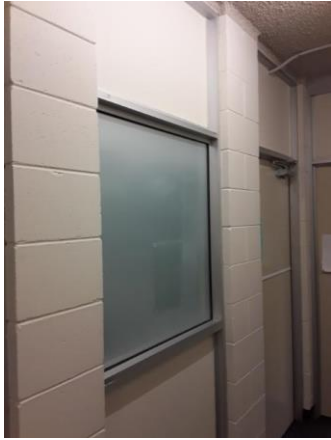
External Doors and windows throughout	Infill panels, Fibrous Cement		NAD
