## ASBESTOS CONTAINING MATERIALS SURVEY REPORT

Social Sciences C  
Building 032  
Rockhampton North

Report Number 622.10968.00000/0040-R01-ASR-Bld032

27 December 2017

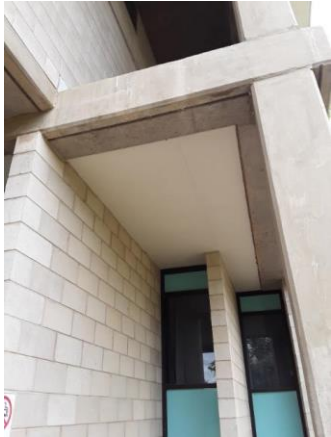
External Awnings west side	Ceiling, Fibrous Cement	10m <sup>2</sup>	NAD

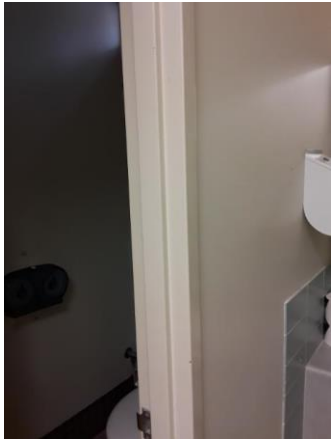
Basement Bathroom LG T.07	Internal walls, Fibrous Cement	14m²	NAD
1-458

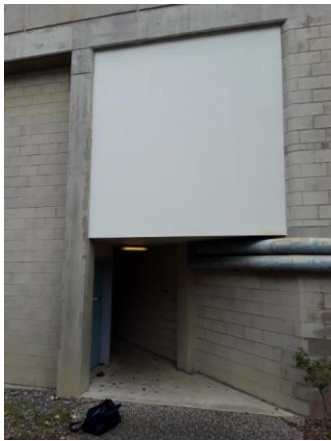
External LG PA13	External cladding, Fibrous Cement	6m²	NAD

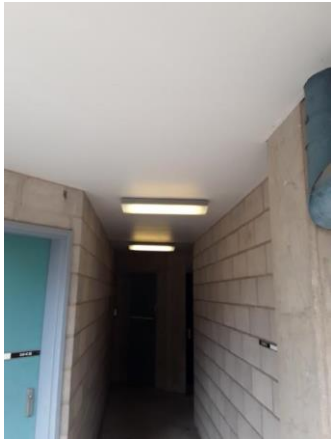
External LG PA13	Ceiling above walkway, Fibrous Cement	16m²	NAD
1-460

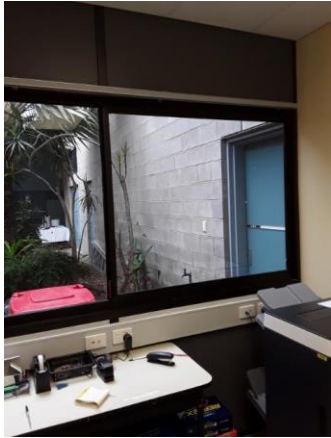
Ground Floor academic learning centre	Infill panel above and below windows, Fibrous Cement	60m²	NAD

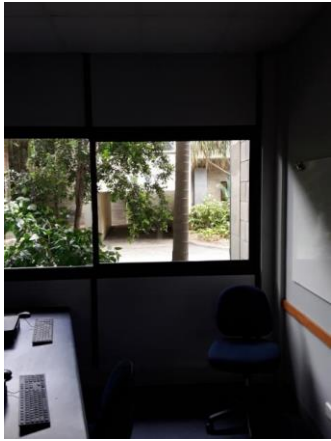
Ground Floor West wall	Infill panel above and below windows, Fibrous Cement	60m²	NAD
Similar to 1-461

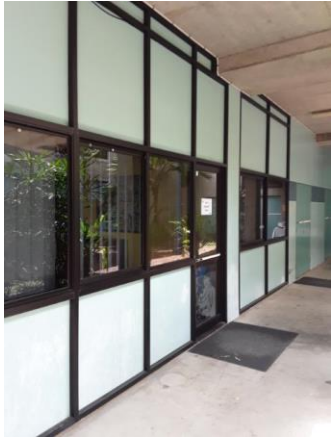
Ground Floor east wall adjacent courtyard	Infill panel above and below windows, Fibrous Cement	60m²	NAD

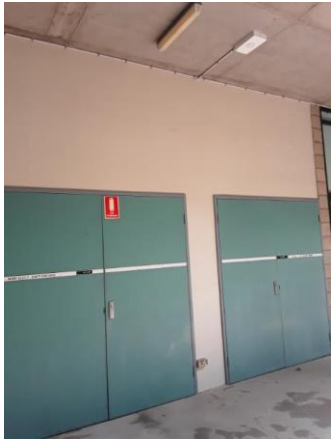
Ground Floor east wall adjacent courtyard	Infill panels, Fibrous Cement	8m <sup>2</sup>	NAD
1-463

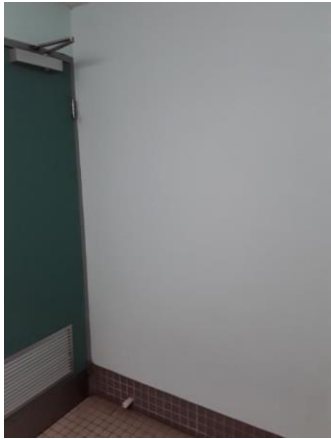
Ground Floor Bathroom GT.05	Internal walls, Fibrous Cement	14m <sup>2</sup>	NAD

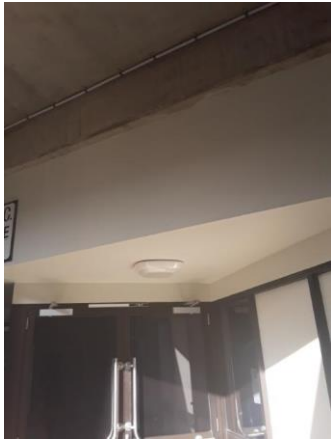
1st Floor Entry to 1.28 lecture theatre	Ceiling, Fibrous Cement	9m <sup>2</sup>	NAD
1-473

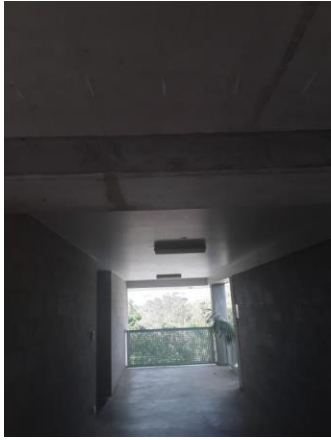
2nd Floor External covered walkways	Ceiling, Fibrous Cement	30m <sup>2</sup>	NAD

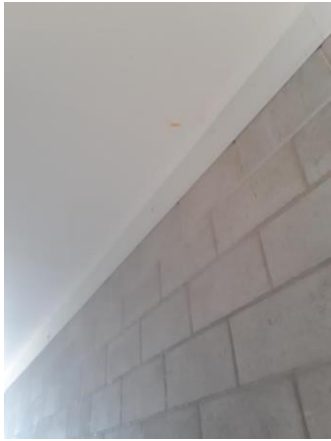
2nd Floor External covered walkways	Cladding to upper wall, Fibrous Cement	4m²	NAD
1-475

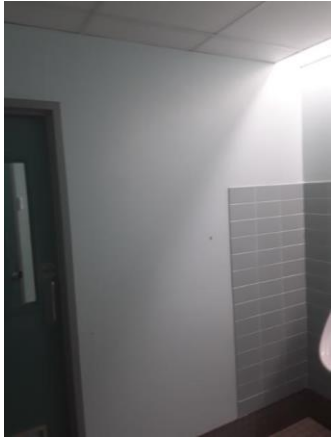
2nd Floor Bathroom 2.T17	Internal walls, Fibrous Cement	25m²	NAD

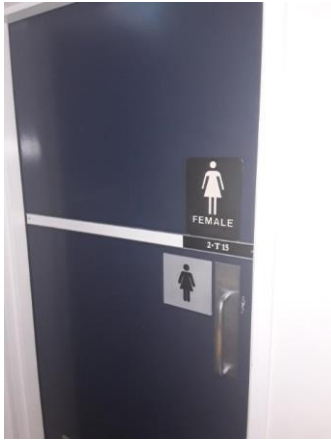
2nd Floor Bathroom 2.T15	Internal walls, Fibrous Cement	25m <sup>2</sup>	NAD
