COMPLIANCE ASBESTOS RE-INSPECTION AND RISK ASSESSMENT

NOVEMBER 2021

J033454

ROCKHAMPTON NORTH CAMPUS_Building 033 - Social Science B
Bruce Highway
ROCKHAMPTON NORTH QLD
4700

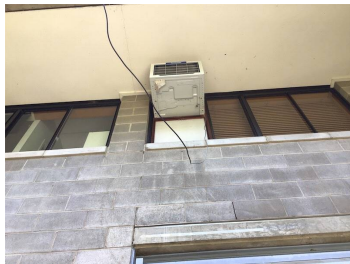
Location		033 Social Sciences - 1st Floor - External - Infill panels - Fibre cement sheet - All elevations - below AC units				
Hazard Type		Asbestos	Material Assessment		Disturbance Assessment	
Friability		Non-friable	Product Type	1	Occupancy	0
Sample No.		Visual	Extent of damage	0	Disturbance	1
Result		Assumed Positive Unknown or Crocidolite	Surface Treatment	1	Exposure	0
			Asbestos Type	3	Maintenance	0
Item Number		1	Material Score	5	Disturbance Score	1
			Priority Score	6	Very Low	
No Additional Photographic Evidence Available

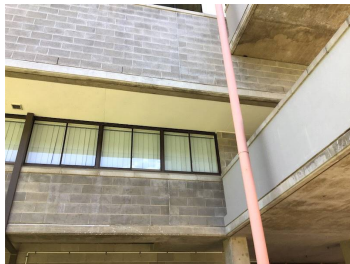
Location		033 Social Sciences - 1st Floor - External - Soffits - Fibre cement sheet - North & South elevations

Hazard Type		Asbestos	Material Assessment		Disturbance Assessment		
Friability		Non-friable	Product Type	1	Occupancy		0
Sample No.		As 1-476 (AO000160)	Extent of damage	0	Disturbance		1
Result		Strongly Assumed Positive Chrysotile	Surface Treatment	1	Exposure		0
			Asbestos Type	1	Maintenance		0
Item Number		2	Material Score	3	Disturbance Score		1
			Priority Score	4	Very Low		
No Additional Photographic Evidence Available

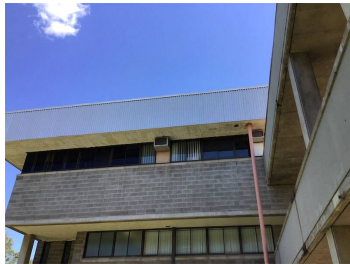
Location		033 Social Sciences - 2nd Floor - External - Soffit - Fibre cement sheet - All elevations

Hazard Type	Asbestos	Material Assessment		Disturbance Assessment		
Friability	Non-friable	Product Type	1	Occupancy	0	
Sample No.	1-476 {AO000160}	Extent of damage	0	Disturbance	1	
Result	Positive Chrysotile	Surface Treatment	1	Exposure	0	
		Asbestos Type	1	Maintenance	0	
Item Number	3	Material Score	3	Disturbance Score	1	
		Priority Score	4	Very Low		
No Additional Photographic Evidence Available

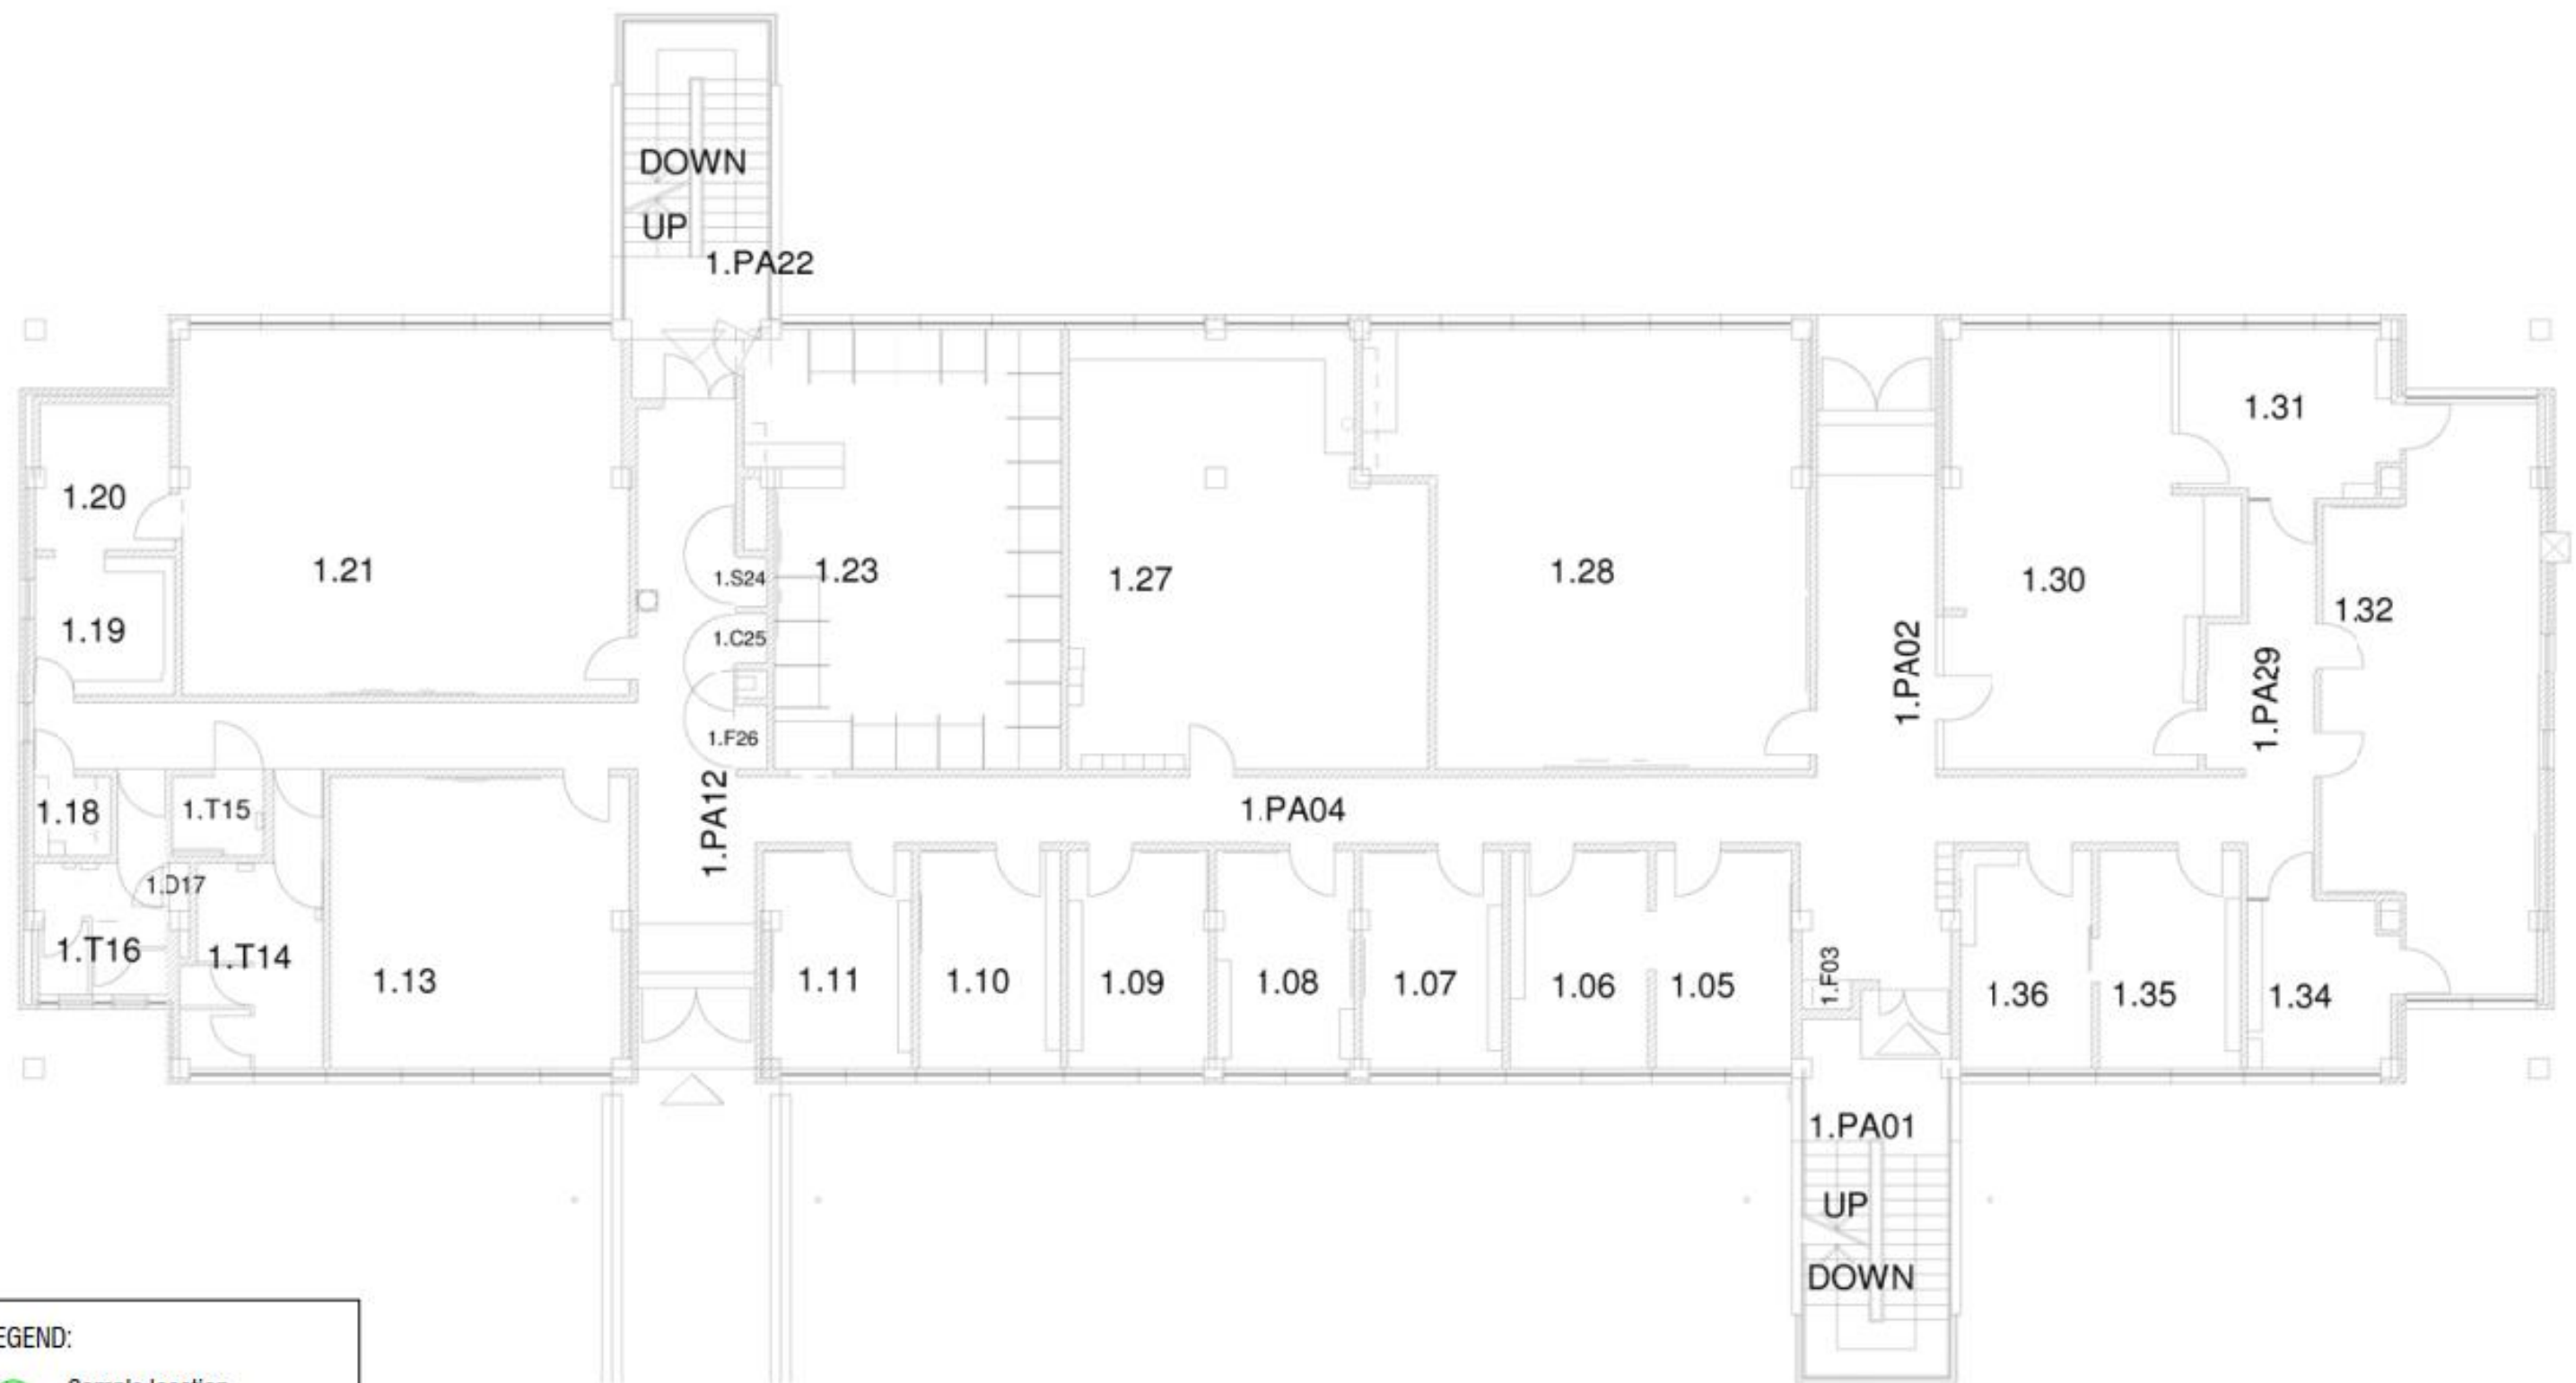
AREA: Social Science 033 – Level One

assumed infill's around all air
conditioning systems
