ASBESTOS CONTAINING MATERIALS SURVEY REPORT

John Carkeek Building
Building 034
Rockhampton North

Report Number 622.10968.00000/0040-R01-ASR-Bld34

27 December 2017

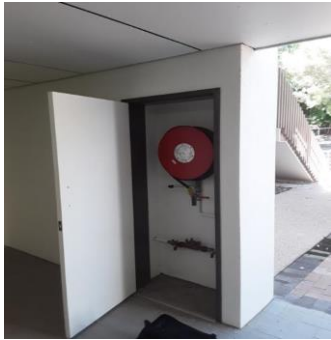
External North hose reel cupboard	Internal wall, Fibrous Cement	1m ²	NAD
1-478

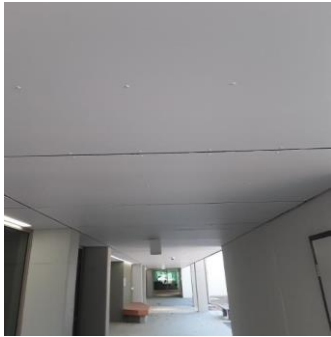
External walkways	Ceiling above walkway, Fibrous Cement	200m ²	NAD
