## ASBESTOS CONTAINING MATERIALS SURVEY REPORT

Student Association Building  
Building 036  
Rockhampton North

Report Number 622.10968.00000/0040-R01-ASR-Bld036

28 November 2017

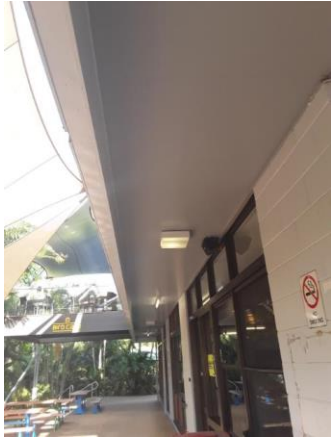
Sample No./ Visual Observation	Photo	Location			Analysis
		Int / Ext Floor Specific Location	Material Application	Extent	Result
1-435

External Balcony above G.01	Ceiling below balcony, Fibrous Cement	4m <sup>2</sup>	NAD

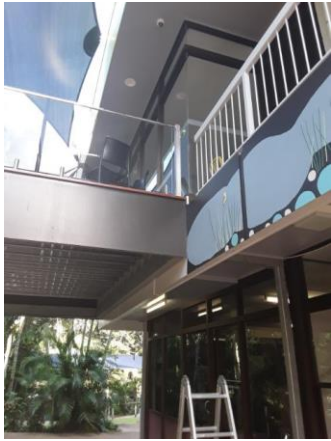
Sample No./ Visual Observation	Photo	Location			Analysis
		Int / Ext Floor Specific Location	Material Application	Extent	Result
1-436

External Balcony above G.01	Cladding to balcony , Fibrous Cement	4m <sup>2</sup>	NAD
1-437

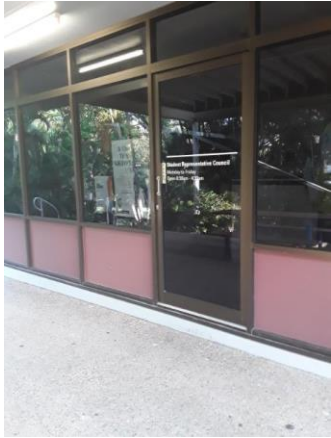
External Infill panels below windows	Infill panels, Fibrous Cement	42m <sup>2</sup>	NAD

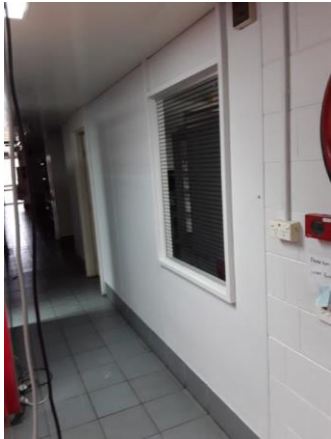
Sample No./ Visual Observation	Photo	Location			Analysis
		Int / Ext Floor Specific Location	Material Application	Extent	Result
1-438

Ground Floor G01 - kitchen	Internal walls, Fibrous Cement	12m <sup>2</sup>	NAD
1-439

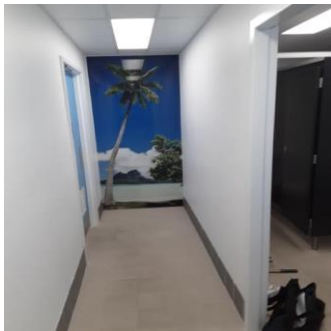
Ground floor toilets	All internal walls, Fibrous Cement	65m <sup>2</sup>	NAD
