ASBESTOS CONTAINING MATERIALS SURVEY REPORT

Marketing/Facilities Management
Building 037
Rockhampton North

Report Number 622.10968.00000/0040-R01-ASR/Bld37

27 December 2017

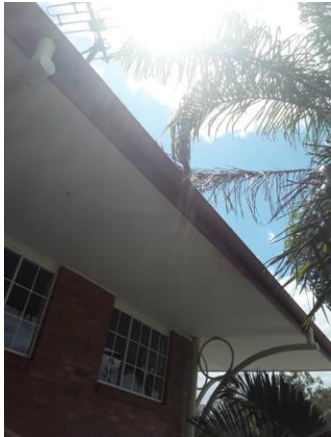
Sample No./ Visual Observation	Photo	Location			Analysis
		Int / Ext Floor Specific Location	Material Application	Extent	Result
1-338

External Eaves	Eave lining , Fibrous Cement	160m ²	NAD

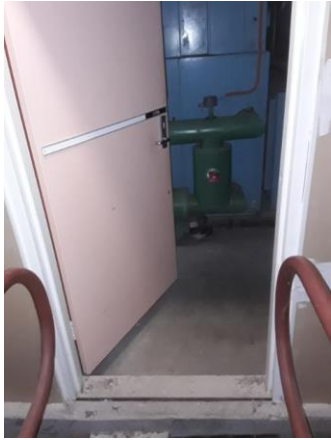
Sample No./ Visual Observation	Photo	Location			Analysis
		Int / Ext Floor Specific Location	Material Application	Extent	Result
1-339

2nd Floor Plant room 2.P01 doorway	Jamb infill, Fibrous Cement	0.2m ²	NAD
