# COMPLIANCE ASBESTOS RE-INSPECTION AND RISK ASSESSMENT

NOVEMBER 2021

J033455

ROCKHAMPTON NORTH CAMPUS\_Building 041 - South Annex  
Bruce Highway  
ROCKHAMPTON NORTH QLD  
4700

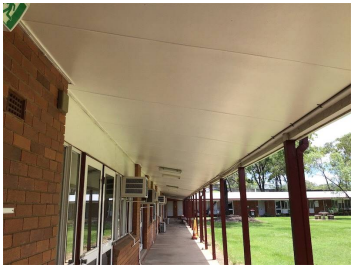
Location	041 Annexure Building - Ground Floor - External - All elevationsSoffits - Fibre cement sheet

Item No	Location / Description	Hazard Type	Sample No.	Item Status	Est. Extent	Current Label	Condition	Friability	Disturbance Risk	Material Risk	Control Priority	Recommended Action	Record of Works
1	041 Annexure Building -Ground Floor -External, All elevations												
	Soffits -Fibre cement sheet	Asbestos	1-318 {AO000161}	Identified, Positive	160m <sup>2</sup>	No	Good Condition	Non-friable	Very Low	Very Low	P4	Manage In Situ	
2	041 Annexure Building -Ground Floor -External, All elevations -Above windows												
	Infill panels -Fibre cement sheet	Asbestos	1-320 {AO000162}	Identified, Positive	160m <sup>2</sup>	No	Good Condition	Non-friable	Very Low	Very Low	P4	Manage In Situ	
3	041 Annexure Building -Ground Floor -External, Both ends of buildings												
	Gable end -Fibre cement sheet	Asbestos	1-321 {AO000163}	Identified, Positive	45m <sup>2</sup>	No	Good Condition	Non-friable	Very Low	Very Low	P4	Manage In Situ

Hazard Type	Asbestos	Material Assessment	Disturbance Assessment	
Friability	Non-friable	Product Type	1	
Sample No.	1-318 {AO000161}	Extent of damage	0	
Result	Positive Chrysotile	Surface Treatment	1	
		Asbestos Type	1	
Item Number	1	Material Score	3	
		Priority Score	4	Very Low

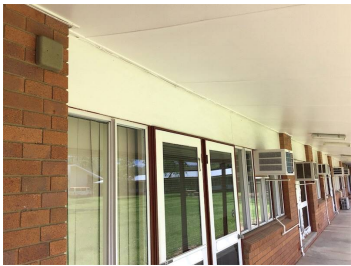
Location	041 Annexure Building - Ground Floor - External - All elevations - Above windowsInfill panels - Fibre cement sheet

Hazard Type	Asbestos	Material Assessment	Disturbance Assessment	
Friability	Non-friable	Product Type	1	
Sample No.	1-320 {AO000162}	Extent of damage	0	
Result	Positive Chrysotile	Surface Treatment	1	
		Asbestos Type	1	
Item Number	2	Material Score	3	
		Priority Score	4	Very Low

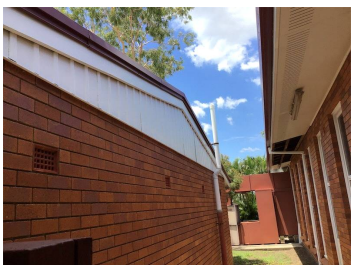
Location	041 Annexure Building - Ground Floor - External - Both ends of buildingsGable end - Fibre cement sheet

Hazard Type	Asbestos	Material Assessment	Disturbance Assessment	
Friability	Non-friable	Product Type	1	
Sample No.	1-321 {AO000163}	Extent of damage	0	
Result	Positive Chrysotile	Surface Treatment	1	
		Asbestos Type	1	
Item Number	3	Material Score	3	
		Priority Score	4	Very Low
