ASBESTOS CONTAINING MATERIALS SURVEY REPORT

Child Care Centre
Building 063
Rockhampton North

Report Number 622.10968.00000/0040-R01-ASR- Bld 63

9 December 2017

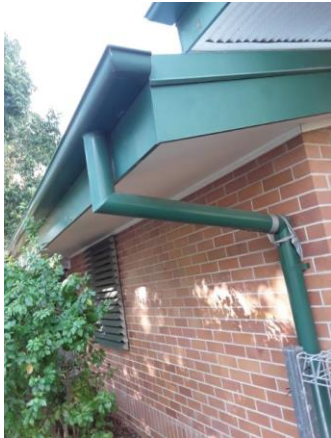
External Eaves all sides	Eave lining , Fibrous Cement	120m ²	NAD

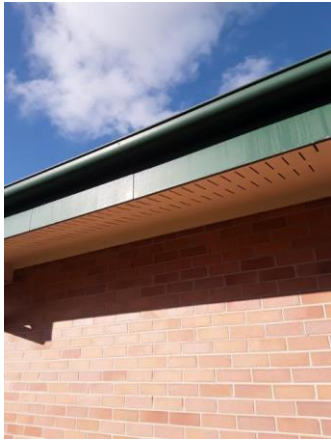
External Eaves - all sides	Eave lining - perforated, Fibrous Cement	15m²	NAD
1-347

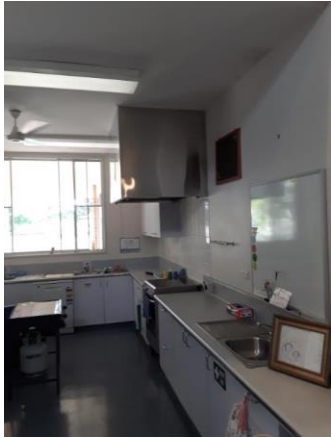
Ground Floor Walls behind kitchen benches	Internal wall, Fibrous Cement	14m²	NAD

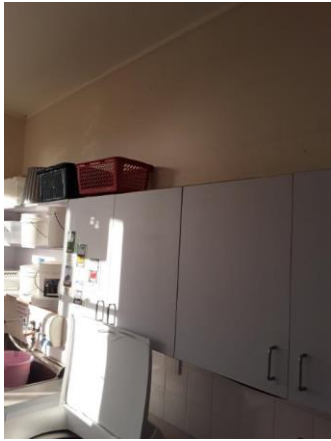
Ground Floor Laundry	Internal walls, Fibrous Cement	24m²	NAD
1-349

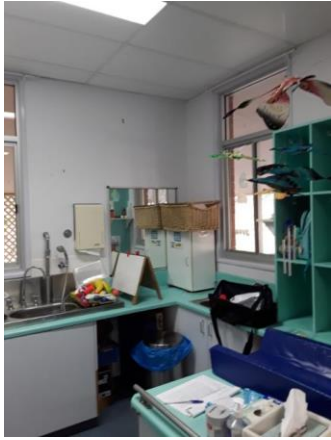
Ground Floor Kitchen in babies room	Internal walls in kitchen sections, Fibrous Cement	30m²	NAD

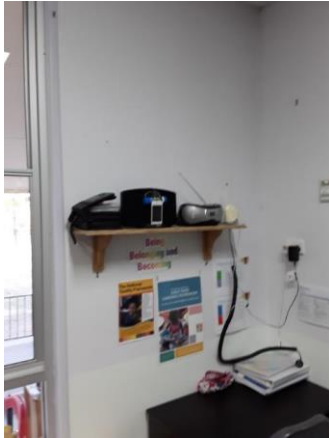
Ground Floor Babies room	Internal walls adjacent glass doors, Fibrous Cement	15m²	NAD
1-350

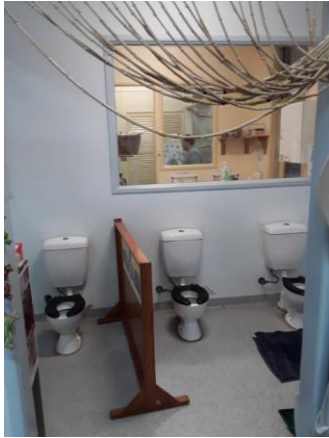
Ground Floor Children's bathroom 3	Internal walls, Fibrous Cement	14m²	NAD

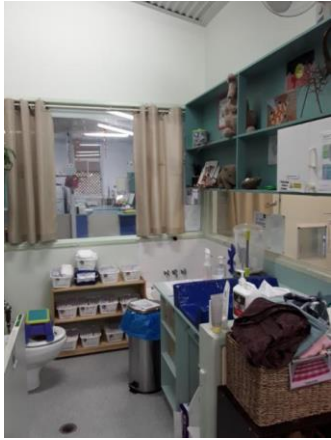
Ground Floor Children's bathroom 2	Internal walls, Fibrous Cement	14m²	NAD
1-351

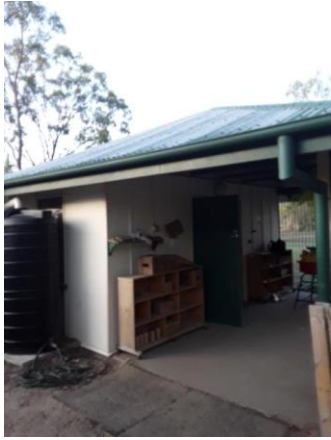
Ground Floor Rear storage building	External cladding, Fibrous Cement	30m²	NAD

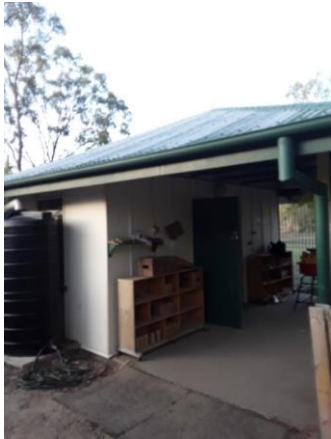
Ground Floor Rear storage building	External cladding upper wall, Fibrous Cement	5m ²	NAD
1-353

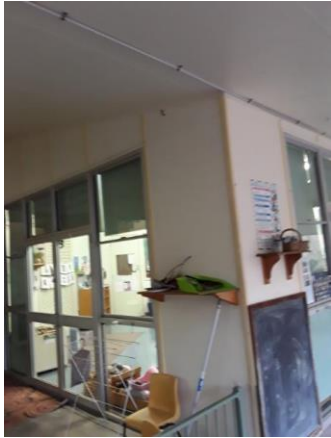
Rear of building	External cladding, Fibrous Cement	40	NAD

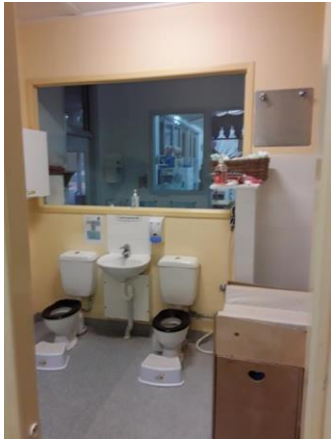
Ground Floor Children's bathroom 4	Internal walls, Fibrous Cement	14m ²	NAD
1-355

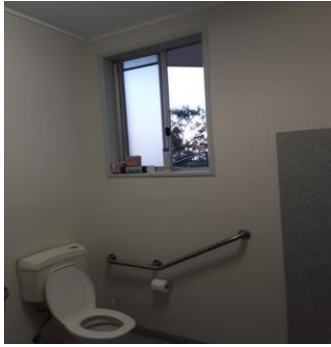
Ground Floor Staff bathrooms	Internal walls, Fibrous Cement	45m ²	NAD
