## ASBESTOS CONTAINING MATERIALS SURVEY REPORT

Science Workshop  
Building 064  
Rockhampton North

Report Number 622.10968.00000/0040-R01-ASR-Bld64

27 December 2017

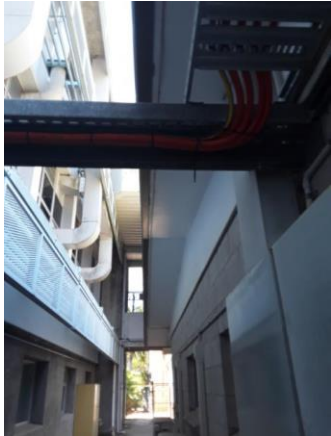
Sample No./ Visual Observation	Photo	Location			Analysis
		Int / Ext Floor Specific Location	Material Application	Extent	Result
1-305

External eaves to entire building	Eave lining , Fibrous Cement	35m <sup>2</sup>	NAD
