ASBESTOS CONTAINING MATERIALS SURVEY REPORT

Science Workshop
Building 064
Rockhampton North

Report Number 622.10968.00000/0040-R01-ASR-Bld64

27 December 2017

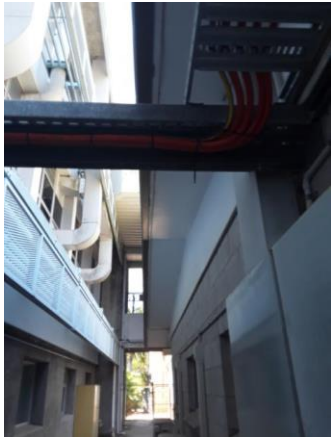
External eaves to entire building	Eave lining , Fibrous Cement	35m ²	NAD
