ASBESTOS CONTAINING MATERIALS SURVEY REPORT

Commercial Centre
Building 065
Rockhampton North

Report Number 622.10968.00000/0040-R01-ASR-Bld 065

02 December 2017

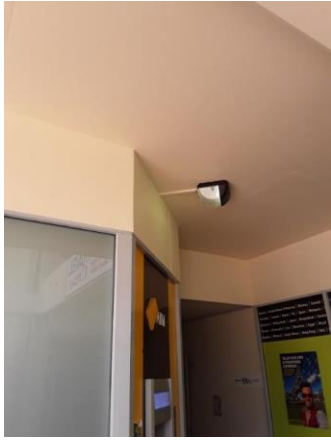
External Upper external walls all floors	External cladding, Fibrous Cement	200	NAD

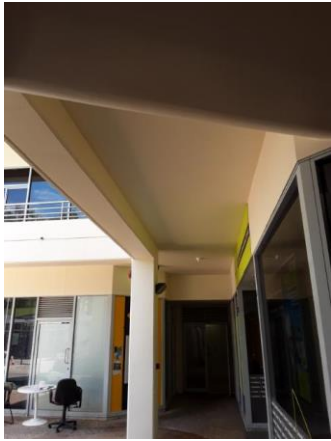
External covered walkways	Ceiling, Fibrous Cement	250m²	NAD
1-432

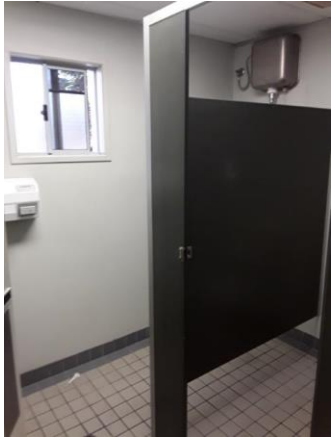
Ground Floor Bathrooms G T15, 16, 17	Internal walls, Fibrous Cement	40m²	NAD

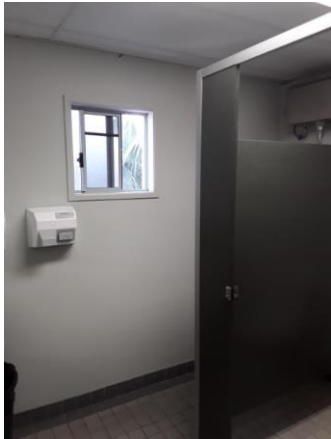
1st Floor Bathrooms 1 T21, 22	Internal walls, Fibrous Cement	40m²	NAD
Similar to 1-433

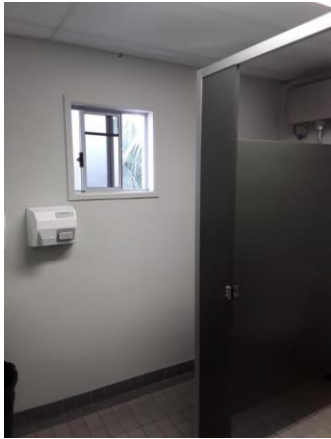
2nd Floor Bathrooms 2 T18, T19	Internal walls, Fibrous Cement	40m²	NAD

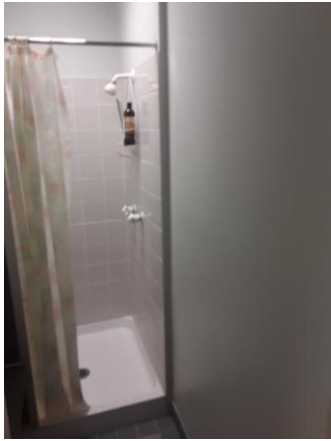
2nd Floor Shower 2.15	Internal walls, Fibrous Cement	8	NAD
