## ASBESTOS CONTAINING MATERIALS SURVEY REPORT

Analysis and Planning  
Building 067  
Rockhampton North

Report Number 622.10968.00000/0040-R01-ASR-Bld067

27 December 2017

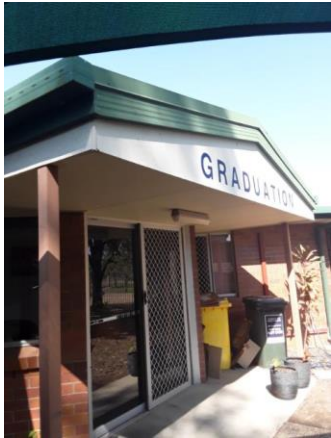
External All eaves	Eave lining , Fibrous Cement	50m <sup>2</sup>	NAD

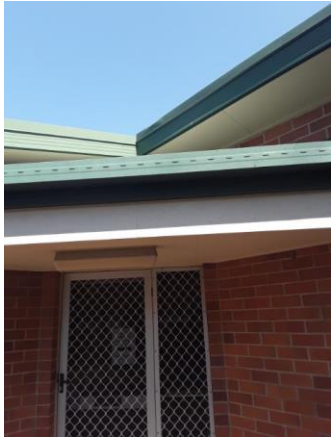
External Gable facing secondary entrance	External cladding, Fibrous Cement	2m <sup>2</sup>	NAD
