# COMPLIANCE ASBESTOS RE-INSPECTION AND RISK ASSESSMENT

NOVEMBER 2021

J033456

ROCKHAMPTON NORTH CAMPUS\_Building 070 - Engineering Research  
Bruce Highway  
ROCKHAMPTON NORTH QLD  
4700

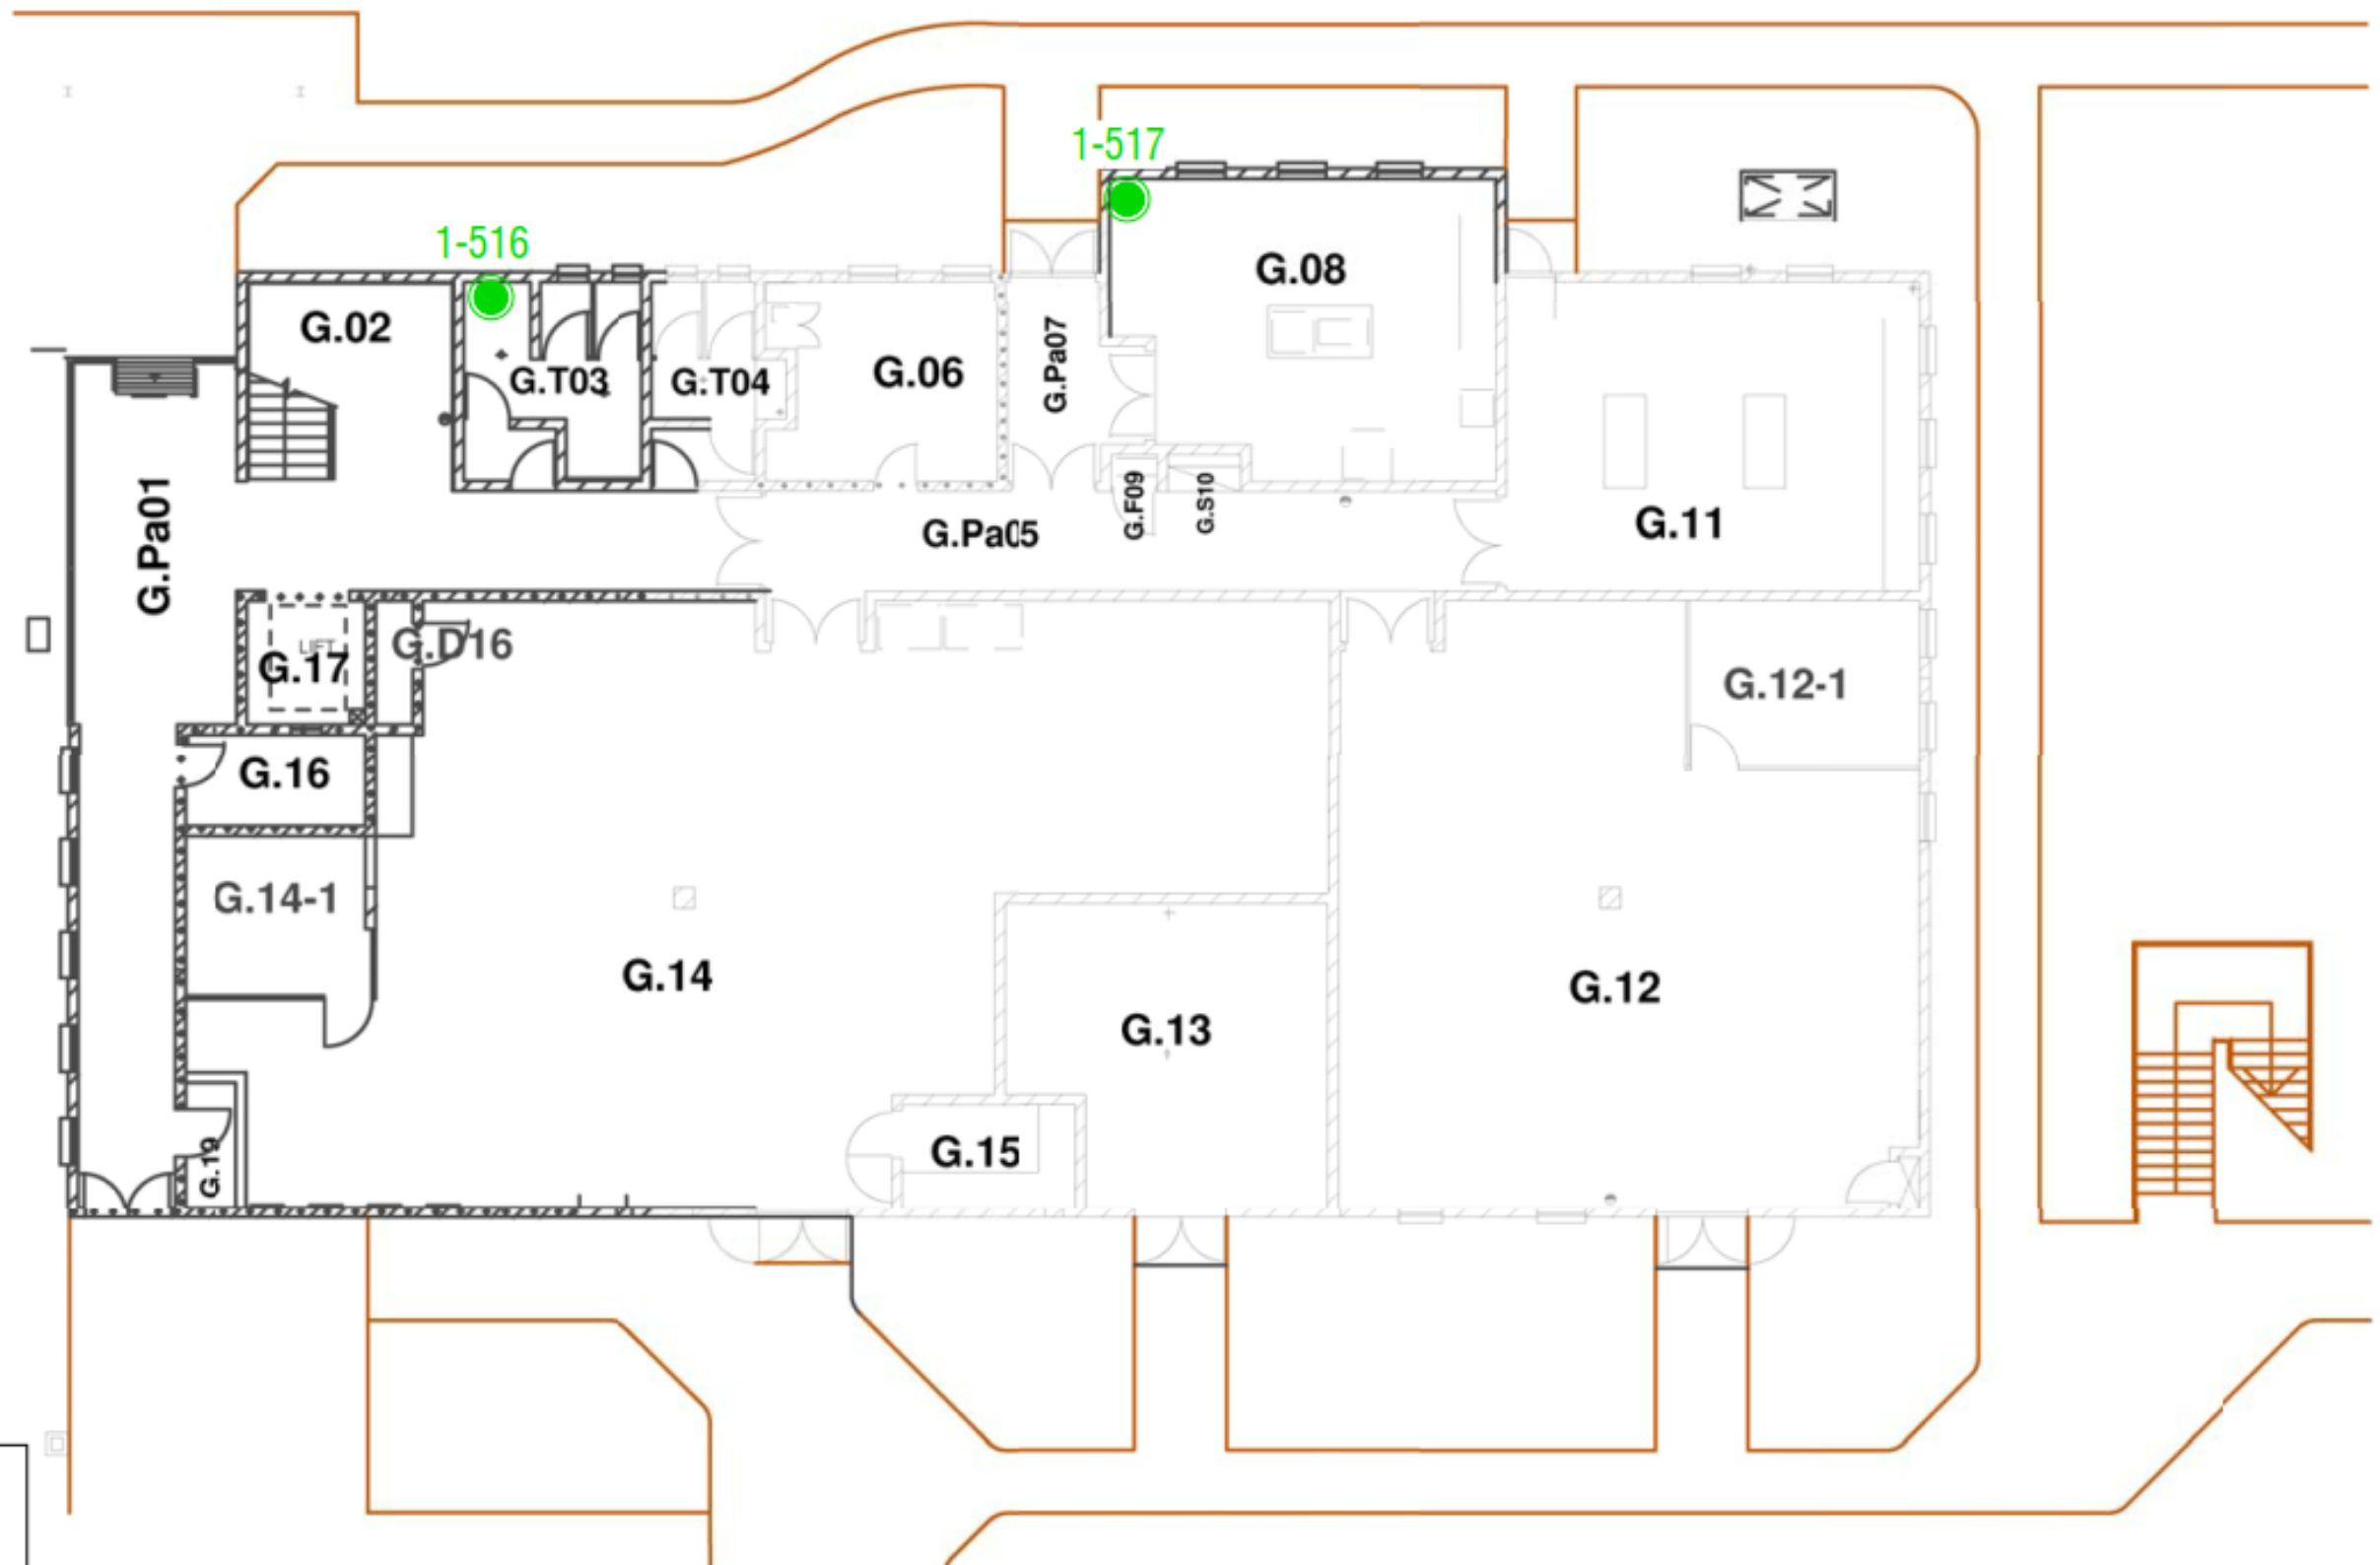
| <b>CLIENT No.:</b> C126956 | <b>JOB No.:</b> J033456 | <b>AREA:</b> Research 070 – Ground Level | | <b>DATE:</b> 16/11/2021 |

- Sample location  
No Asbestos Detected
