ASBESTOS CONTAINING MATERIALS SURVEY REPORT

Plant Material and Prep Shed Rockhampton North

Reference	Date	Prepared	Checked	Authorised
622.10968.00000/0040-R01-v1-Bld72	27 December 2017	Jordan Harley	Narelle Carnes	Narelle Carnes

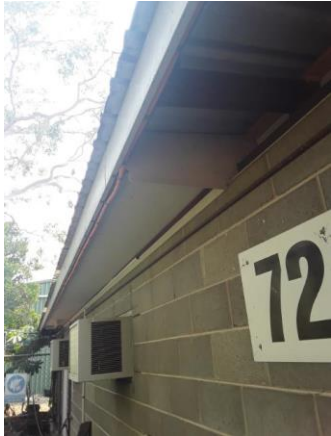
External Ground floor left side of building	Eave lining , Fibrous Cement	6m ²	NAD

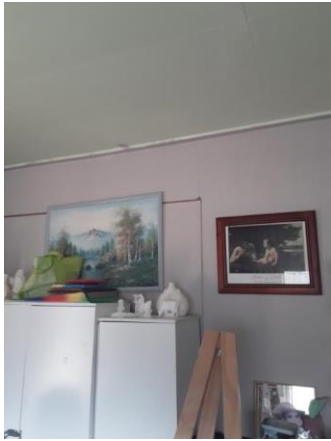
Ground Floor Workbay	Internal wall between workshop and office,	80m ²	NAD
1-274

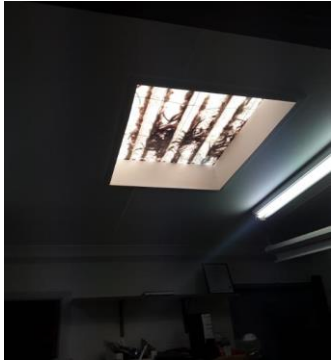
Office	Skylight surround, Fibrous Cement	1m ²	NAD
