## ASBESTOS CONTAINING MATERIALS SURVEY REPORT

Plant Material and Prep Shed  
Building 072  
Rockhampton North

Report Number 622.10968.00000/0040-R01-ASR-Bld72

27 December 2017

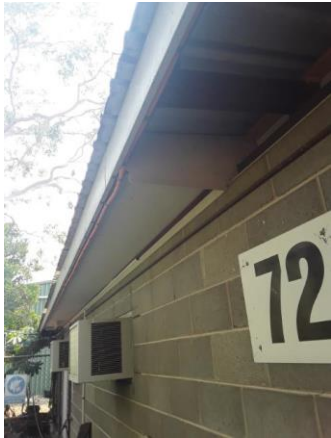
External Ground floor left side of building	Eave lining , Fibrous Cement	6m <sup>2</sup>	NAD

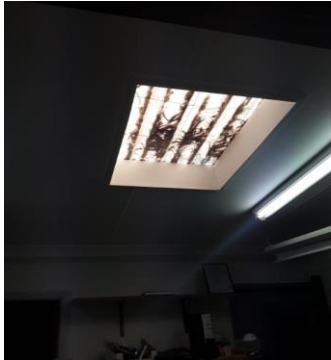
Office	Skylight surround, Fibrous Cement	1m²	NAD

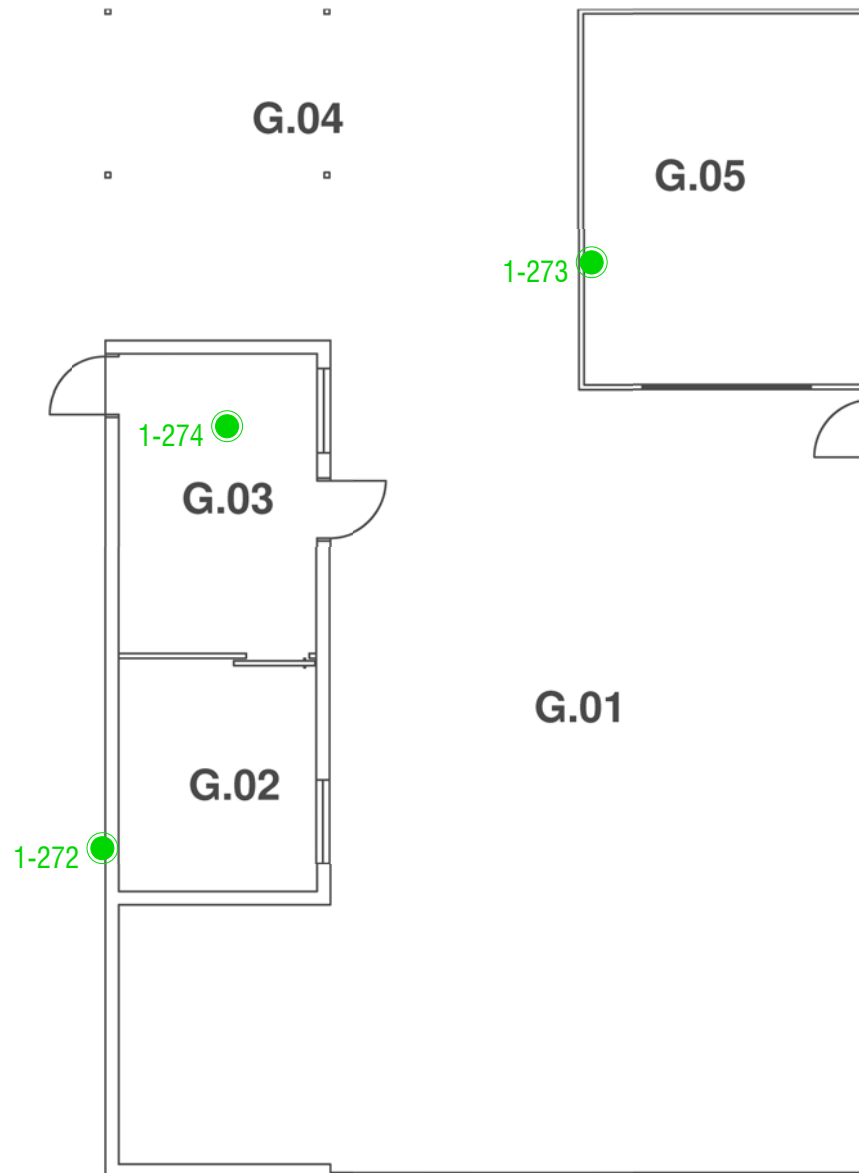
Building No:	72
Inspection Date:	Sept / Oct 2017
Inspected By:	NC / JH / SA
Figure No.:	SLR62210968-RN-72G-01
Drawn By:	LF
Drawn Date:	18/1/18

Sample location.  
No Asbestos Detected.
