## ASBESTOS CONTAINING MATERIALS SURVEY REPORT

Health Science B  
Building 77  
Rockhampton North

Report Number 622.10968.00000/0040-R01-ASR-Bld 77

27 December 2017

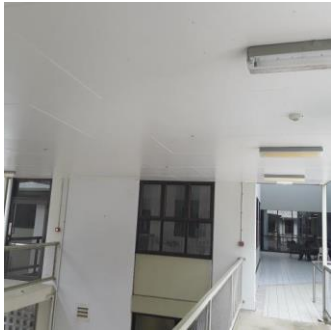
Sample No./ Visual Observation	Photo	Location			Analysis
		Int / Ext Floor Specific Location	Material Application	Extent	Result
1-520

1st Floor EXTERNAL	Ceiling lining that links bldg 77 to bldg 18, Fibrous Cement	60m²	NAD
1-521

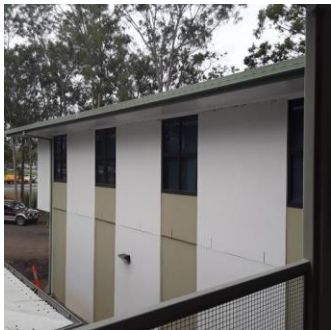
1st Floor EXTERNAL	Soffits all elevations to level 1, Fibrous Cement	74m²	NAD
