ASBESTOS CONTAINING MATERIALS SURVEY REPORT

Community Sports Complex
Building 081
Rockhampton North

Report Number 622.10968.00000/0040-R01-ASR-Bld081

27 December 2017

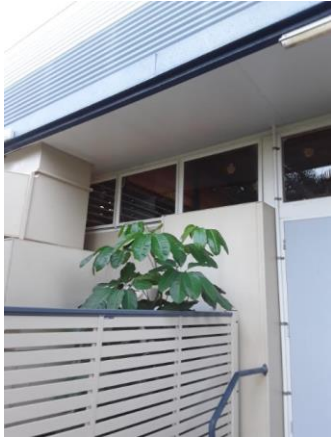
External South external wall	External cladding, Fibrous Cement	60m ²	NAD

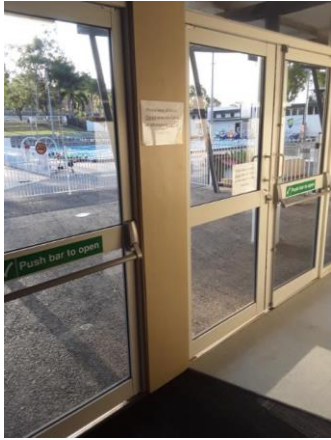
Ground Floor Doorway infill panels	Internal wall, Fibrous Cement	8m ²	NAD
1-336

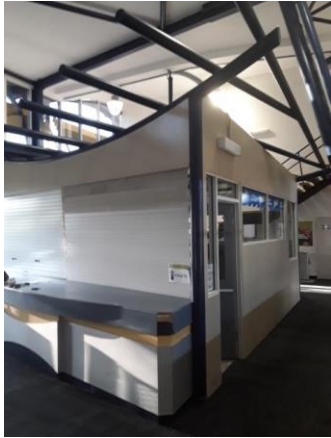
Ground Floor Canteen	Internal and cladding to canteen, Fibrous Cement	45m ²	NAD

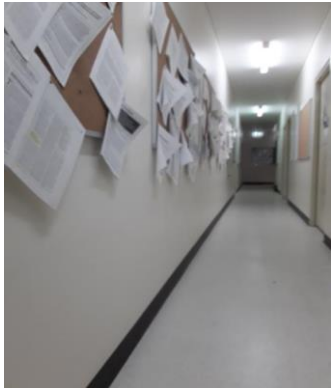
1st Floor Upstairs hallway	Internal wall, Fibrous Cement	65m²	NAD
Similar to 1-337

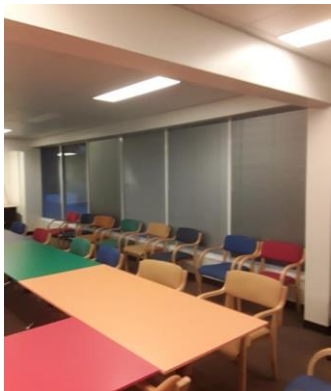
1st Floor Room 1.17 Northern wall	Internal wall, Fibrous Cement	65m²	NAD
