ASBESTOS CONTAINING MATERIALS SURVEY REPORT

Facilities Management Space Storage Rockhampton North

Reference	Date	Prepared	Checked	Authorised
622.10968.00000/0040-R01-v1-Bld209	27 December 2017	Jordan Harley	Narelle Carnes	Narelle Carnes

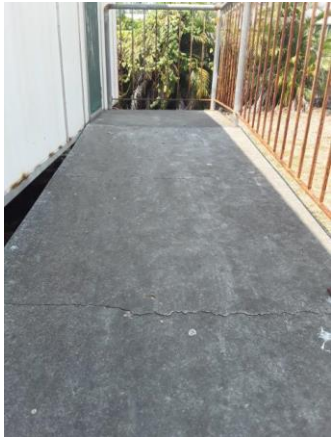
Sample No./ Visual Observation	Photo	Location			Analysis
		Int / Ext Floor Specific Location	Material Application	Extent	Result
1-277

External ramp	Concrete , Fibrous Cement		NAD

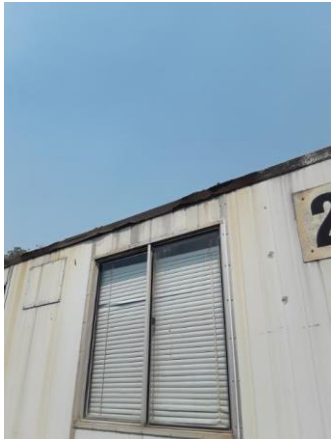
Sample No./ Visual Observation	Photo	Location			Analysis
		Int / Ext Floor Specific Location	Material Application	Extent	Result
1-278

External east wall	Bitumous sealant, Sealant	4m ²	NAD
