## ASBESTOS CONTAINING MATERIALS SURVEY REPORT

Facilities Management Space Storage  
Building 209  
Rockhampton North

Report Number 622.10968.00000/0040-R01-ASR-Bld209

27 December 2017

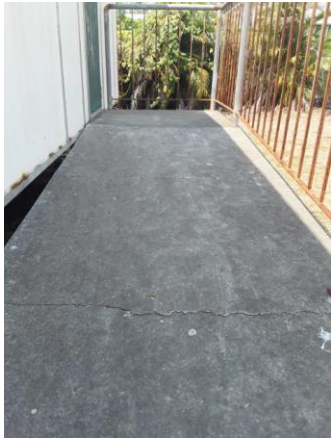
Sample No./ Visual Observation	Photo	Location			Analysis
		Int / Ext Floor Specific Location	Material Application	Extent	Result
1-277

External ramp	Concrete , Fibrous Cement		NAD

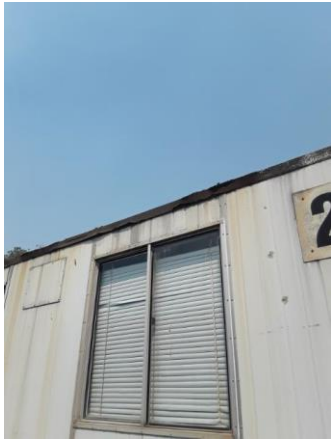
Sample No./ Visual Observation	Photo	Location			Analysis
		Int / Ext Floor Specific Location	Material Application	Extent	Result
1-278

External east wall	Bitumous sealant, Sealant	4m <sup>2</sup>	NAD
